July 8, 2016

RE: Nyack River Club Restaurant – Structural Assessment

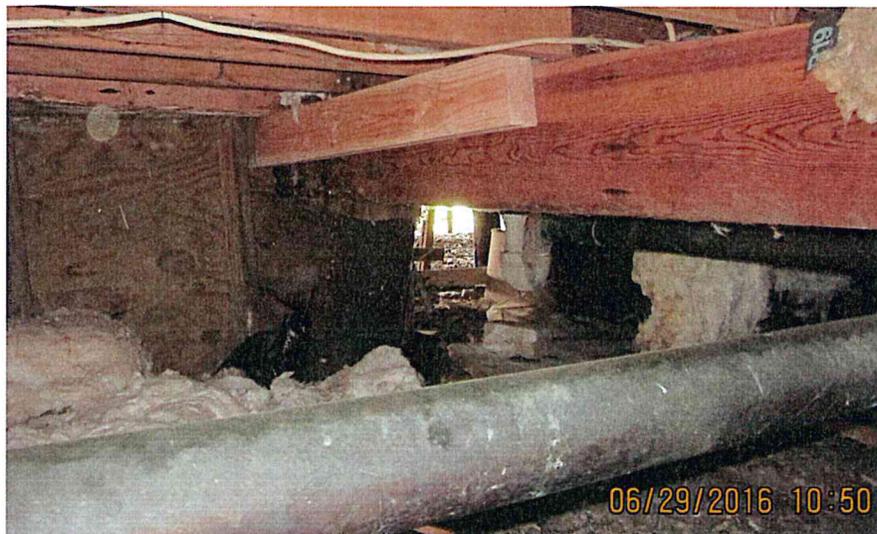
The most pressing deficiency observed was the crushing of the wood joist support beam ends from a combination of the heavy roof and floor loads, as well as the increased moisture content of the environment. It was determined that the three joist support beam ends in question do not provide sufficient bearing area for the wall and floor loads above, and as a result are crushing, causing excessive deformation of the floor they are supporting. Re-supporting the sagged wall and floor is required.

Problem Number 1 – Failing joist support beam end.

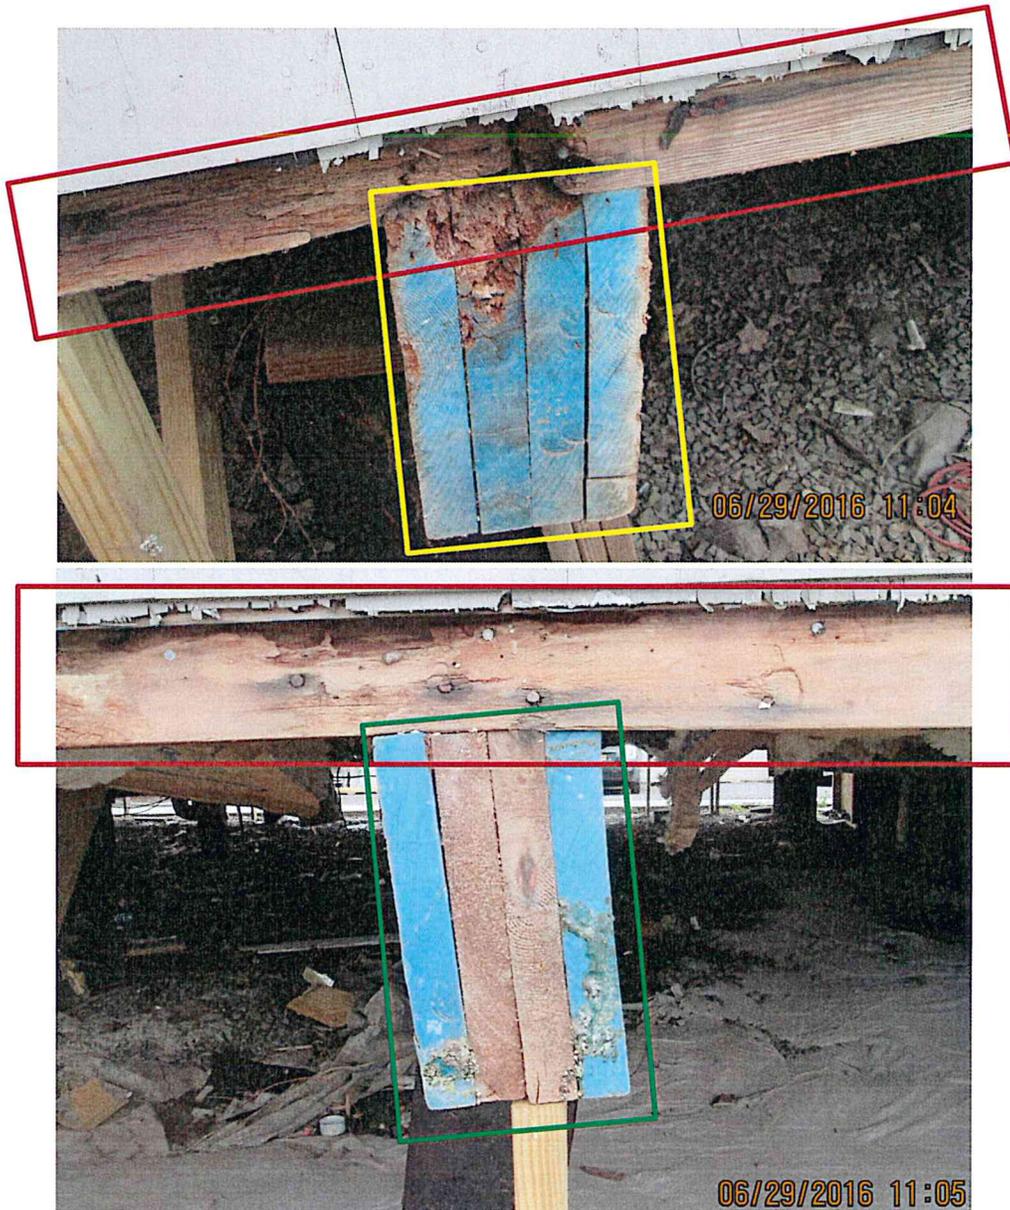
Another issue is the wood box beam along the southern edge of the building has been rotting away, leaving the structure vulnerable to future serviceability problems. Replacement of the rotten portion of the box beam is required.

Much like the box beam, this particular joist support beam end is also rotting away, creating a potential failure point. Re-supporting and blocking of the joist support beam is required.

Another joist support beam in the same area as Problems 2 and 3 is displaying a significant amount of twisting about its longitudinal axis. Re-supporting and blocking to prevent further rotation is required.

Problem Numbers 2 through 4 – Rotten box beam and compromised joist support beam ends.
Problem Number 2 in red, Problem Number 3 in yellow, and Problem Number 4 in green.

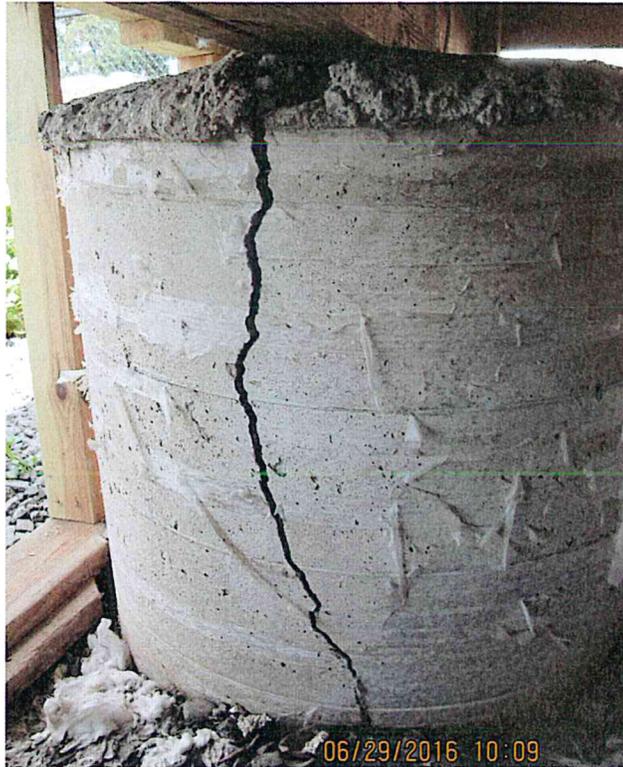
Inspection of the structure resulted in the discovery that a concrete piling cover in the South-Western most corner of the building had cracked down the middle, and is in danger of completely splitting in half. Replacement or strapping of the concrete is required.

Problem Number 5 – Severe cracking of the concrete piling cover.

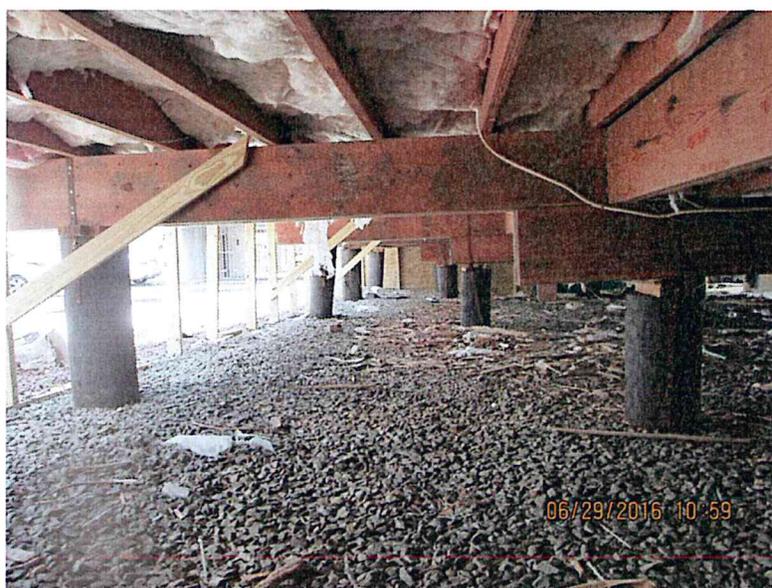
The joist support beams along the North-East wing of the building step up a significant amount, and could be at risk for lateral movement. Blocking at the joist support beam step point between all stepped beams is required.

Problem Number 6 – Joist support beam step.
