**Village of Nyack TAP
New Connectivities for Nyack
Village of Nyack, NY**

**Site Reconnaissance
Report**

**McLaren Project No. 150119.00
October 30, 2015**

Prepared by:
**McLaren Engineering Group
100 Snake Hill Road
West Nyack, NY 10994
(845) 353-6400**

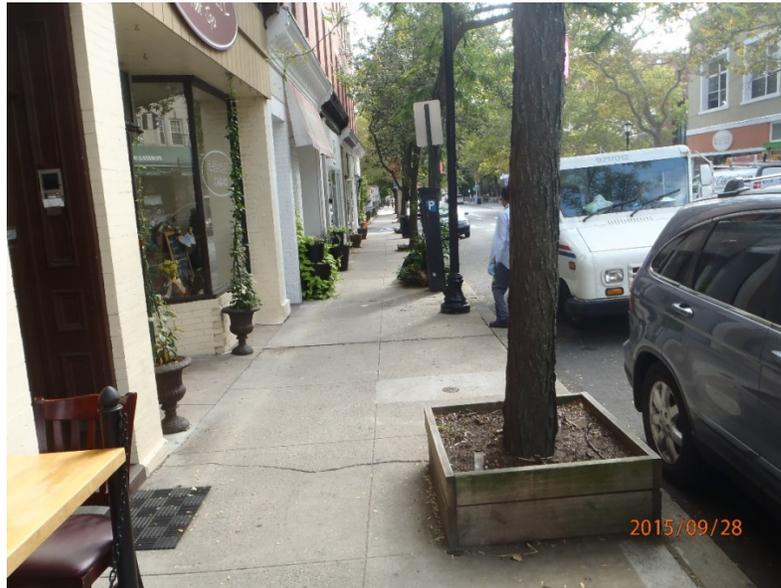
1. Sidewalk Width

Sidewalk Eastside of Broadway, Between Burd and Main Streets

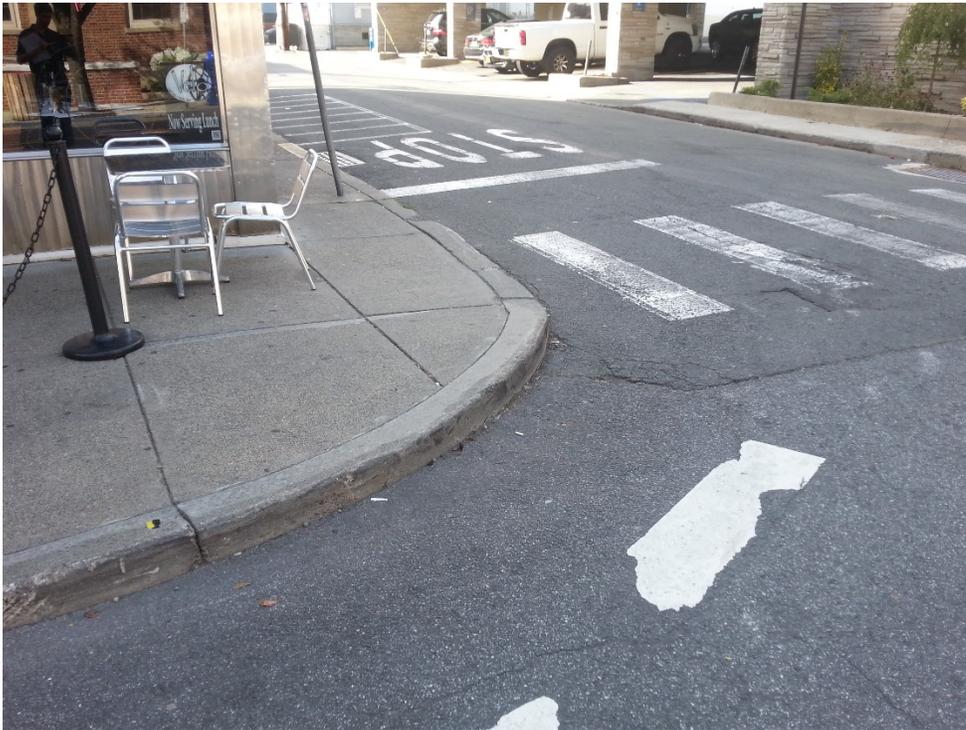
4. Competing Uses For Sidewalk Space

Corner of New and Broadway

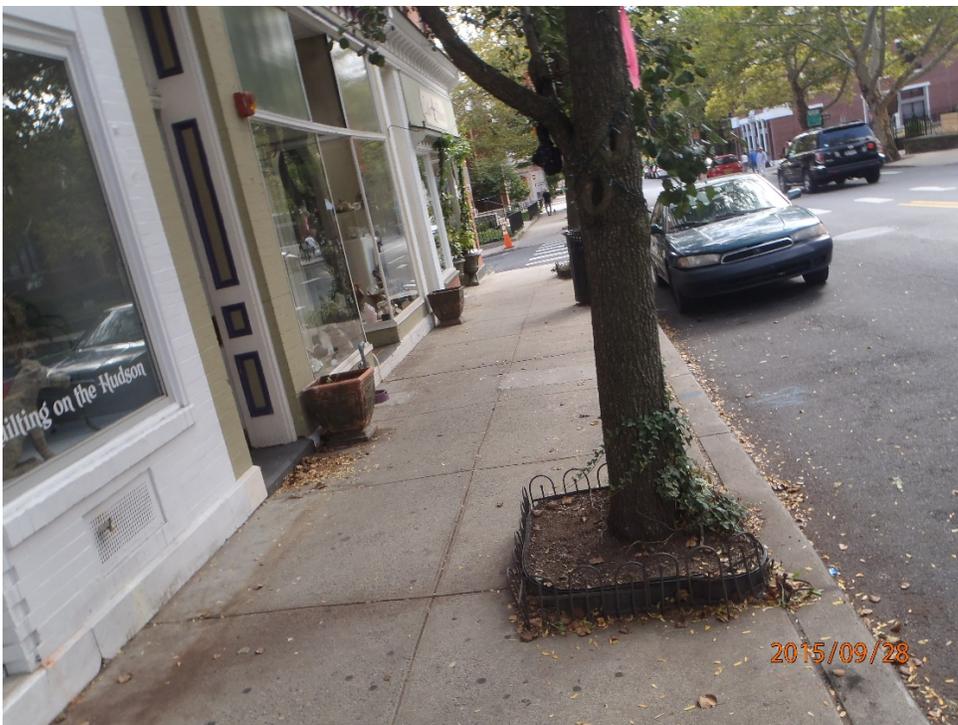
5. Trip hazards of low planting areas and survivability of plantings

Sidewalk of Broadway Between Main and Burd

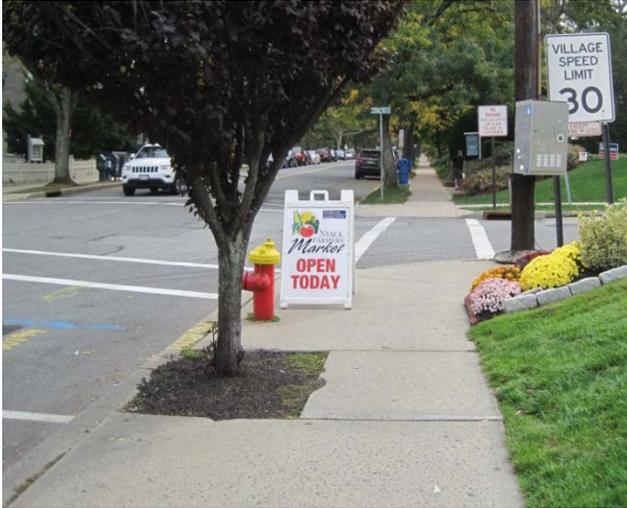
Concrete Sidewalk at transition to Residential Area
Location: NW Corner of Cedar Hill Ave.

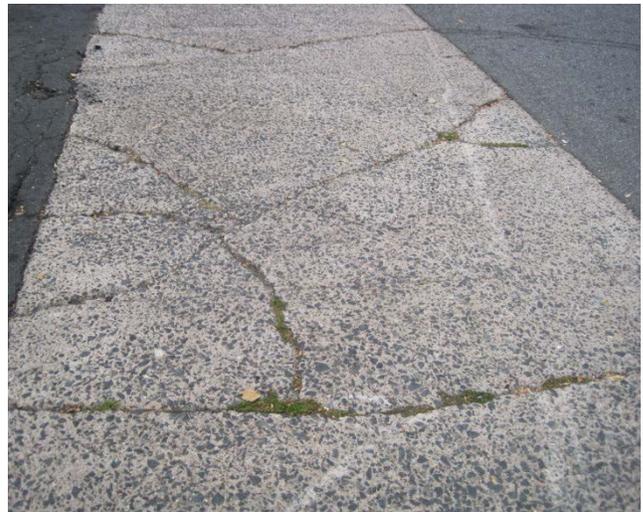
Cracked Exposed Aggregate Concrete Driveway
Location: Gas Station North of Cedar Hill Ave.

The paving on this section of Broadway changes from typical concrete to exposed aggregate. A large driveway provides access to the Citgo gas station. There are signs of wear which include extensive cracking, patching and areas where heaved concrete has been shaved down. Two empty tree pits are present.

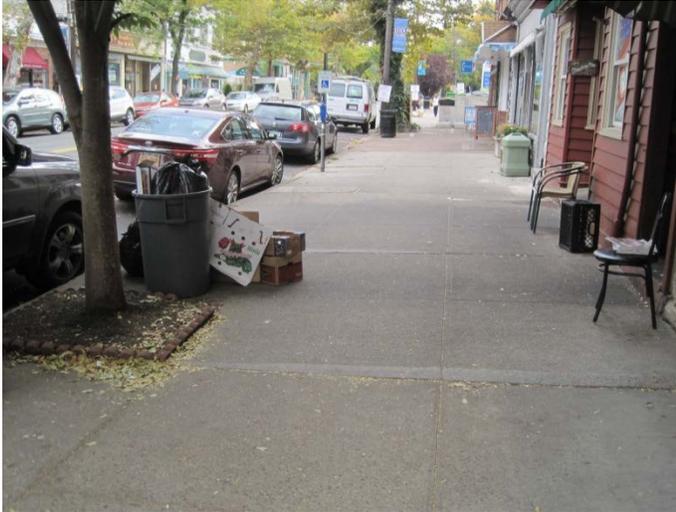
Concrete Sidewalk with shaved areas/heaving
Location: Between Cedar Hill Ave. and Hudson Ave.

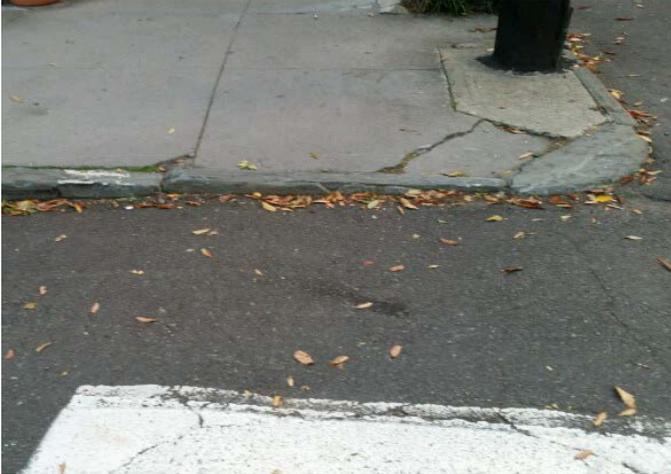
Stone Curb and Cracked Concrete
Location: NW Corner of Hudson Ave.

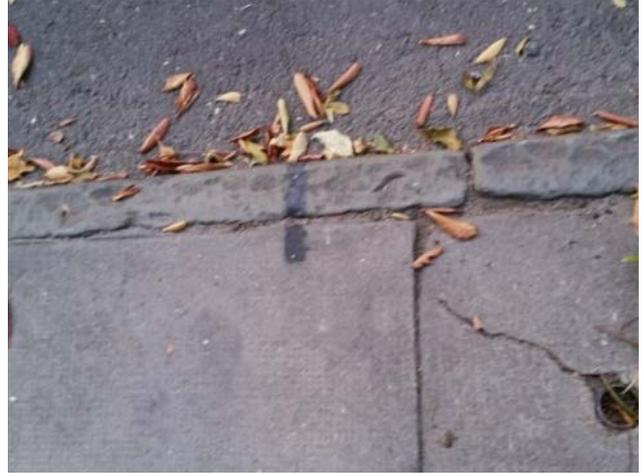
Detail Stone Curb
Location: ~100' From NW Corner of Hudson

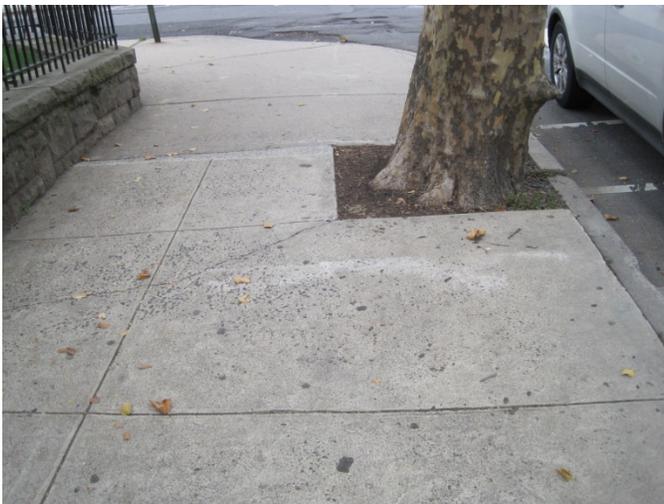
Concrete Sidewalk with Cracks and Shaved Areas
Location: Brick House, NW Corner Church Ave.

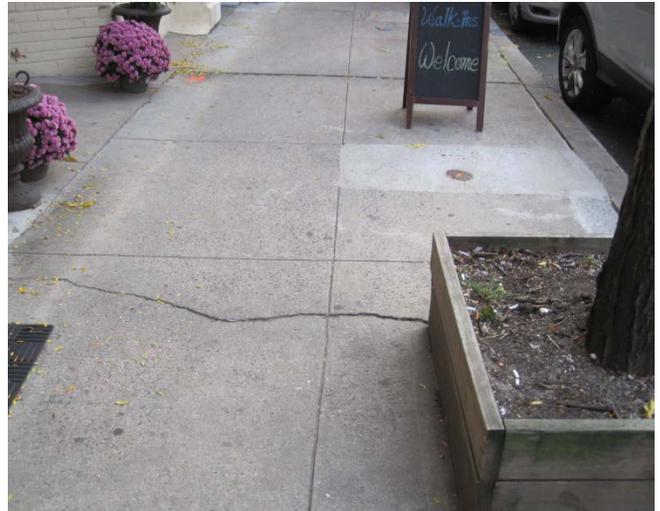
Cracking, Shaved Concrete and Raised Tree Planter
Location: Between Burd St. and Main St.

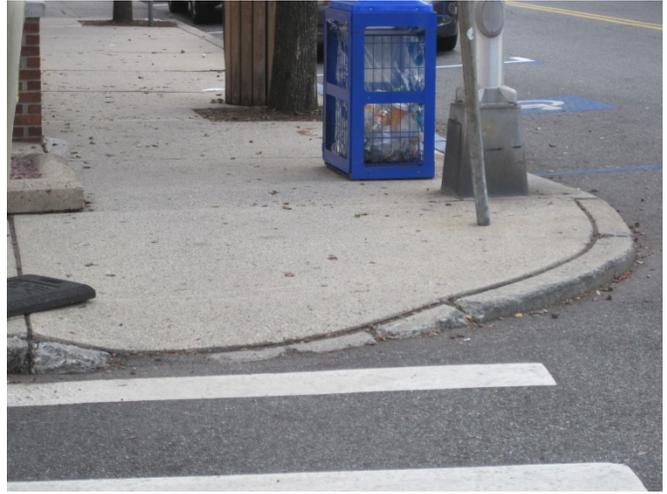
Crosswalk Ramp, Broken Curb
Location: NE Corner Lydecker St.

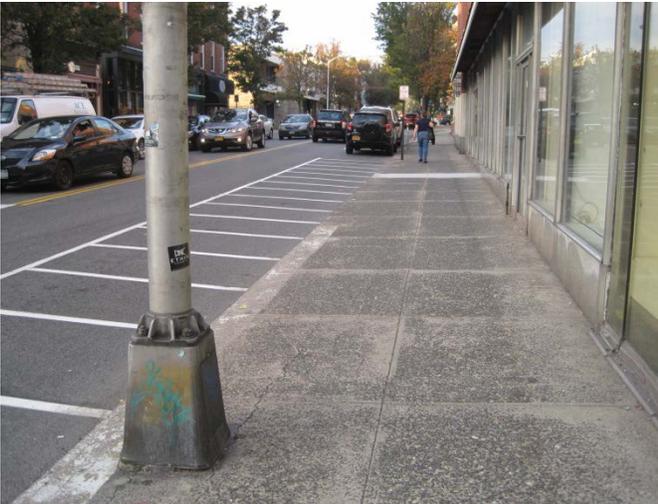
Exposed Aggregate Sidewalk and Curb
Location: SE Corner Main St.

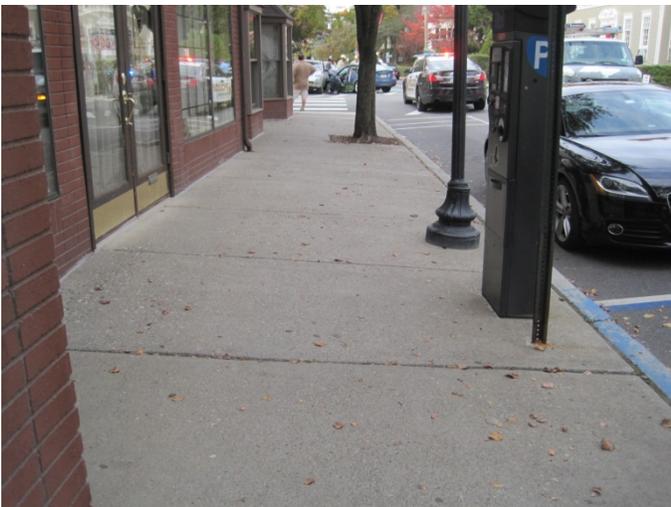
Wider Sidewalk Condition
Location: Between High Ave. and First Ave.

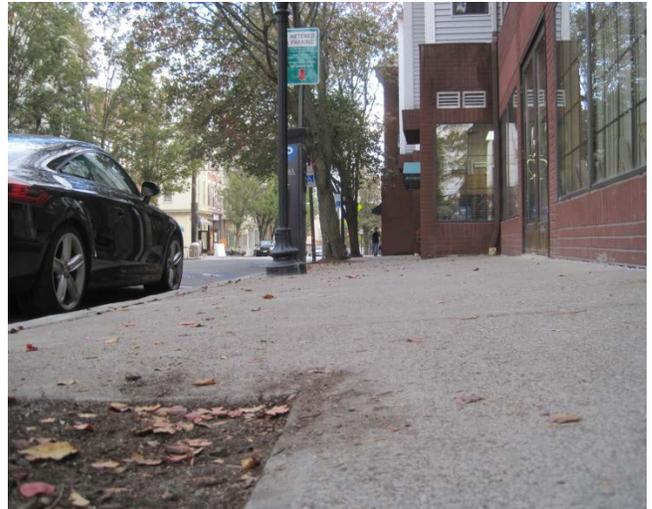
Cross-slope Greater Than Normal Down to Curb
Location: NW Corner First Ave.

Sidewalk has greater than normal cross-slope from building down to curb.

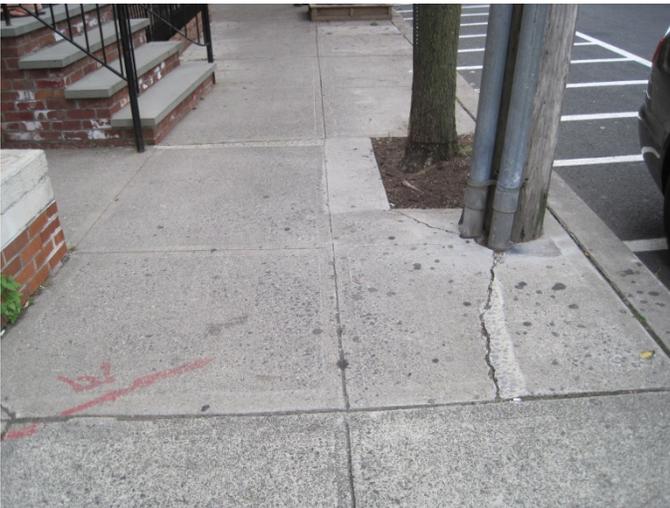
Cracking and Patch at Tree Well
Location: Between High Ave. and First Ave.

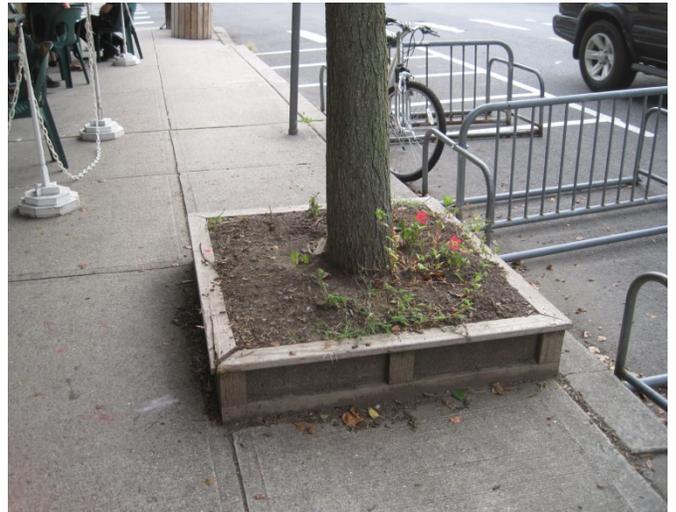
Raised Tree Planter
Location: NE Corner High Ave.

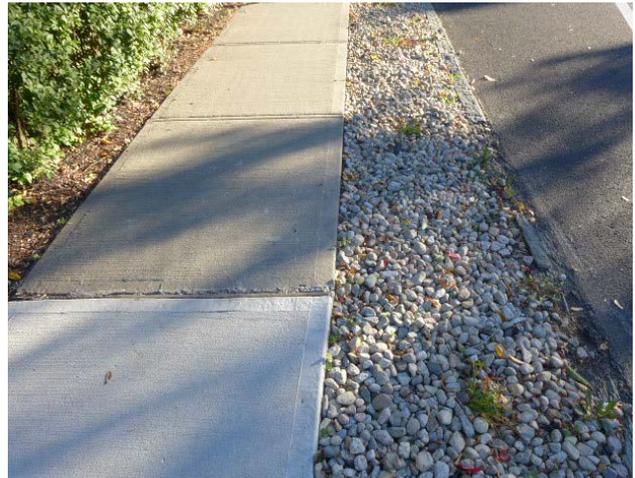
Parkway with Gravel, Only occurs this Residence
Location: East Side Between 4th Ave. and 3rd Ave.

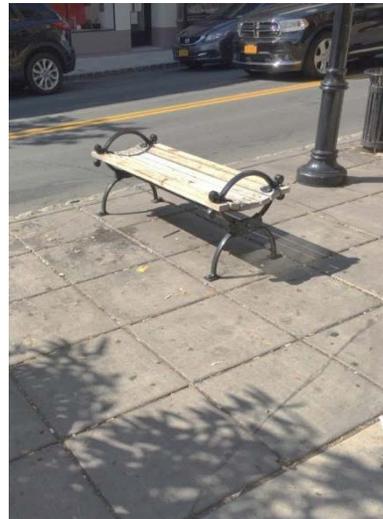
Wood Slat and Metal Base Bench
Location: Starbucks on Main St.

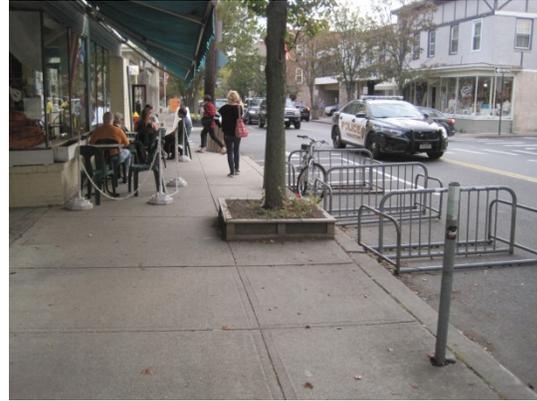
Bicycle Racks
Location: NE Corner High Ave.

There were only two locations where bicycle parking was observed, evidence that there is limited bicycle parking present in the Village. Furthermore, the bicycle racks may be a security risk for users because the racks are not securely fastened to the ground surface. Considering that Nyack is a popular destination for cyclists it may be advisable to install secure, aesthetically integrated bicycle parking. There is a great opportunity to integrate bicycles into the street infrastructure.

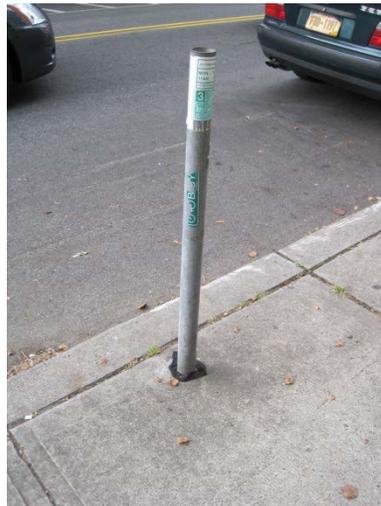
Parking Meter Post
Location: Downtown Blocks

Parking meters are present throughout the downtown zone. There are three types of parking meters in the project area: blue ADA meters, red Village Hall parking meters, and automated parking meters. The ADA parking meters control one single parking space that is reserved for handicapped drivers. The automated parking meters control multiple parking spaces along the street, and they operate with coins and cards for payment. There are some remnant parking meter posts along the project area on Broadway, which may be hazardous to pedestrians. It may be advisable to saw cut the posts flush with the sidewalk.

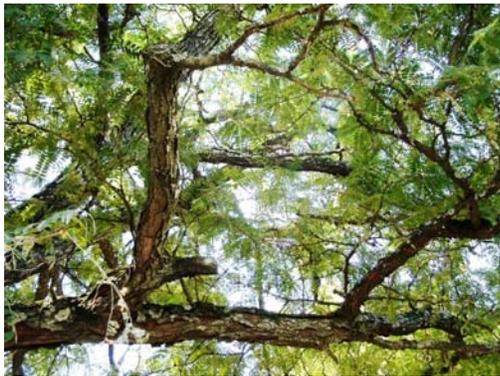
Tree: <i>Gleditsia triacanthos inermis</i> Name: HONEYLOCUST Caliper (DBH): 16	Location: 37 S. Broadway Block No.: Lot No.:	Station Offset:	Tree No. 2
Comments: MINOR DEAD LOWER BRANCHES Condition: 28/32		Date: 9/24/2015 Time: Weather: Sunny Temp: 73 degrees F	
Mitigation Case #:		Cut(-)/Fill(+) (in.):

Dead lower branches

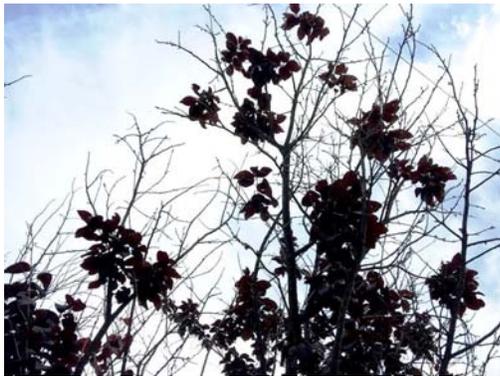
Tree: <i>Prunus cerasifera</i> Name: PLUM, PURPLELEAF Caliper (DBH): 6	Location: 38 S. Broadway Block No.: Lot No.:	Station Offset:	Tree No. 3
Comments: MINOR TRUNK DAMAGE; DEAD SMALLER BRANCHES; POOR FOLIAGE Condition: 25/32		Date: 9/24/2015 Time: Weather: Sunny Temp: 73 degrees F	
Mitigation Case #:		Cut(-)/Fill(+) (in.):

Dead branches

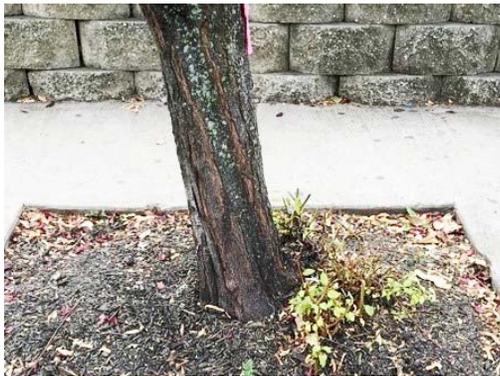
Tree: <i>Prunus cerasifera</i> Name: PLUM, PURPLELEAF Caliper (DBH): 8	Location: 39 S. Broadway Block No.: Lot No.:	Station Offset:	Tree No. 4
Comments: BASAL SPROUTS; MINOR TRUNK DAMAGE Condition: 28/32		Date: 9/24/2015 Time: Weather: Sunny Temp: 73 degrees F	
Mitigation Case #:		Cut(-)/Fill(+) (in.):

Trunk damage

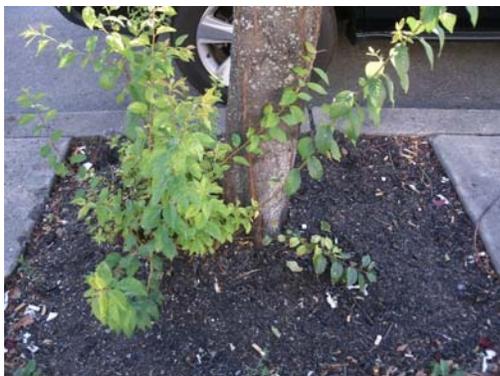
Tree pit

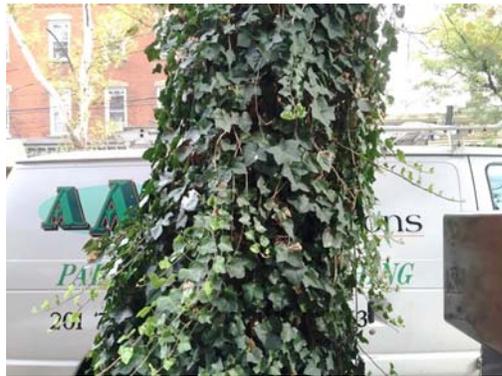
Tree: <i>Platanus x acerifolia</i> Name: LONDON PLANETREE Caliper (DBH): 23	Location: 40 S. Broadway Block No.: Lot No.:	Station Offset:	Tree No. 5
Comments: BURIED ROOT COLLAR IN RAISED PLANTER; MAJOR VINE COVERAGE; CANOPY IN CONFLICT WITH POWER LINES; PARKING METER POST IN TREE PIT Condition: 27/32		Date: 9/24/2015 Time: Weather: Sunny Temp: 73 degrees F	
Mitigation Case #:		Cut(-)/Fill(+) (in.):

Vines climbing trunk

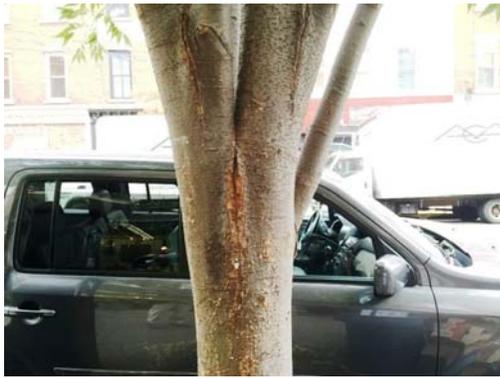
Tree: <i>Zelkova serrata</i> Name: ZELKOVA, JAPANESE Caliper (DBH): 10	Location: 41 S. Broadway Block No.: Lot No.:	Station Offset:	Tree No. 6
Comments: BURIED ROOT COLLAR; INCLUDED BARK; CANOPY IN CONFLICT WITH POWER LINES Condition: 28/32		Date: 9/24/2015 Time: Weather: Sunny Temp: 73 degrees F	
Mitigation Case #:		Cut(-)/Fill(+) (in.):

Included bark

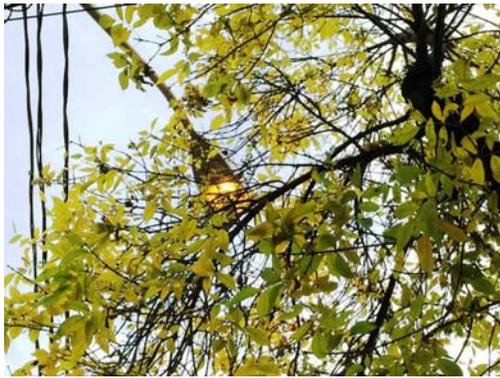
Canopy in conflict with street light

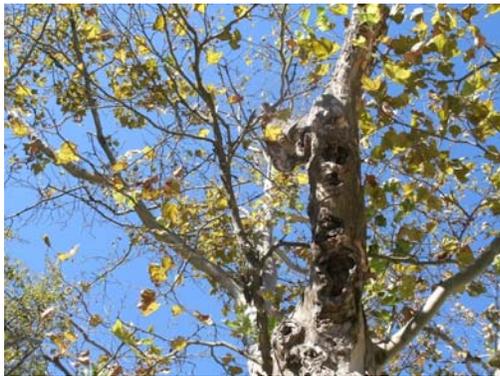
Dead leader and branches

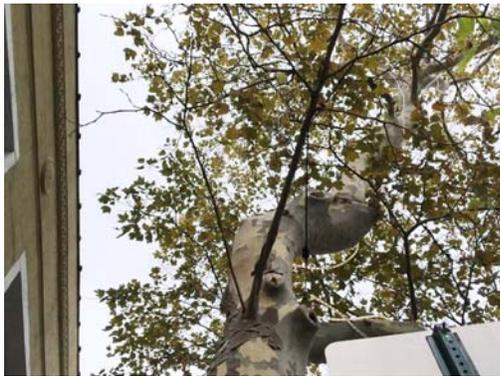
Minor dead branches

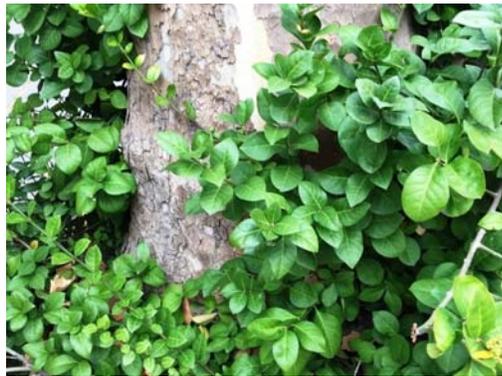
Vines climbing up trunk

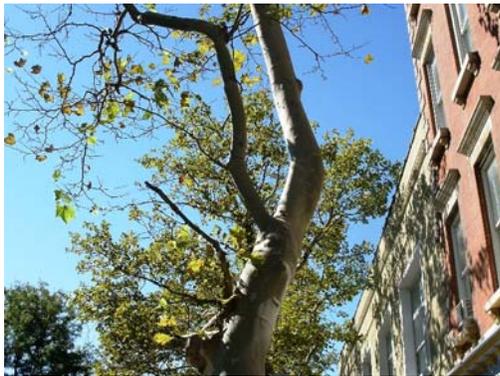
Major dead branches

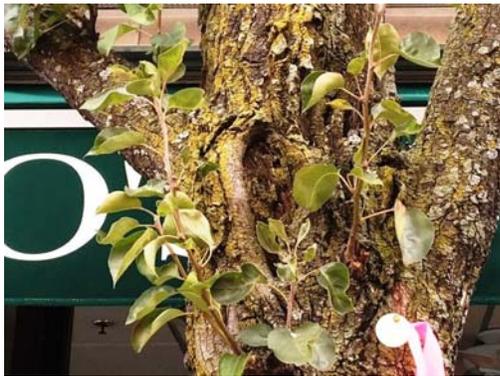
Watersprouting on trunk

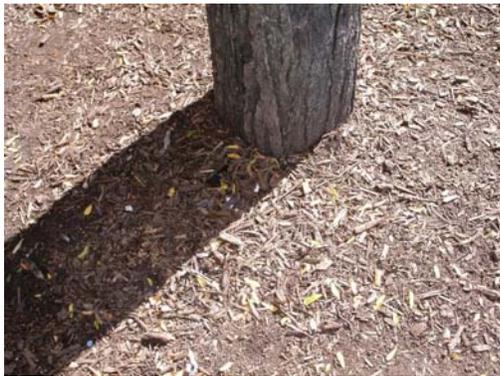
Buried root collar

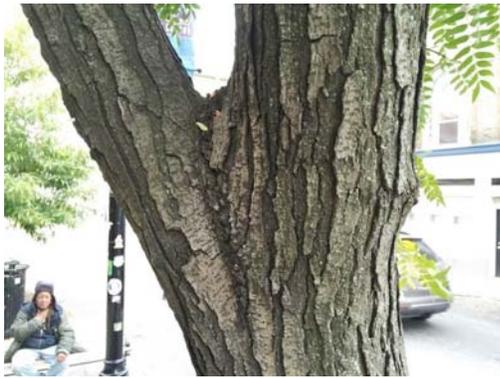
Included bark

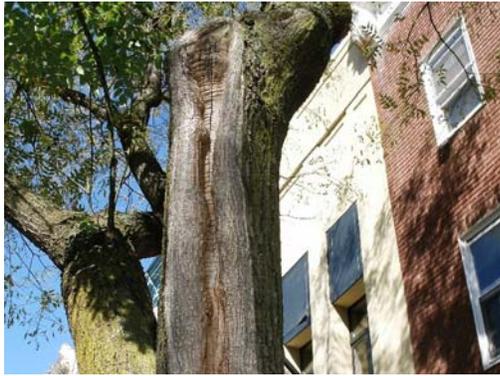
Major scaffold damage

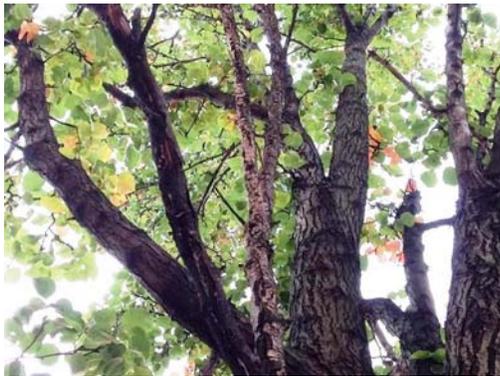
Minor dead branches

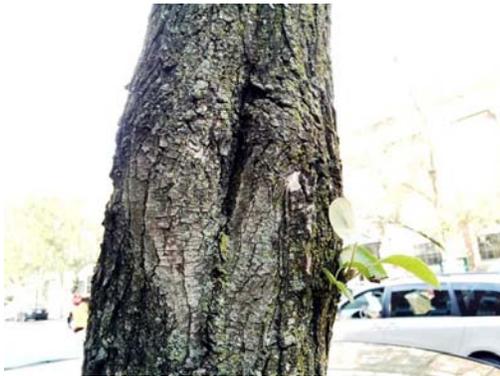
Minor trunk wound

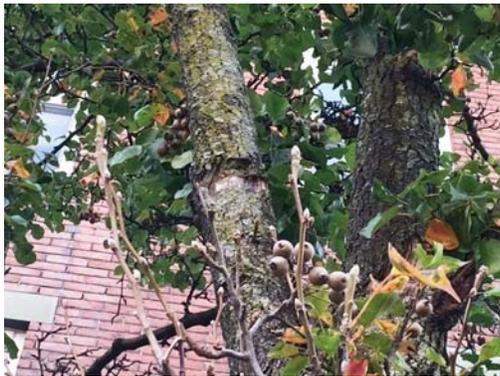
Damage to scaffold branches

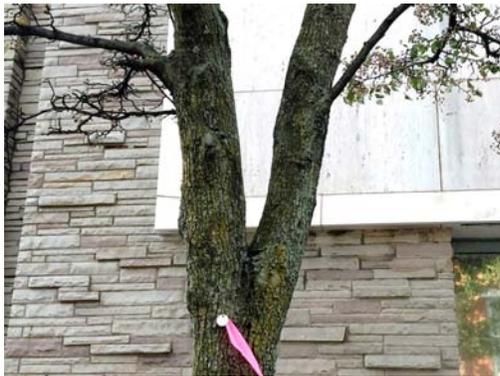
Codominant leaders

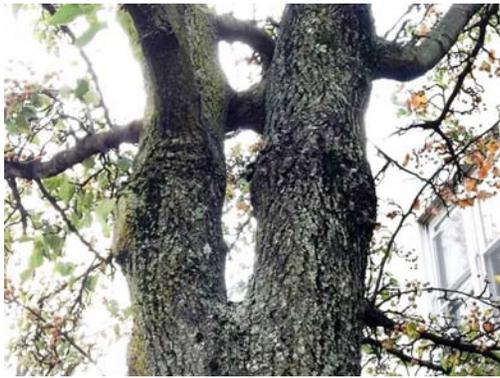
Codominant leaders

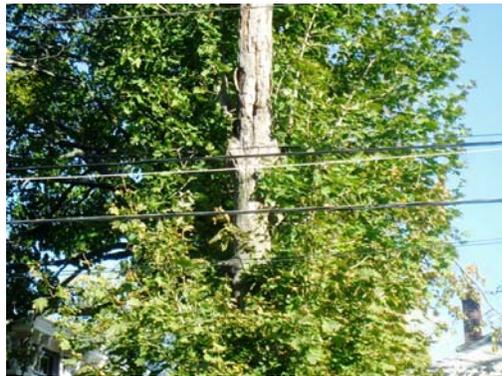
Major scaffold damage

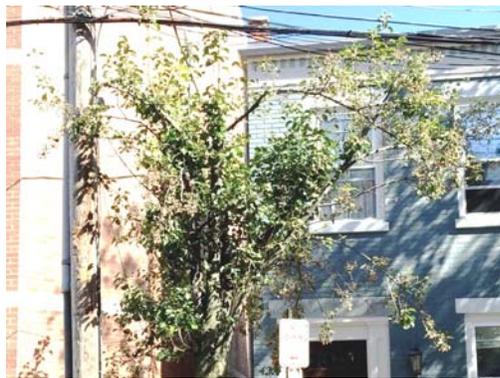
Topped leader

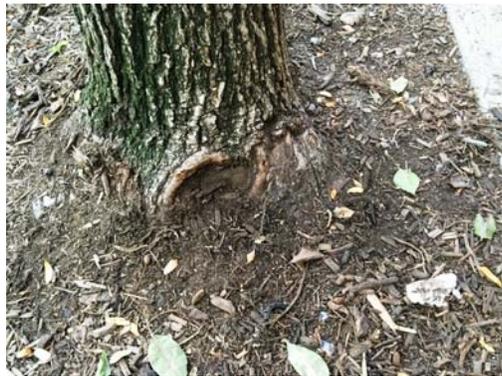
Minor root flare damage

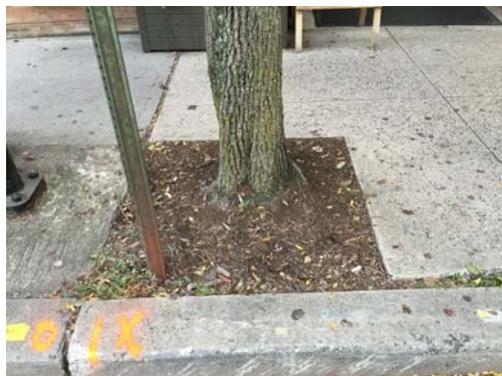
Undersized tree pit with sign post

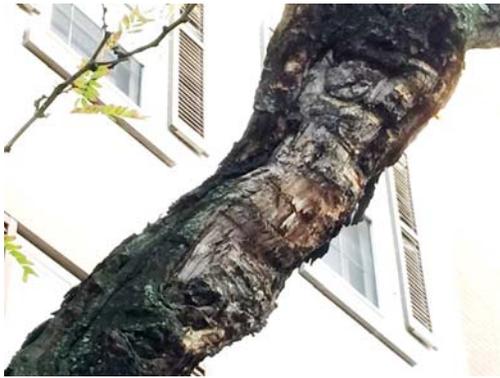
Major damage to scaffold branch

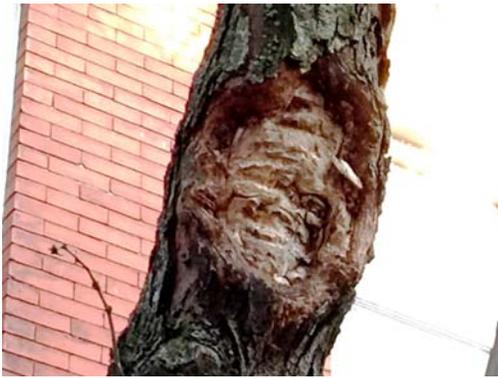
Major damage to trunk

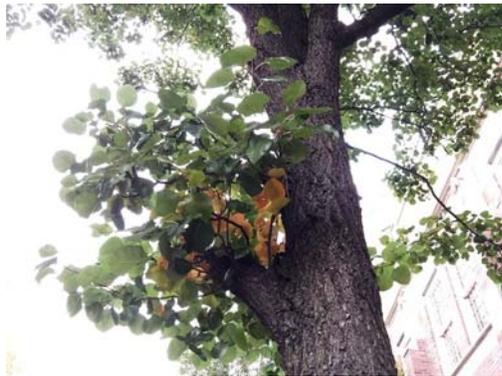
Broken minor branch

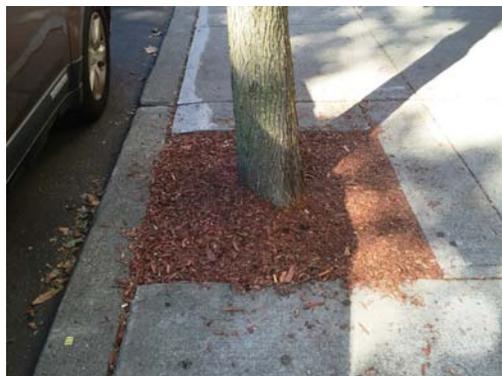
Undersized tree pit

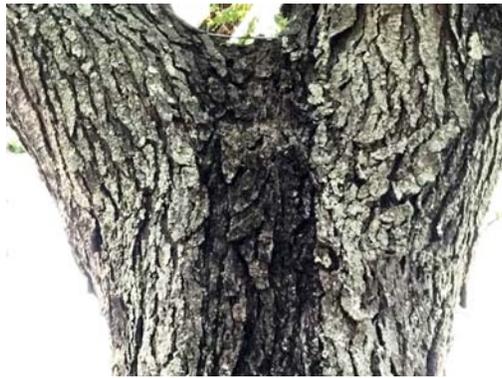
Included bark
