**Village of Nyack TAP
New Connectivities for Nyack
Village of Nyack, NY**

**Site Reconnaissance
Report**

**McLaren Project No. 150119.00
October 30, 2015**

Prepared by:
**McLaren Engineering Group
100 Snake Hill Road
West Nyack, NY 10994
(845) 353-6400**

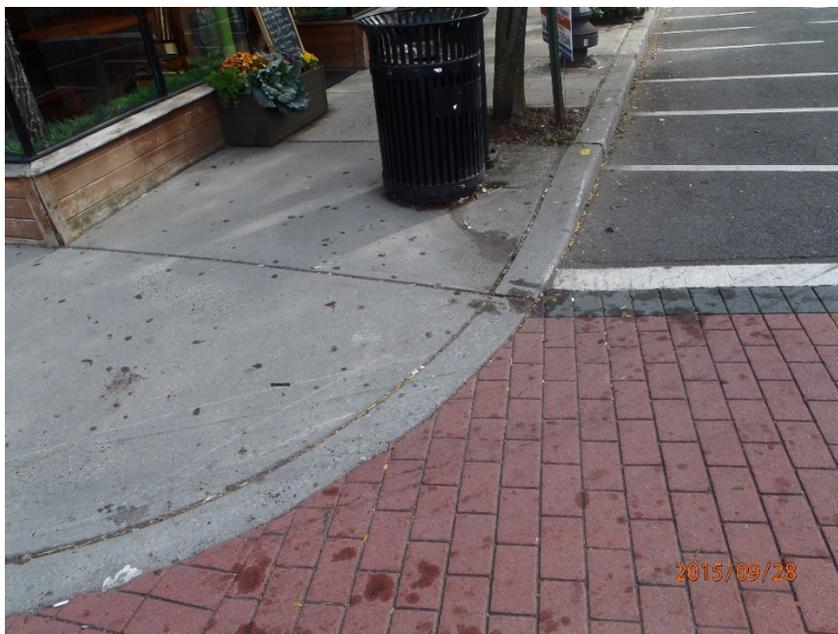
Corner of Main and Broadway

2. Obstruction in Sidewalks Reduce Width

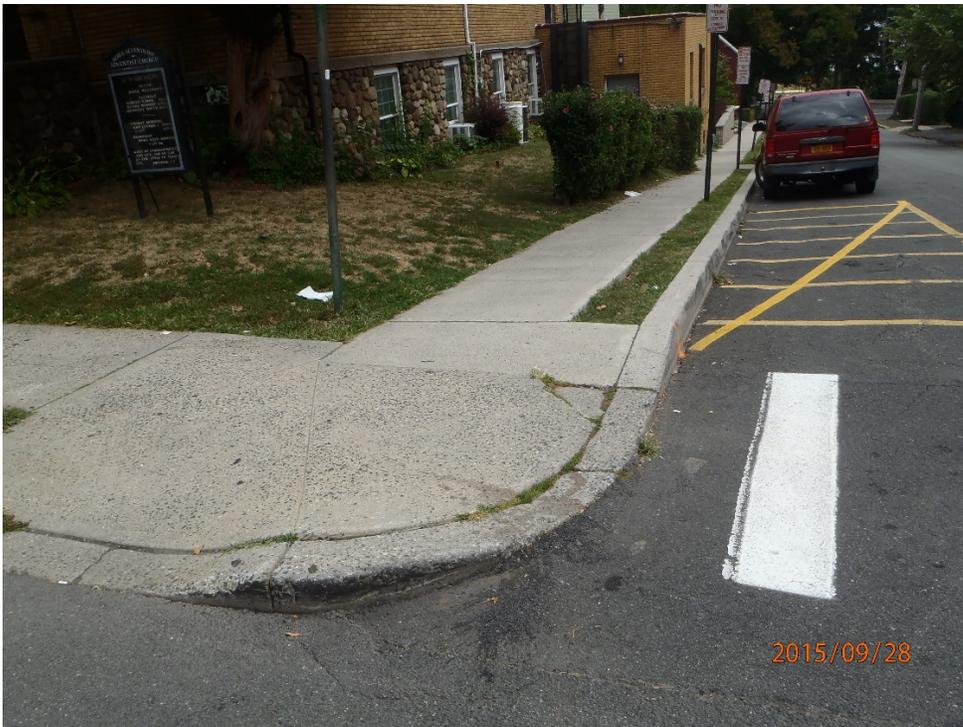
Corner of Hudson and Broadway

3. ADA Ramps and Coordinated Crosswalks

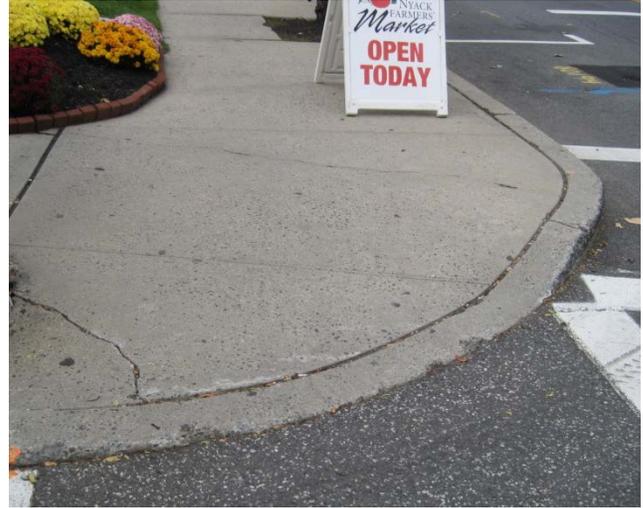
Concrete Ramp and Curb
Location: NW Corner of Cedar Hill Ave.

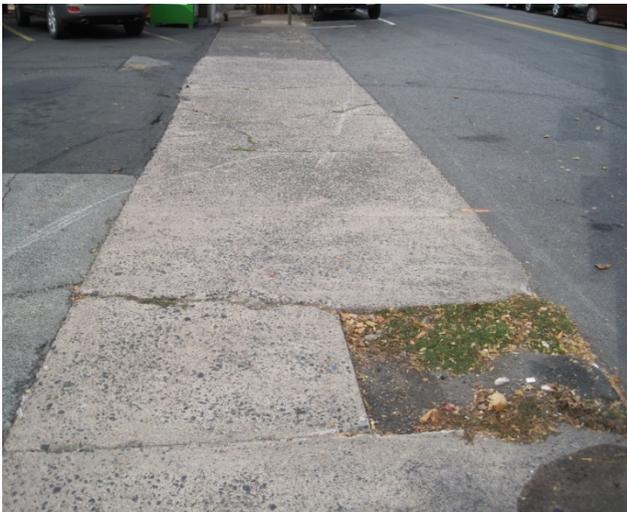
Exposed Aggregate Driveway with Empty Tree Pit
Location: Gas Station North of Cedar Hill Ave.

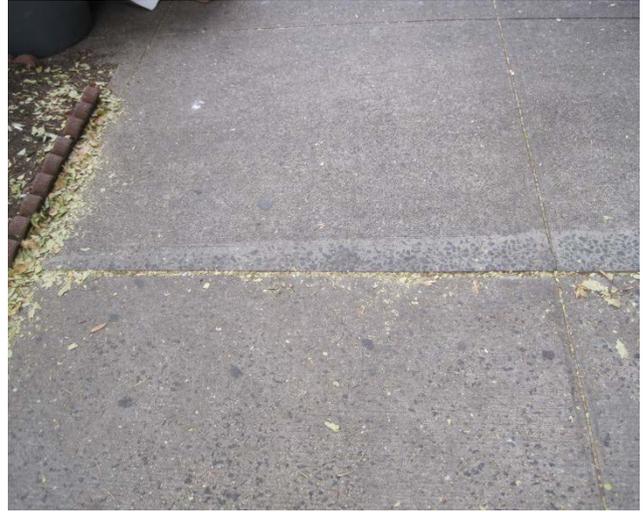
Detail of Shaved Areas
Location: Between Cedar Hill Ave. and Hudson Ave.

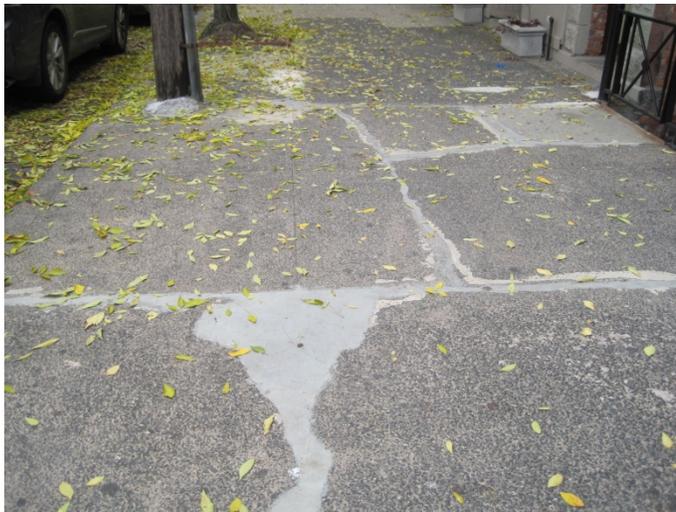
Exposed Aggregate Sidewalk with Concrete Patches
Location: Between Cedar Hill Ave. and Hudson Ave.

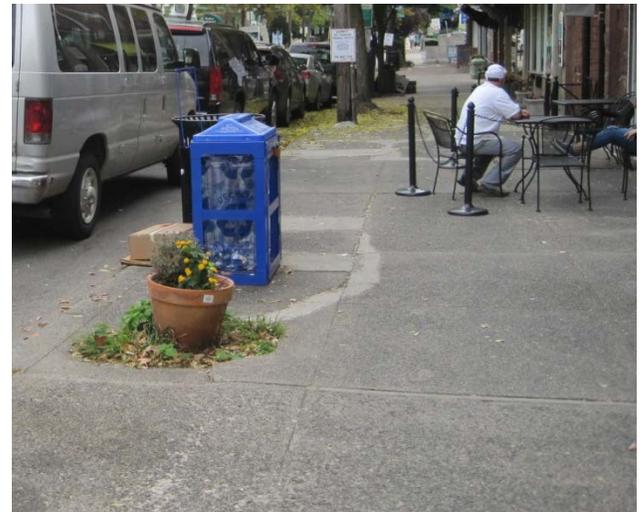
Exposed Aggregate Sidewalk with Empty Tree Pit
Location: NE Corner of Hudson Ave.

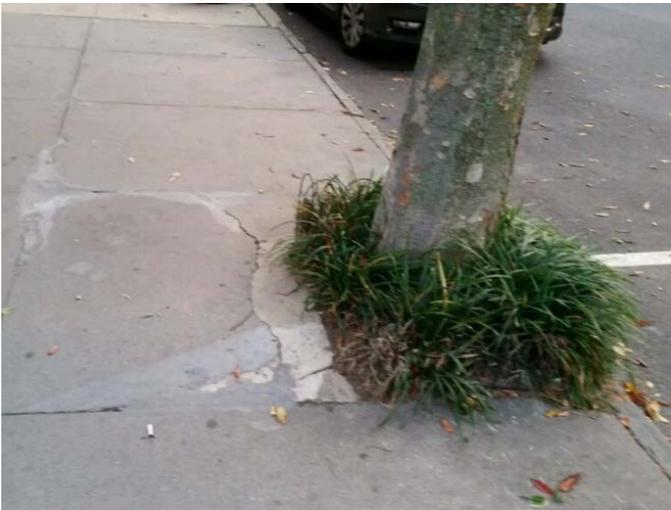
Heaving Sidewalk, Patched and Shaved
Location: Between Cedar Hill Ave. and Hudson Ave.

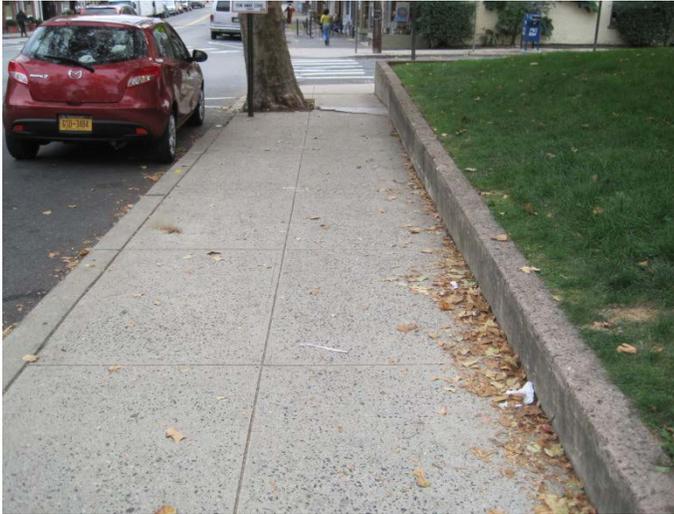
Concrete Sidewalk with shaved areas/heaving
Location: Between Hudson Ave. and Depew Ave.

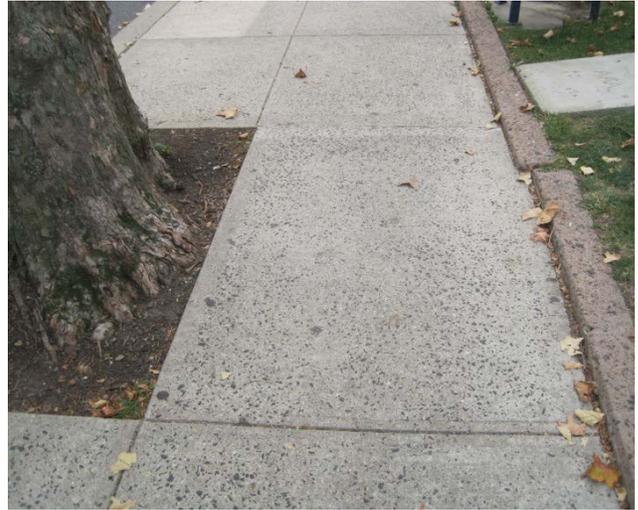
Shaved Concrete Area/Heaving Adjacent to Tree
Location: Between Hudson Ave. and Depew Ave.

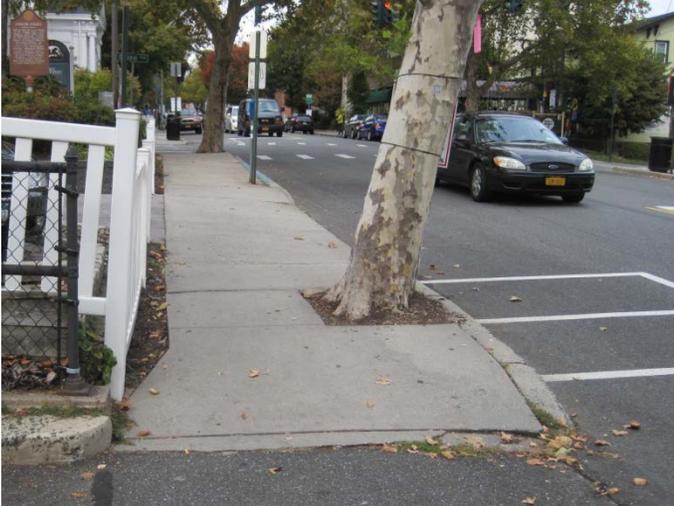
5' Sidewalk with Small Tree Pits
Location: Between Hudson Ave. and Depew Ave.

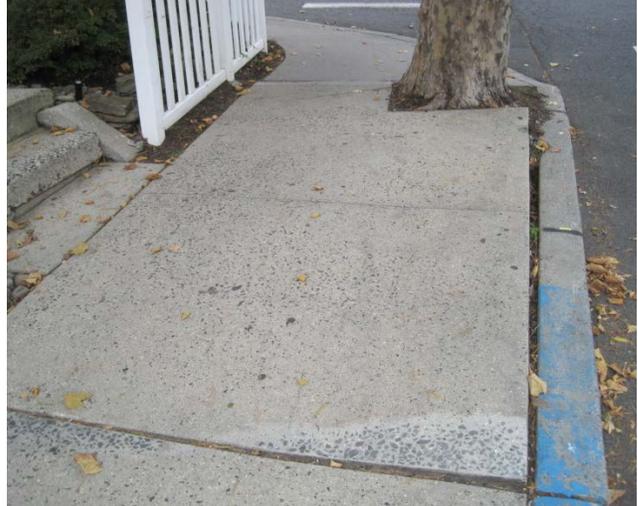
Shaved Concrete Sidewalk, Significant Heaving
Location: NE Corner of Depew Ave.

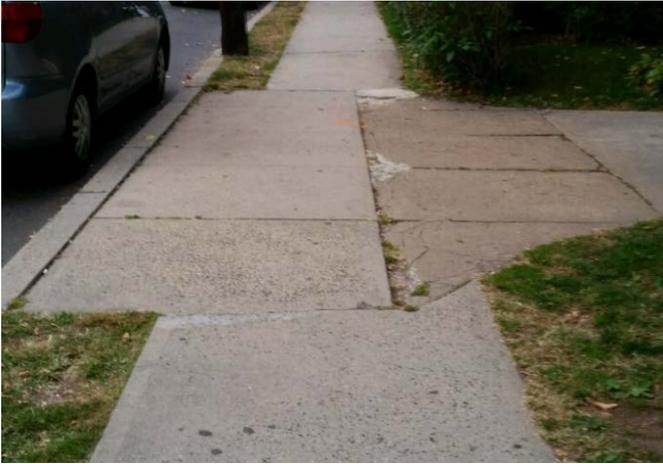
Concrete Sidewalk w/Patch at Church Entry
Location: SE Corner of Hudson Ave.

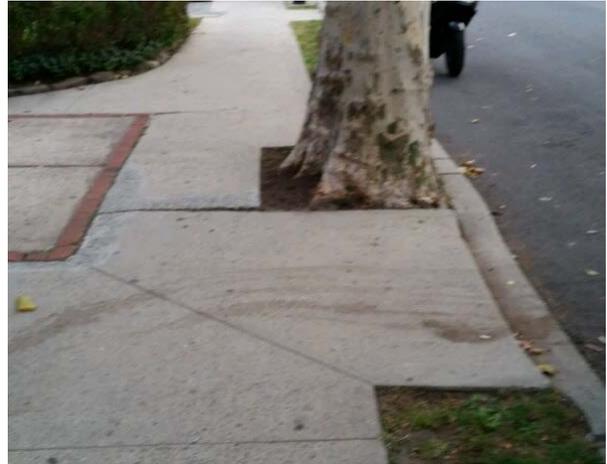
Mid-block Ramp and Enhanced Paving at Library
Location: Between Hudson Ave. and Depew Ave.

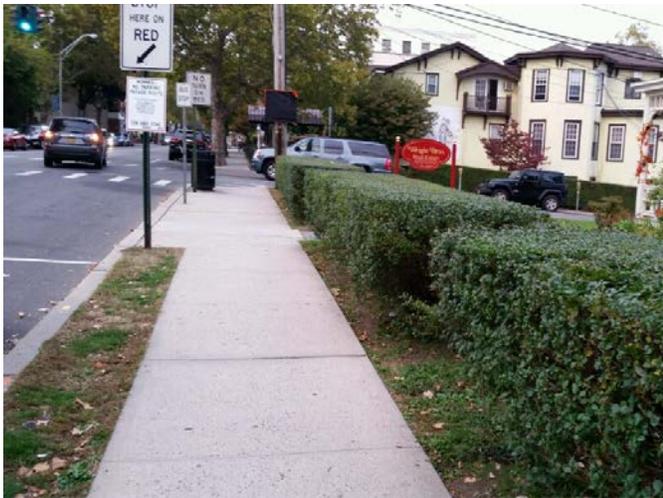
5' Sidewalk with 1' Parkway
Location: NW Corner Depew Ave.

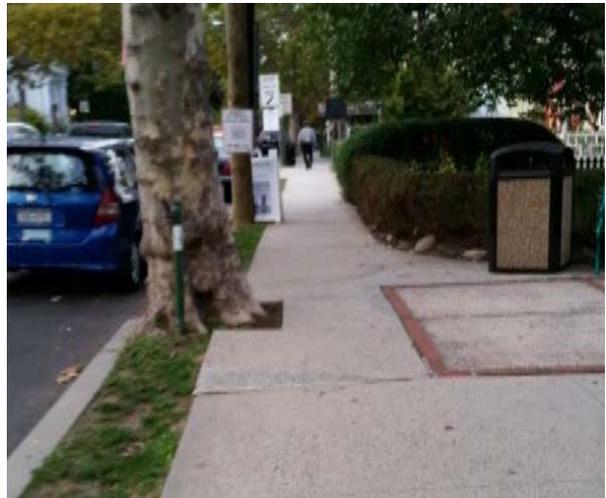
Shaved Concrete Sidewalk, Heaving at Library
Location: Between Hudson Ave. and Depew Ave.

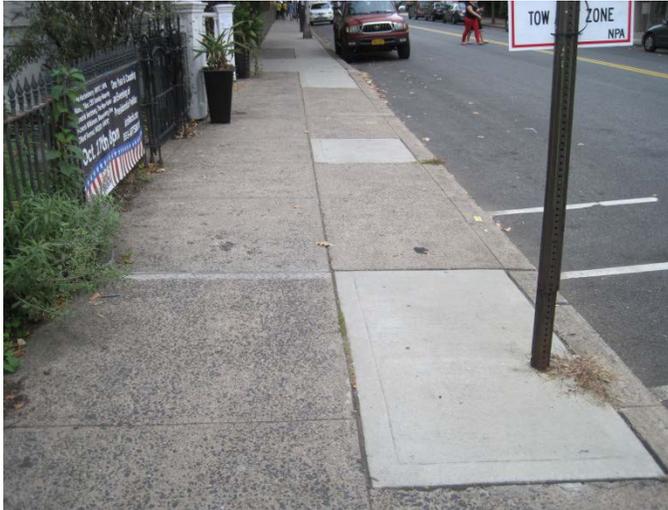
Exposed Aggregate Sidewalk with Typ. Concrete Patches
Location: SW Corner of Depew St.

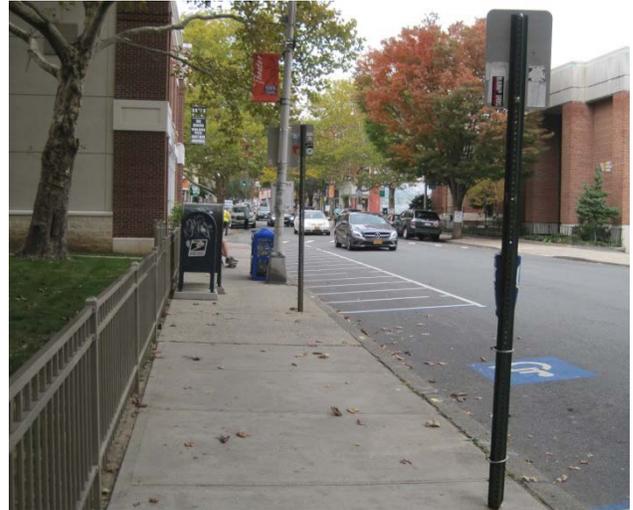
Concrete Sidewalk and Curb
Location: Between Depew Ave. and Church St.

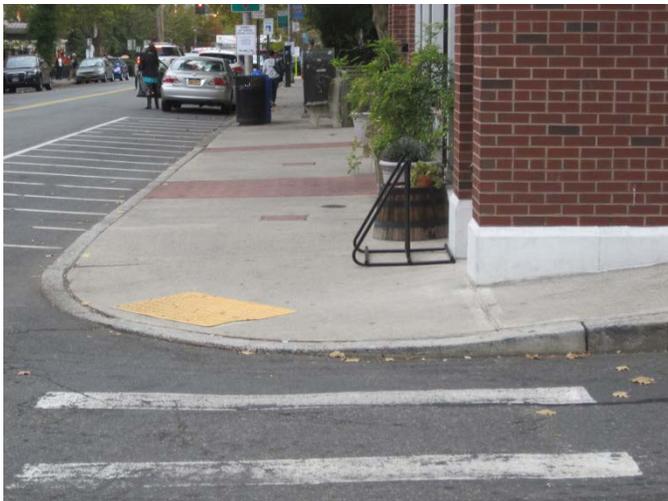
Stamped Concrete Accent Paving
Location: Brick House, NW Corner Church Ave.

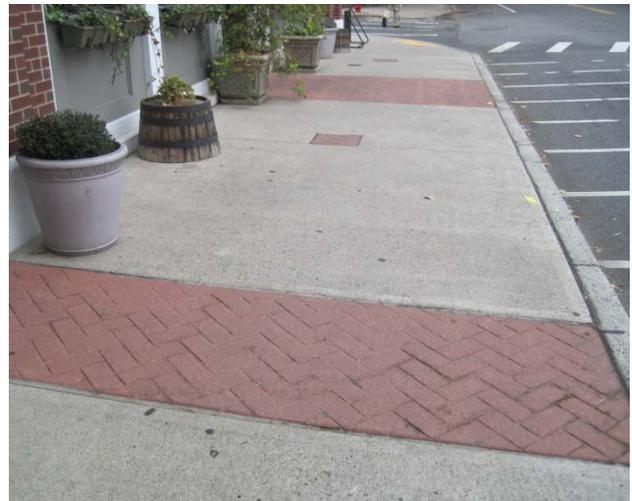
Detail Stamped Concrete
Location: NW Corner Church Ave.

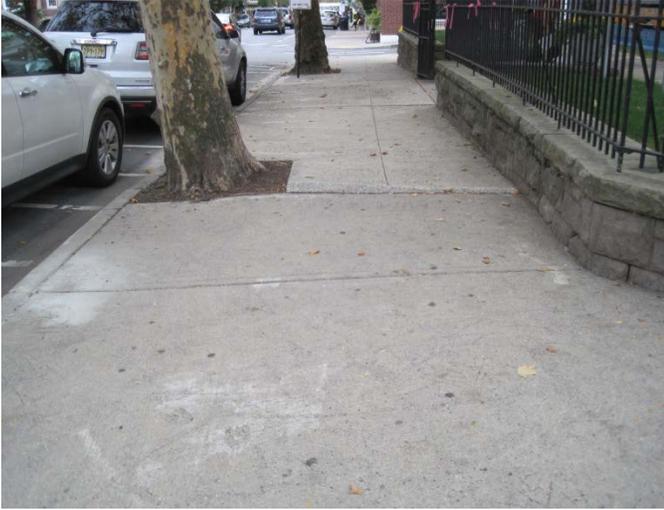
Concrete Sidewalk with Small Tree Wells
Location: SW Corner of Church St.

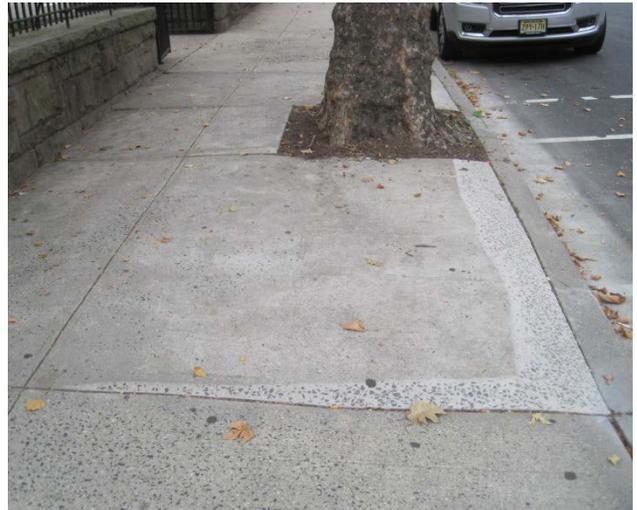
Concrete Sidewalk with Shaved Areas
Location: SW Corner of Church St

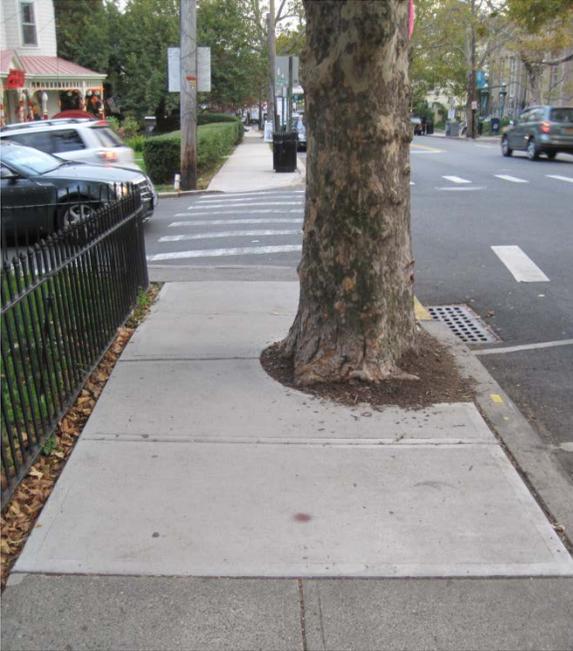
Concrete Sidewalk with Patch around Tree Well
Location: NE Corner of Depew Ave.

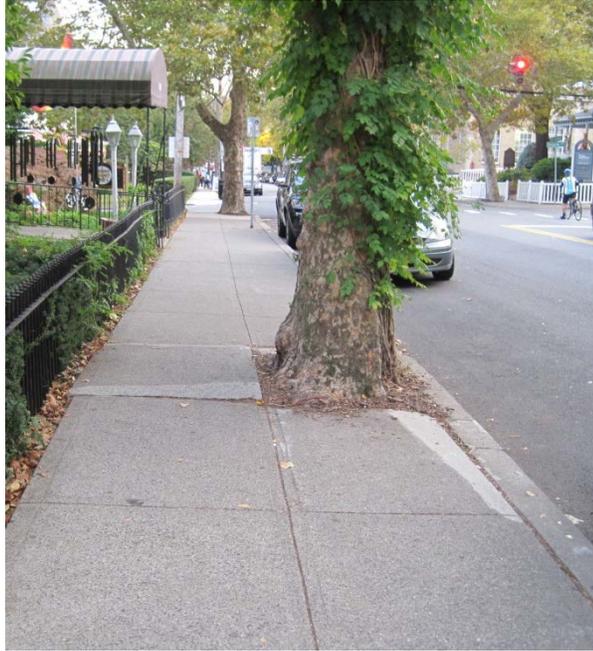
Heaving and Shaved Concrete at Tree
Location: Between Depew Ave. and Remsen St.

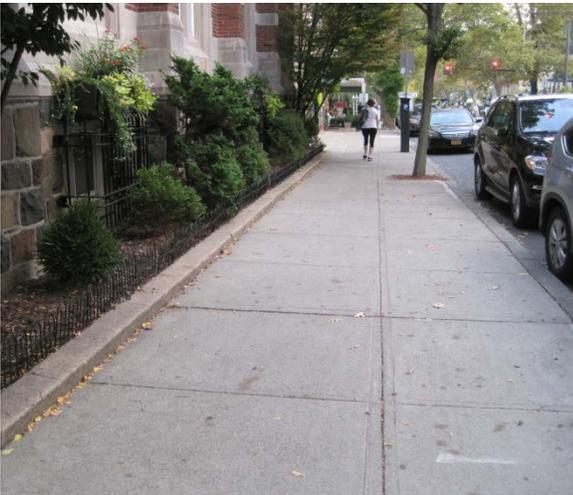
Typical Concrete Sidewalk & Curb at YMCA
Location: SE Corner of Remsen St.

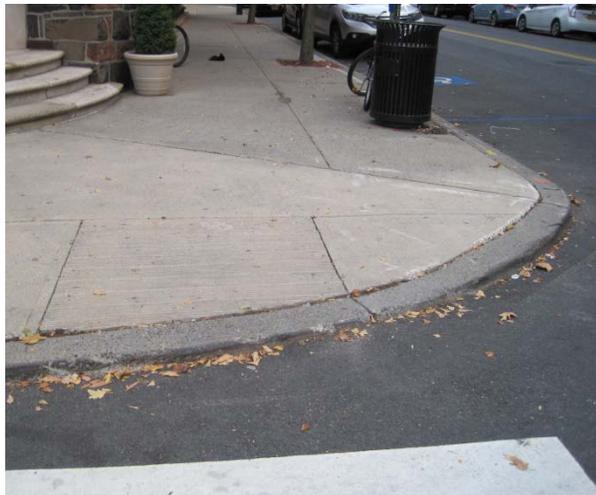
Concrete Curb at YMCA
Location: SE Corner of Remsen St.

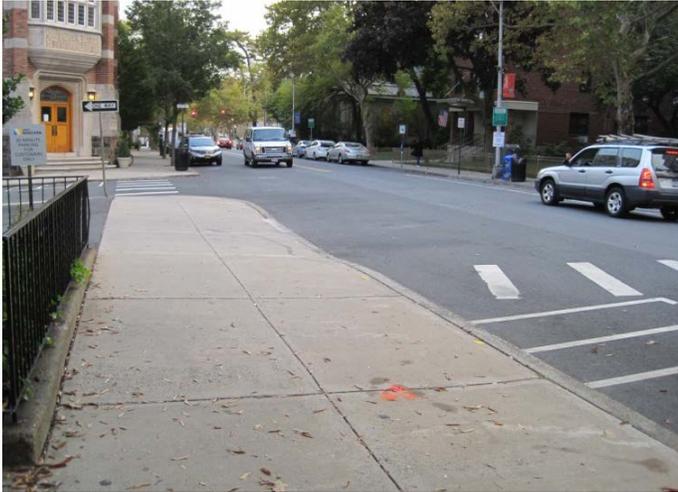
Typical Concrete Sidewalk, Ramp to Bank Parking
Location: NE Corner of Remsen St.

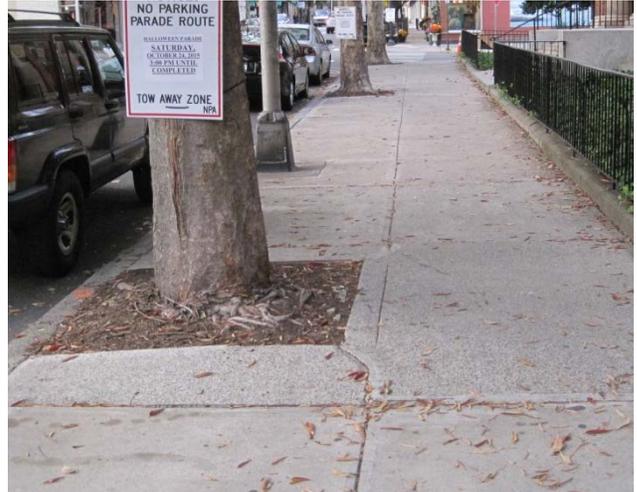
Heaving and Shaved Concrete Sidewalk
Location: Between Remsen St. and Burd St.

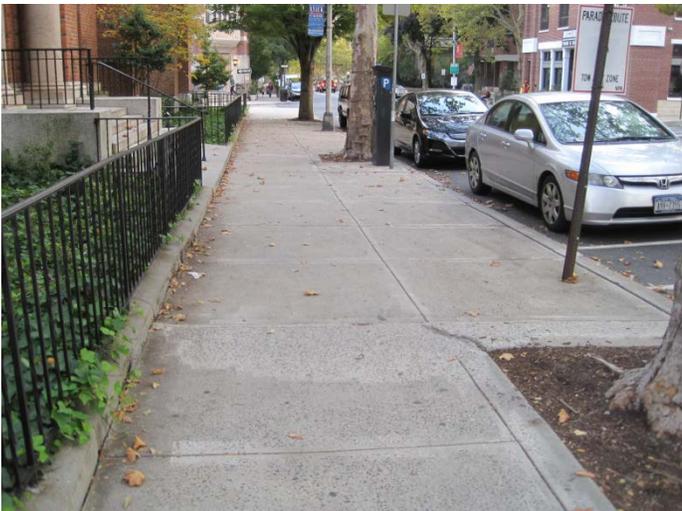
Concrete Sidewalk with Significant Shaved Areas
Location: SE Corner Burd St.

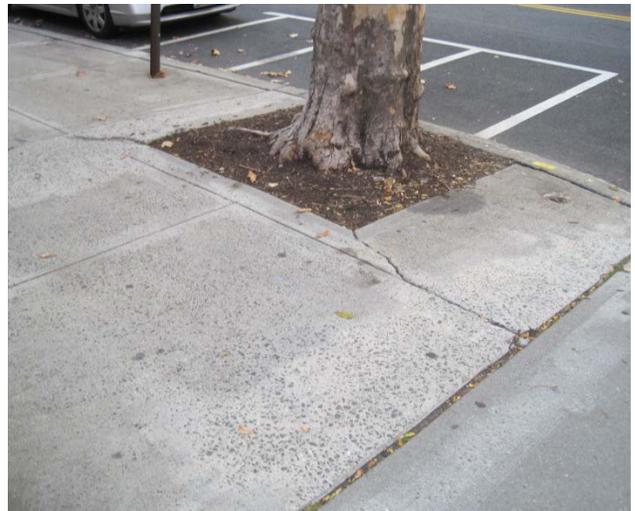
Detail Shaved Concrete at Tree Well
Location: Between Remsen Ave. and Burd St.

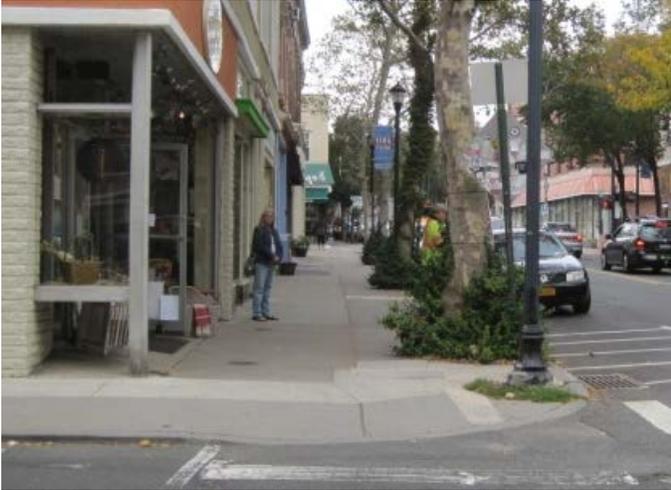
Sidewalk and ADA Ramp, Extensive Patching
Location: SE Corner of Burd St.

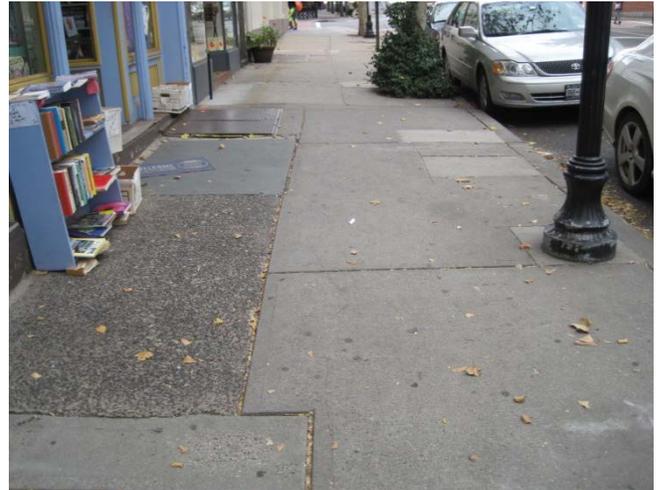
Variety of Concrete Types, Extensive Patching
Location: Between Burd St. and Main St.

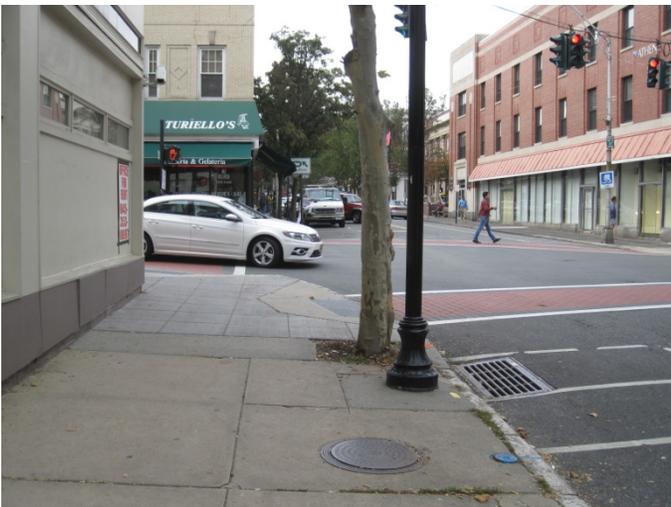
Sidewalk meeting Accent Paving
Location: NW Corner of Main St.

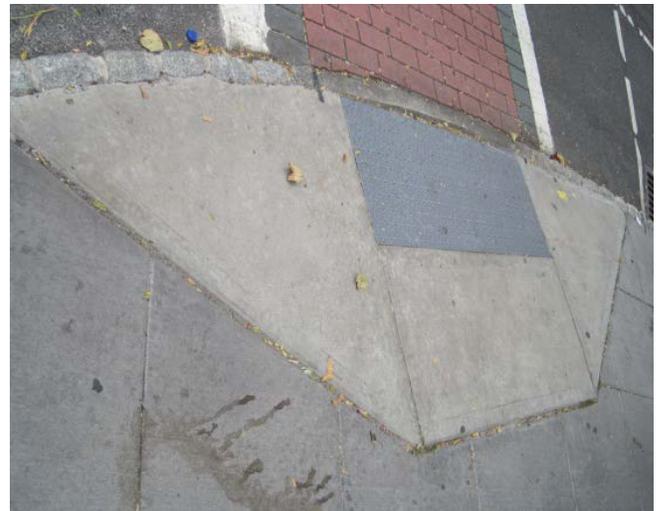
ADA Ramp with Stone Curb, Stamped Concrete
Crosswalk
Location: NW Corner of Main St.

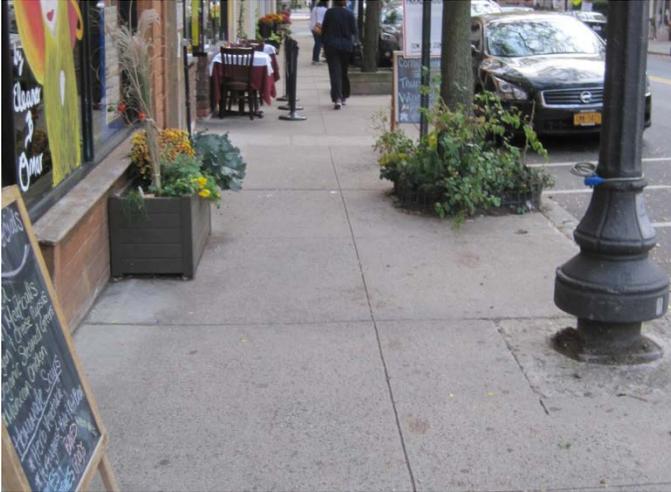
Concrete Sidewalk
Location: Between Burd St. and Main St.

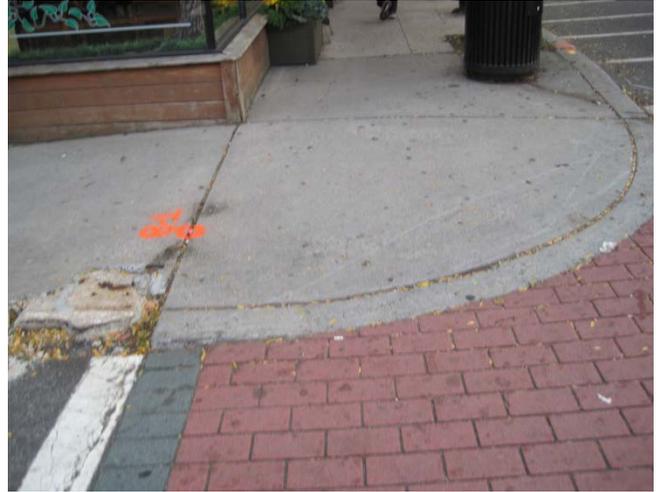
Concrete Ramp, Stamped Concrete Crosswalk
Location: NE Corner Main St.

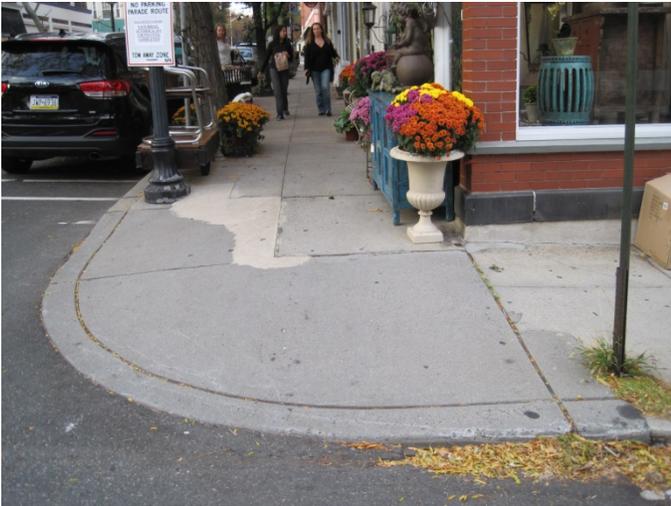
Ramp and Large Concrete Patch
Location: SE Corner Burd St.

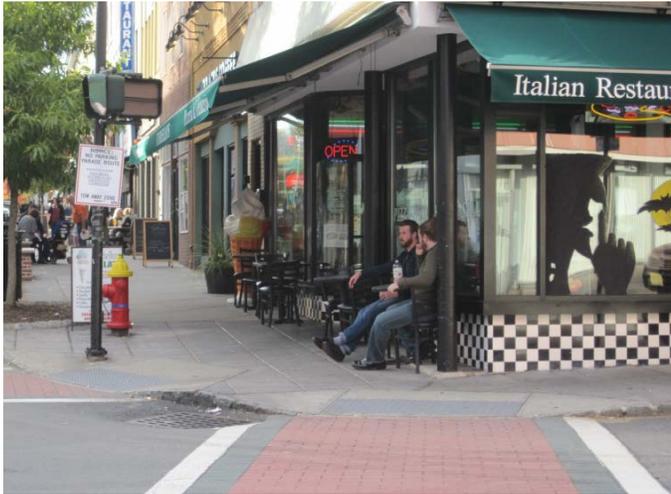
Crosswalk with Stamped Concrete, ADA Ramp
Location: SW Corner Main St.

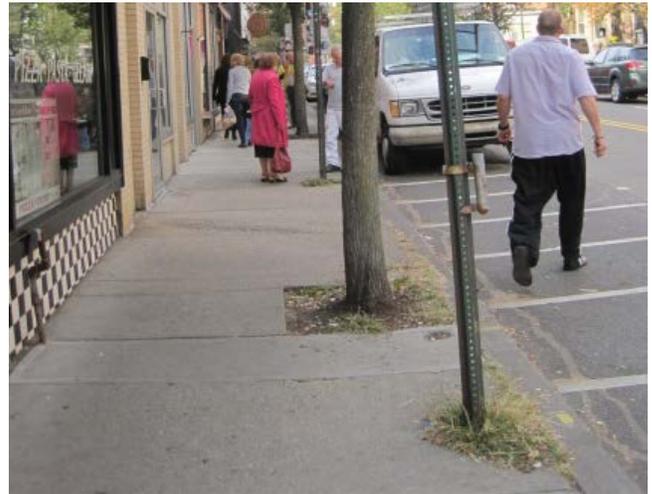
Sidewalk with Small Tree Well, Awning Overhang
Location: SW Corner Main St.

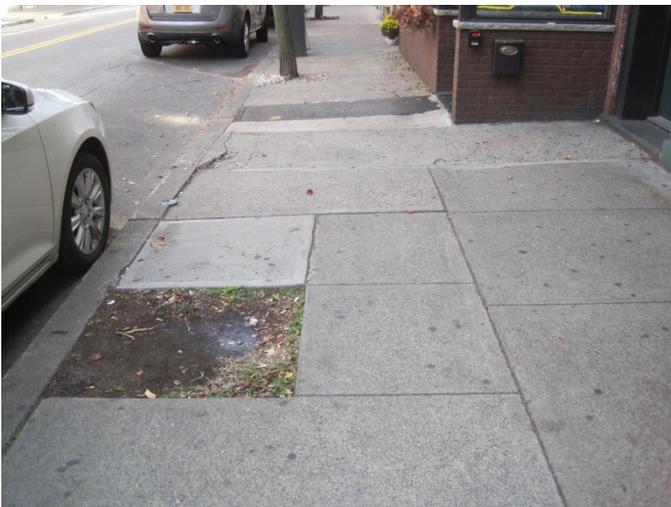
Empty Tree Well, Patched Concrete
Location: Between Main St. and New St.

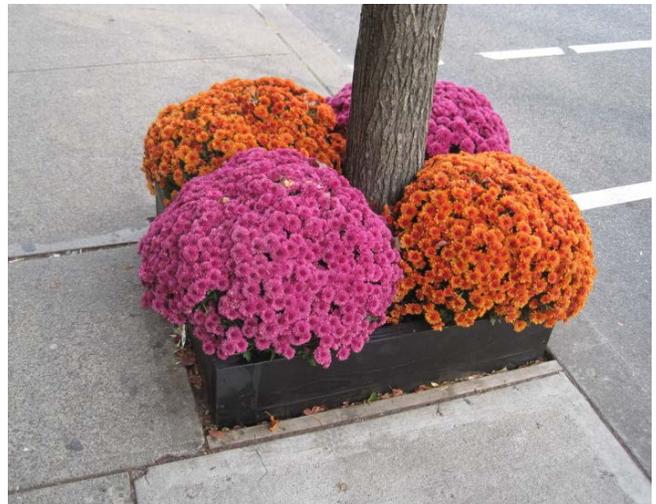
Planter Edging at Tree Well, Plants in Pots
Location: NW Corner of New St.

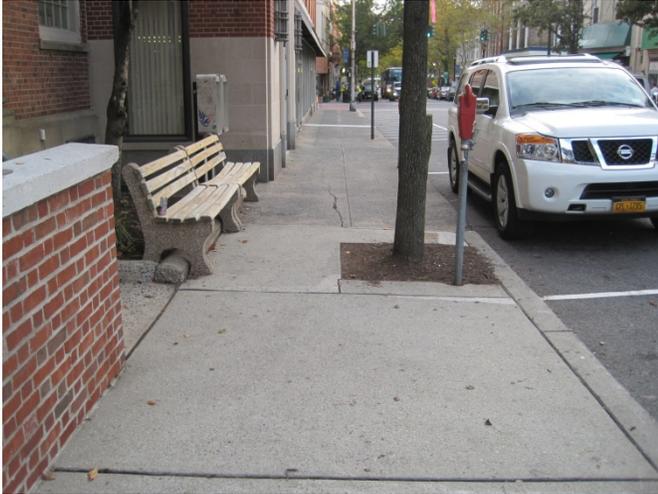
Concrete Sidewalk, transitions to Exposed Aggregate
Location: NE Corner Lydecker St.

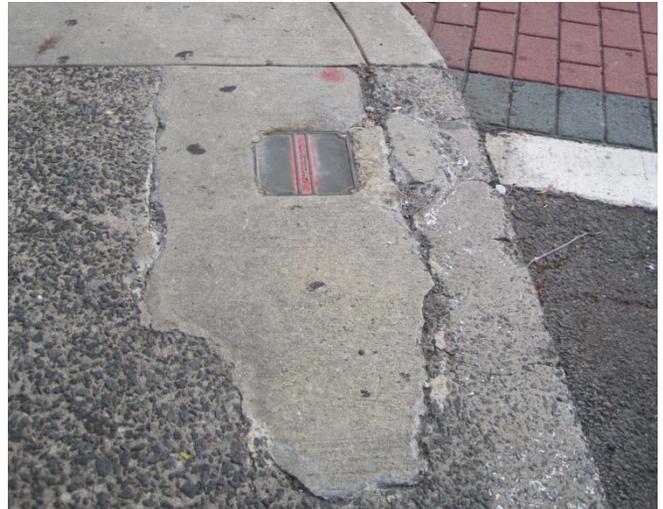
Large Concrete Patch
Location: SE Corner Main St.

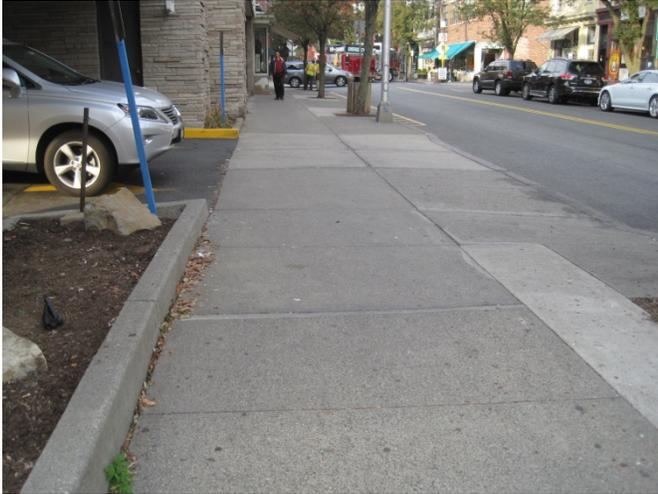
Typical Concrete Sidewalk, Ramp to Bank Parking
Location: NW Corner of New St.

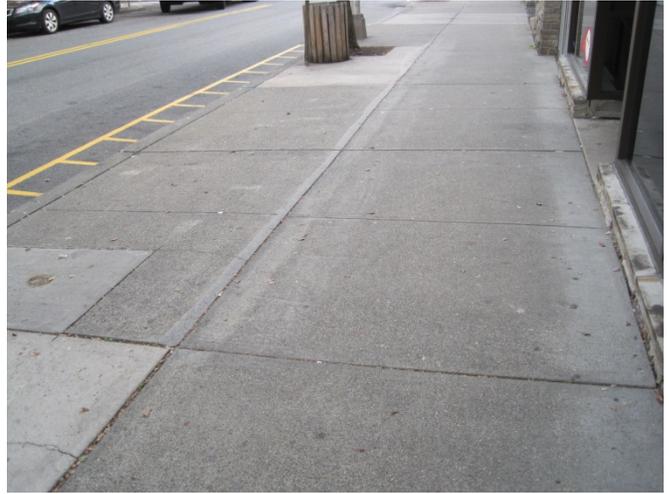
Heaving and Shaved Concrete Sidewalk
Location: Between New St. and High Ave.

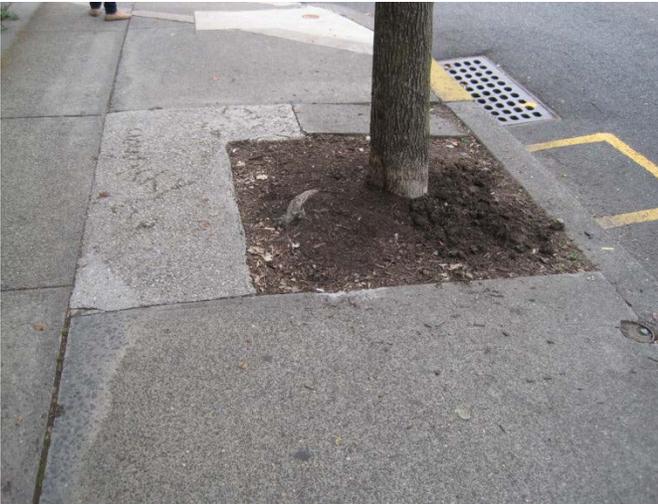
Concrete Sidewalk with Significant Shaved Areas
Location: SW Corner High Ave.

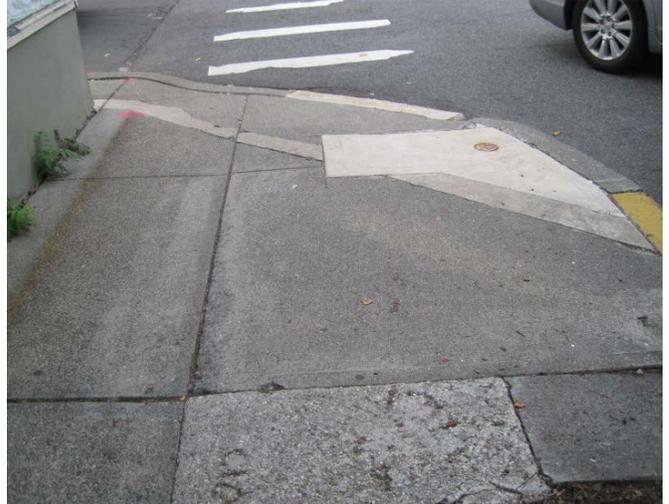
Detail Shaved Concrete
Location: SW Corner High Ave.

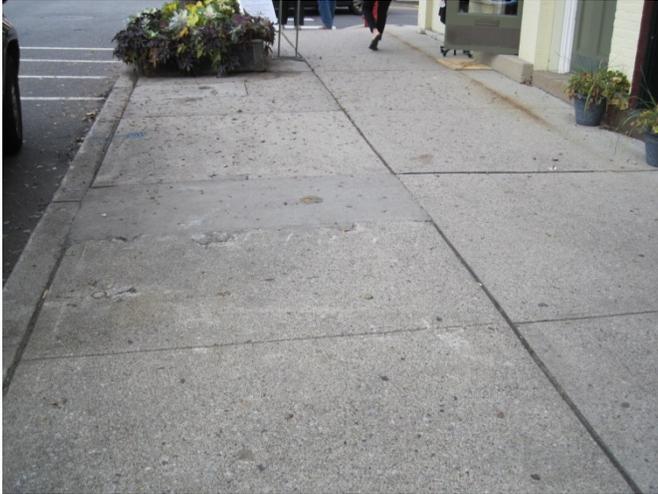
Sidewalk and Curb, Raised Planter
Location: NE Corner High Ave.

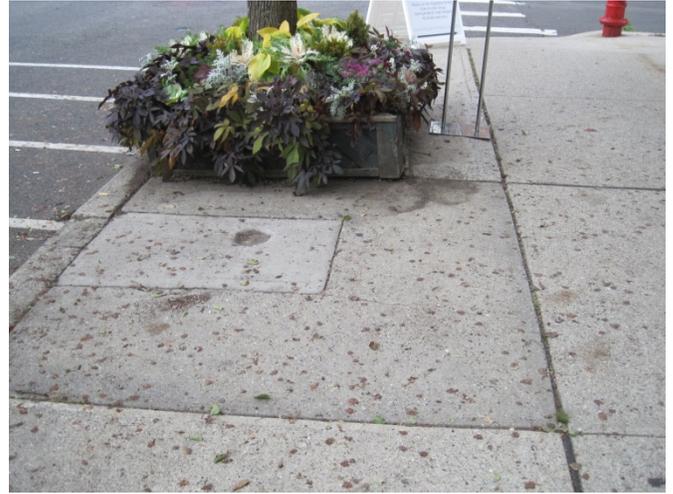
Raised Planter, Possible Salt Pitting on Concrete
Location: NE Corner High Ave.

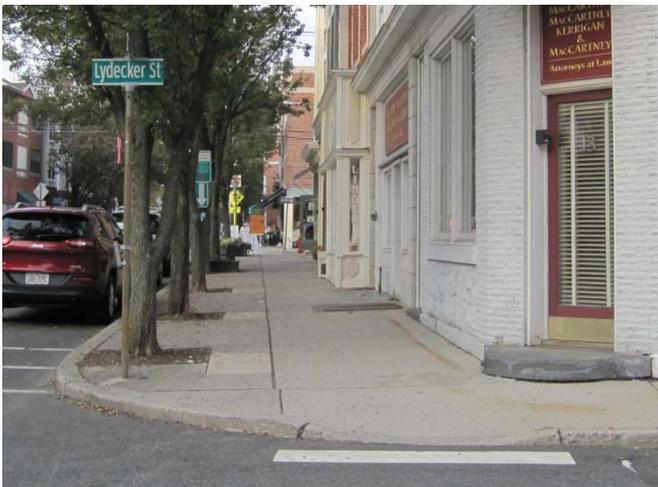
Patches at Tree Wells, Crosswalk Ramp
Location: SE Corner Lydecker St.

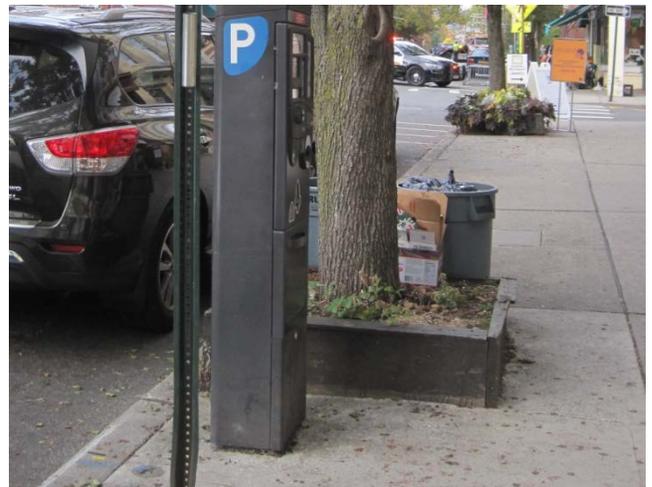
Raised Planter
Location: Between Lydecker St. and High Ave.

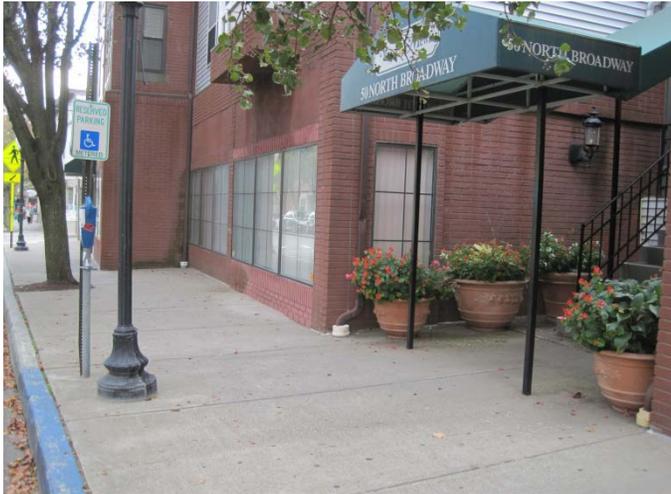
Sidewalk Width Varies with Building Facade
Location: SW Corner High Ave.

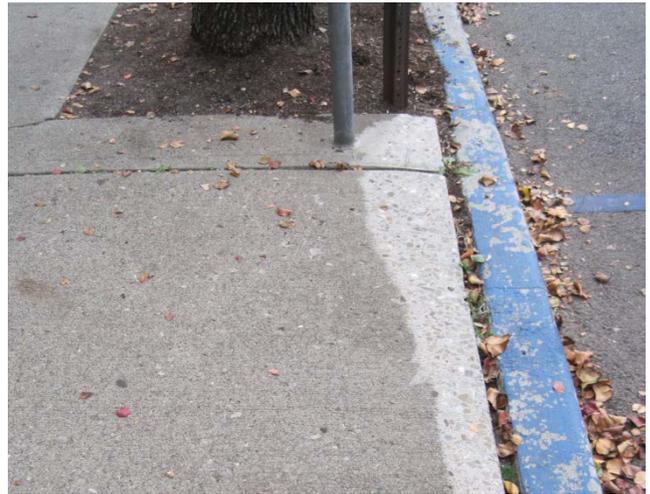
Heaving and Shaved Concrete
Location: Between High Ave. and First Ave.

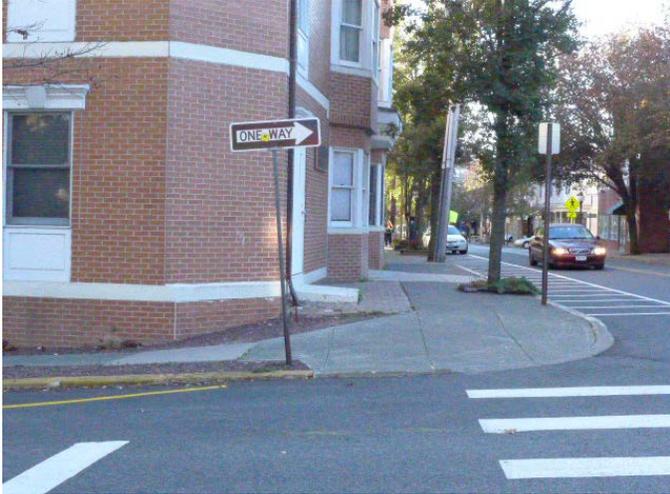
Crosswalk Ramp
Location: SE Corner First Ave.

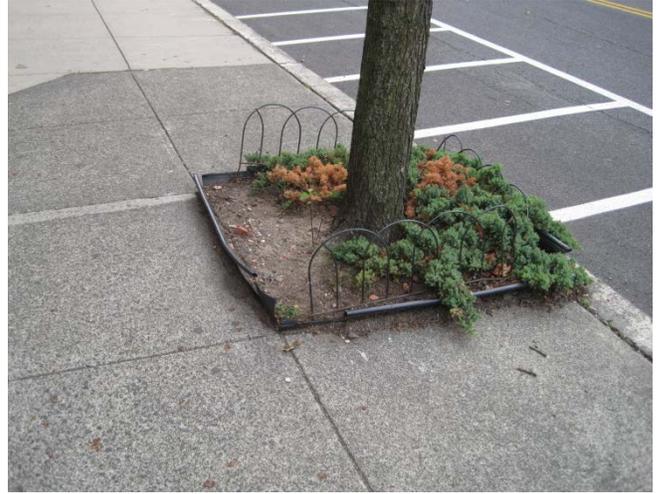
Garden Edging at Tree Well, Soil at Grade
Location: SE Corner First Ave.

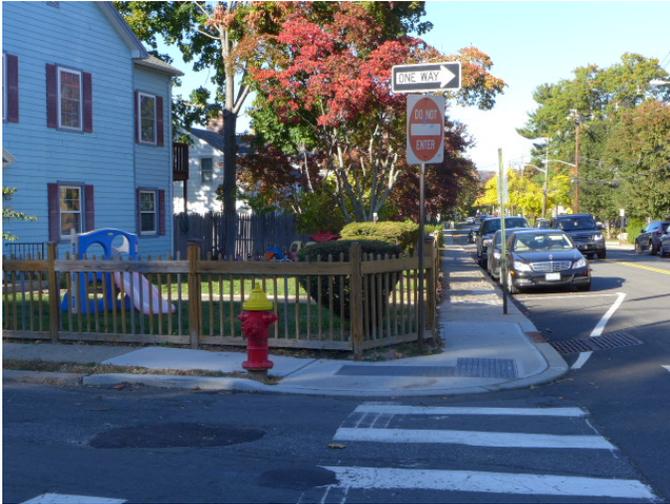
Typical Concrete Sidewalk, Ramp to Bank Parking
Location: SE Corner of Depew Ave.

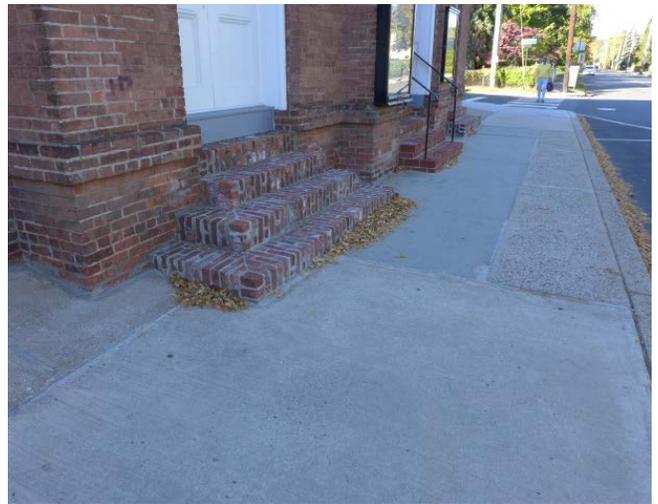
Sidewalk in front of Baptist Church
Location: NW Corner of Fifth Ave.

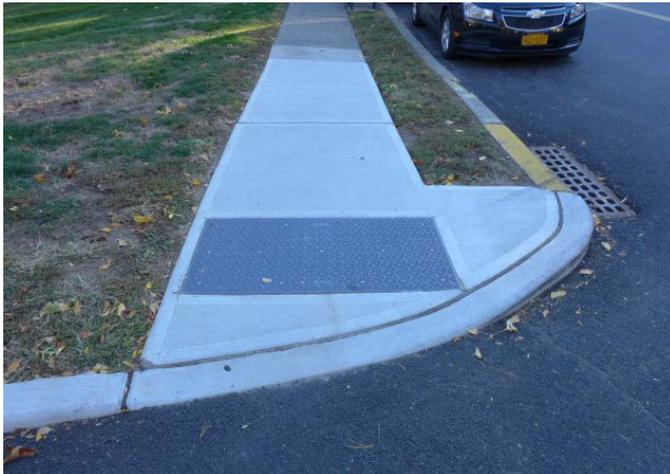
New ADA Crosswalk Ramp
Location: NE Corner Ackerman Lane

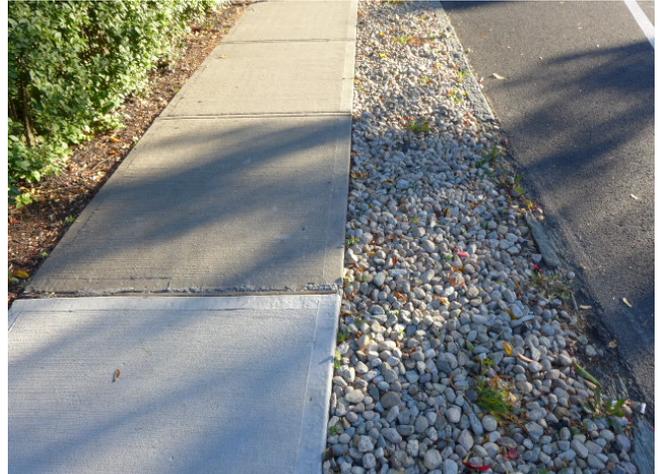
Parkway with Gravel, Only Occurs at this Residence
Location: East Side Between 4th Ave. and 3rd Ave.

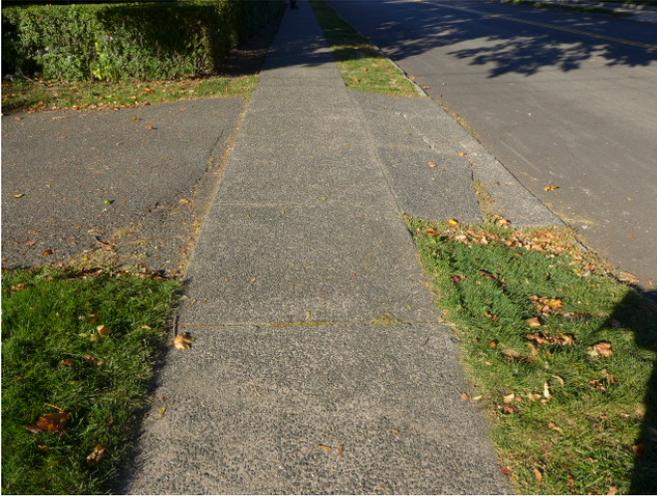
Exposed Aggregate Sidewalk and Driveway
Location: West Side Between 5th Ave. and 6th Ave.

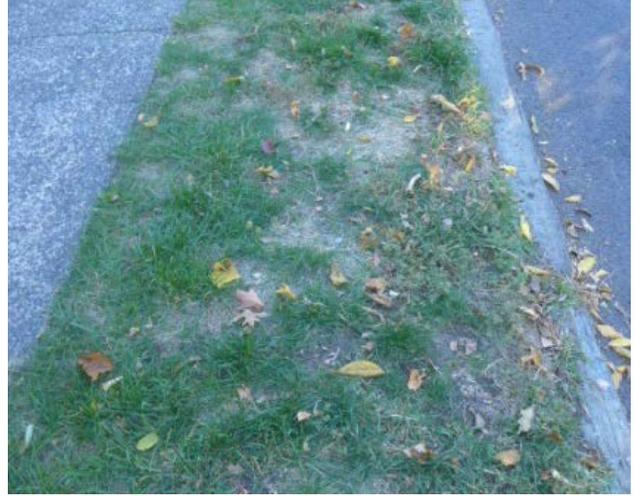
Exposed Aggregate Sidewalk and Stone Curb
Location: West Side Between 5th Ave. and 6th Ave.

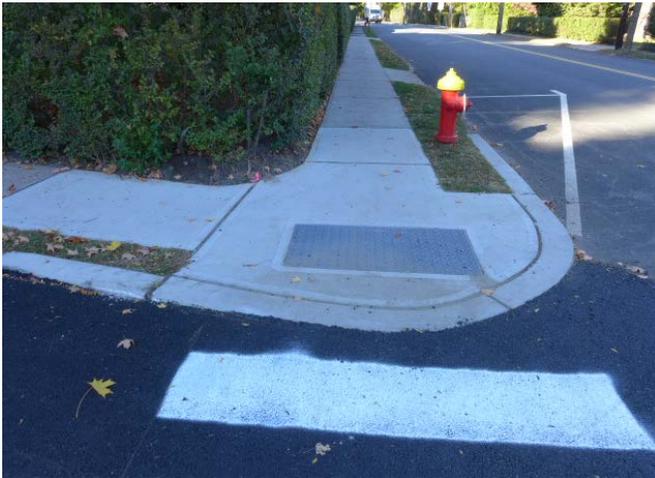
New ADA Crosswalk Ramp
Location: SW Corner Tallman Ave.

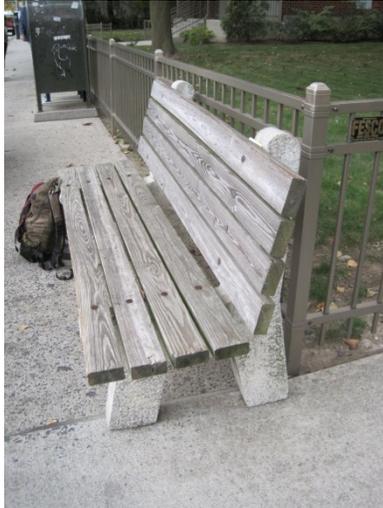
Wood Slat and Concrete Base Bench
Location: Apts. Depew/Church

Benches in the downtown area are located at popular gathering spots, such as the municipal building, the library, and a coffee shop. Some benches show more wear than others. The Village of Nyack could promote social activity, and establish a more cohesive look along the streetscape by installing one bench style throughout the downtown blocks.

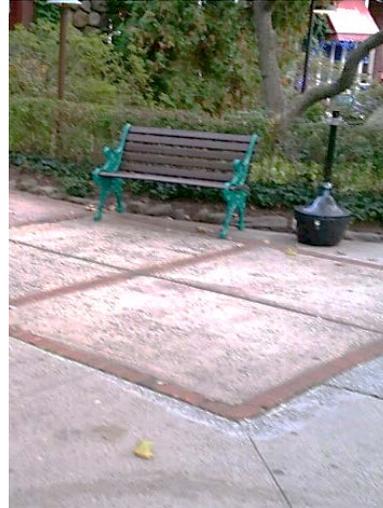
Wood Slat and Metal Base Bench
Location: The Nyack Library

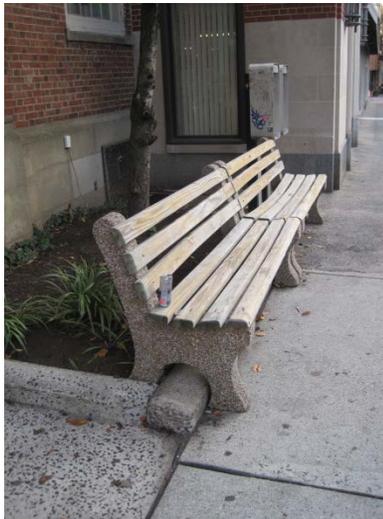
Wood Slat and Concrete Base Bench
Location: Village Hall
