**Village of Nyack TAP
New Connectivities for Nyack
Village of Nyack, NY**

**Site Reconnaissance
Report**

**McLaren Project No. 150119.00
October 30, 2015**

Prepared by:
**McLaren Engineering Group
100 Snake Hill Road
West Nyack, NY 10994
(845) 353-6400**

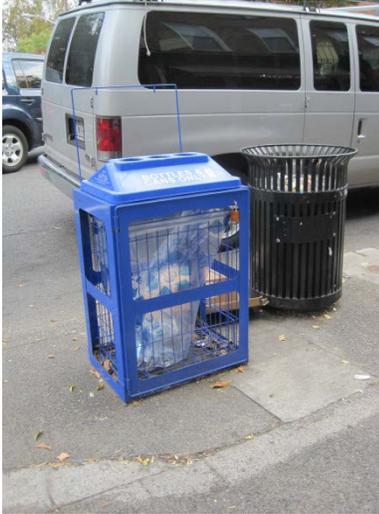
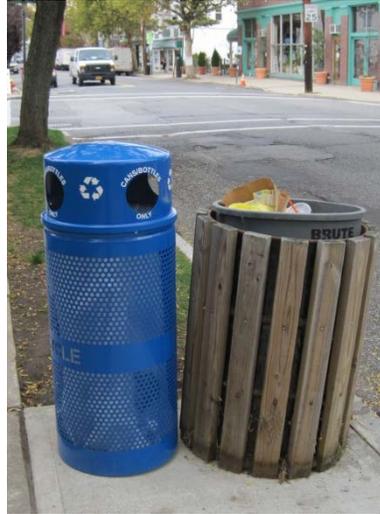
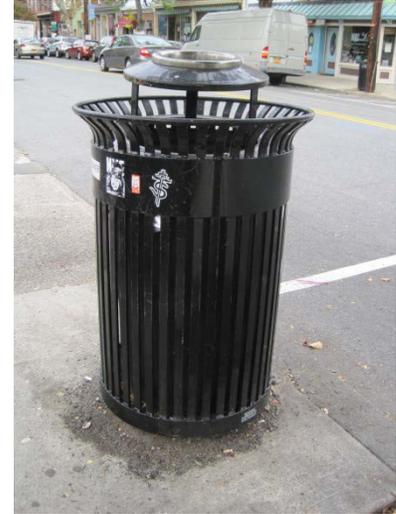
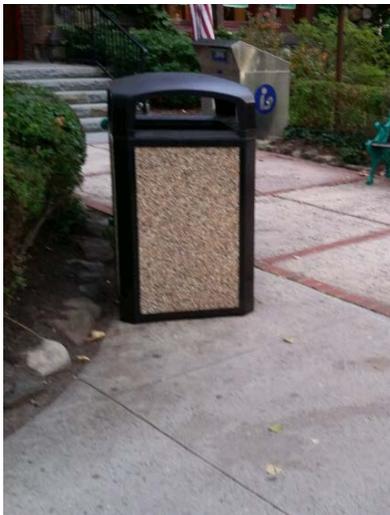
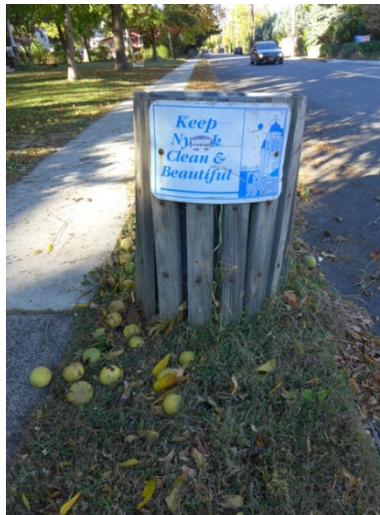
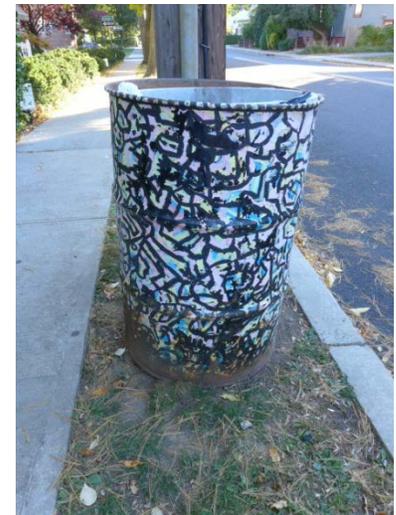
Metal Trash Receptacle and Plastic Recycling Receptacle
Location: Downtown Blocks

Wooden Frame Trash Receptacle and Metal Recycling Receptacle
Location: South of Cedar Hill Ave.

Metal Trash Receptacle with Ash Tray Lid
Location: Downtown Blocks

Square Trash Receptacle with Stone Side Panels
Location: The Nyack Library

Customized Wood Frame Trash Receptacle
Location: Residential area

Customized Metal Trash Receptacle
Location: Residential area

There are many trash and recycling receptacles along Broadway in the downtown area and a few in the residential area. The Town has a fair number of trash receptacles, with some variability to their design. The Village of Nyack could establish a more cohesive look along the streetscape by installing one trash receptacle and one recycling receptacle style throughout the downtown blocks.

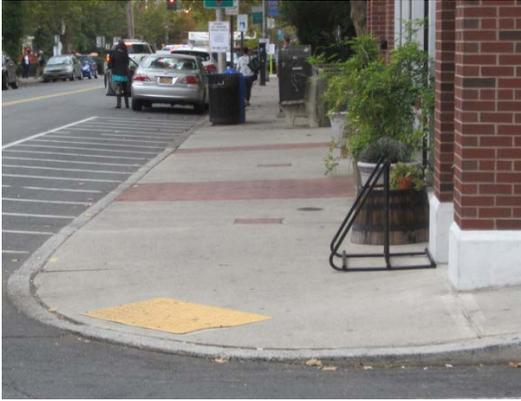
Black Bicycle Rack
Location: SW Corner Church Ave.

There were only two locations where bicycle parking was observed, evidence that there is limited bicycle parking present in the Village. Furthermore, the bicycle racks may be a security risk for users because the racks are not securely fastened to the ground surface. Considering that Nyack is a popular destination for cyclists it may be advisable to install secure, aesthetically integrated bicycle parking. There is a great opportunity to integrate bicycles into the street infrastructure.

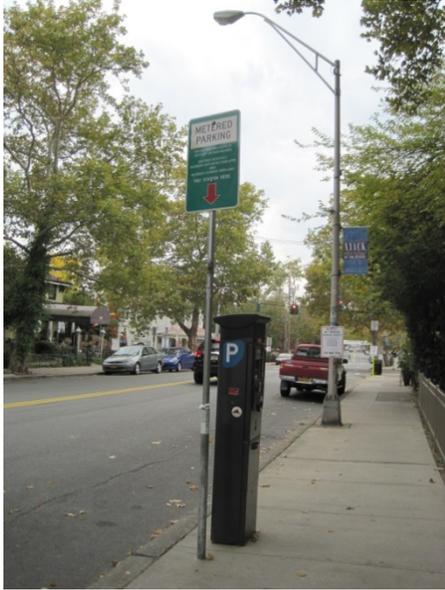
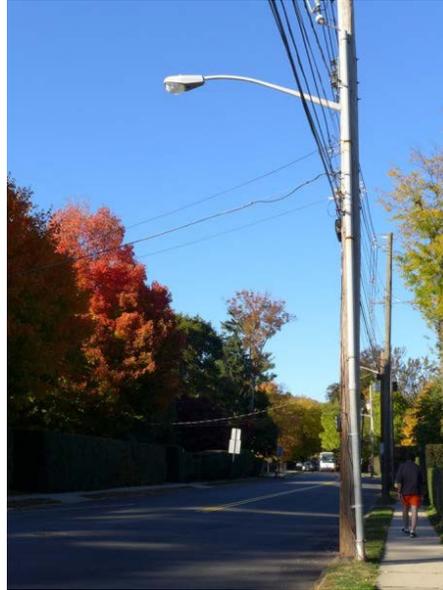
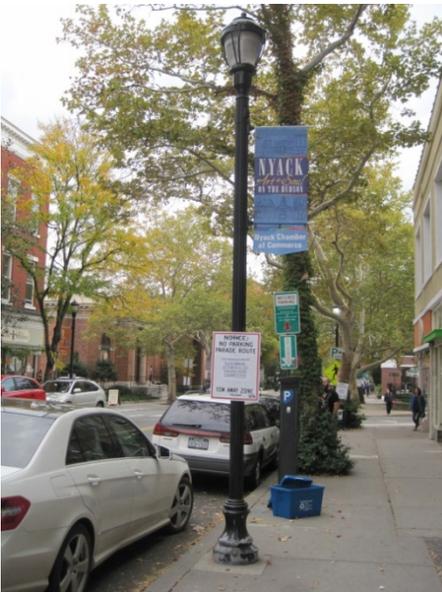
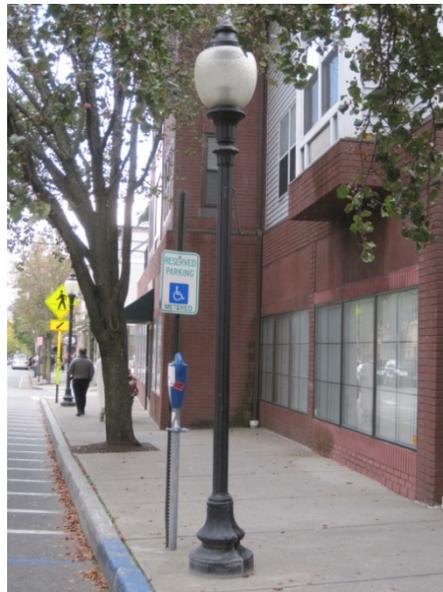
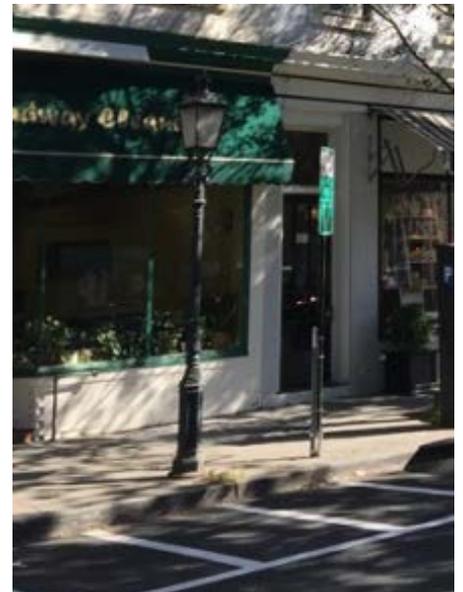
Cobra Head on Light Pole with Banner
Location: Downtown Blocks

Cobra Head on Utility Pole
Location: Residential Area

Pedestrian Scale Light Pole with Caged Acorn Fixture (approx.18' high)
Location: Downtown blocks

Pedestrian Scale Light Pole w/Acorn Fixture (approx. 14' high)
Location: Between High Ave. & First Ave

Pedestrian Scale Light Pole w/square Acorn Fixture (approx. 10' high)
Location: Downtown Blocks

There is no pedestrian scale lighting in residential area. Installing pedestrian-scale lighting may improve user experience. Establishing one type of street lamp along the downtown blocks also may help unify the streetscape.

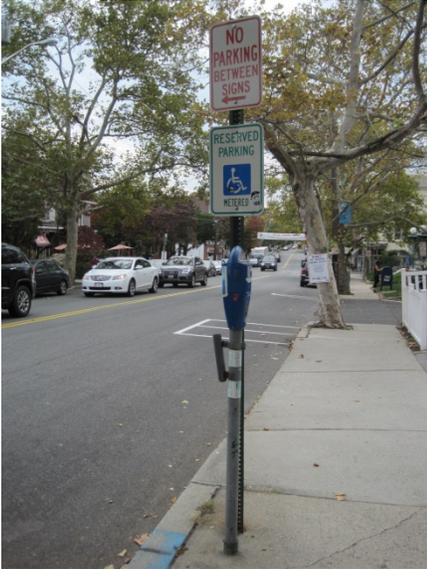
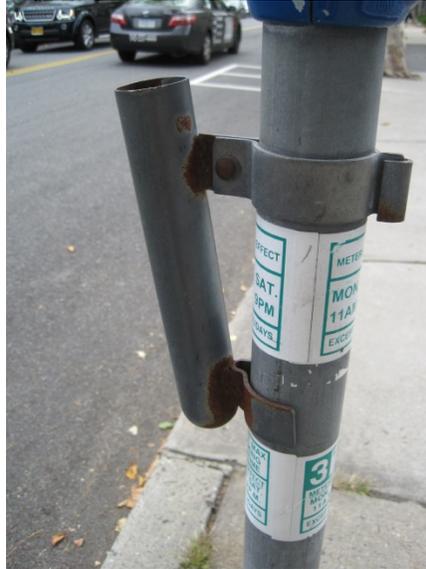
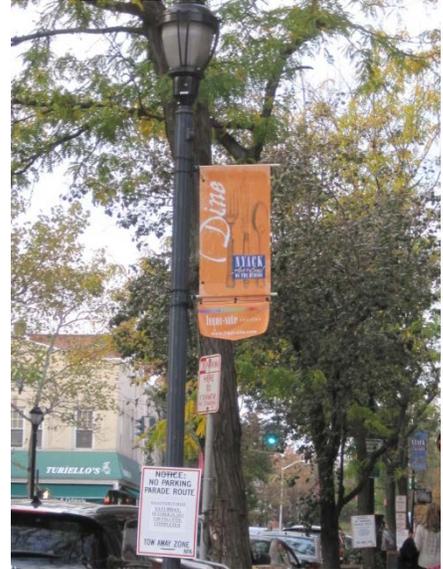
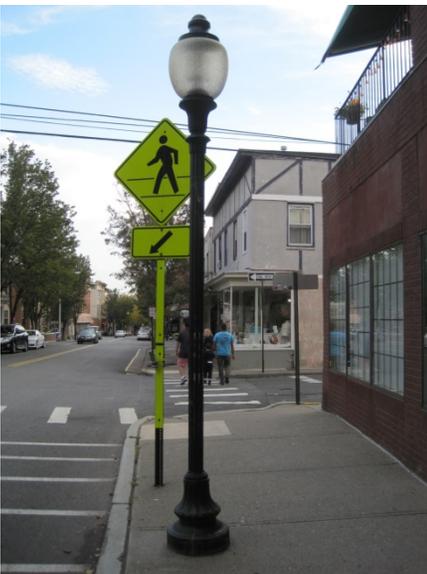
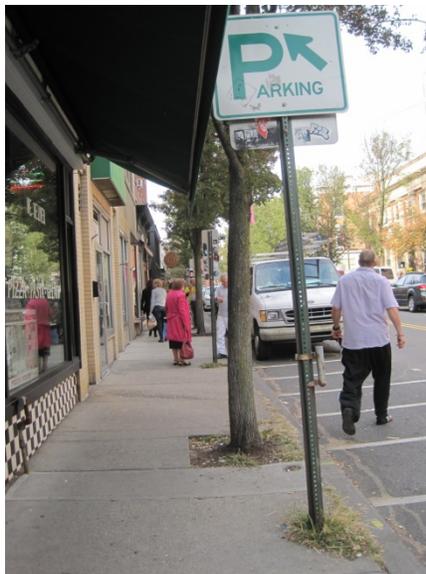
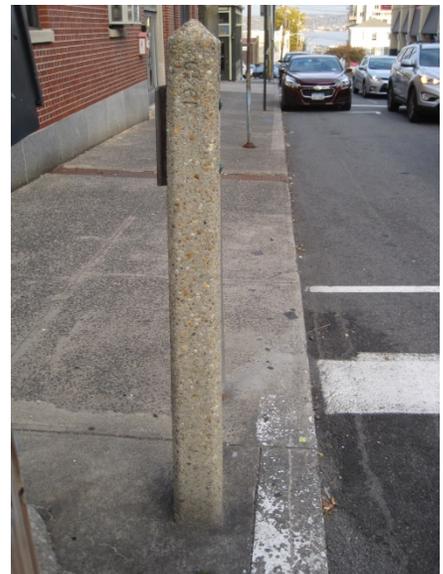
- Extensive parking signage
- Signage presents visual clutter for pedestrians
- A lot of seasonal/temporary event signage on light poles, parking meters, and trees

Sign and Meter with Flag Holder
Location: Downtown Blocks

Flag Holder Mounted to Meter
Location: Downtown Blocks

Banner Mounted to Street Lamp Post
Location: Downtown Blocks

Pedestrian Crossing Sign
Location: Downtown Blocks

Parking Wayfinding Sign
Location: Downtown Blocks

Historic Wayfinding Sign
Location: NE Corner of Main and Broadway

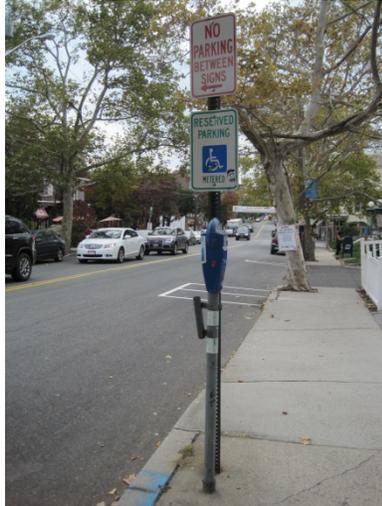
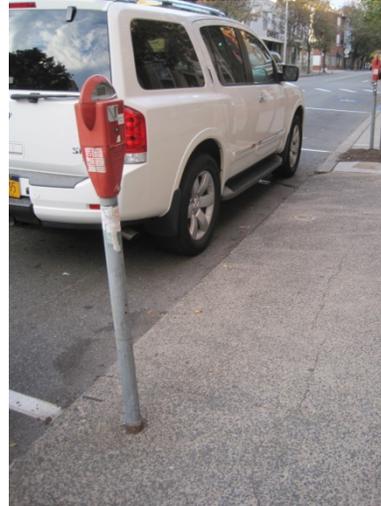
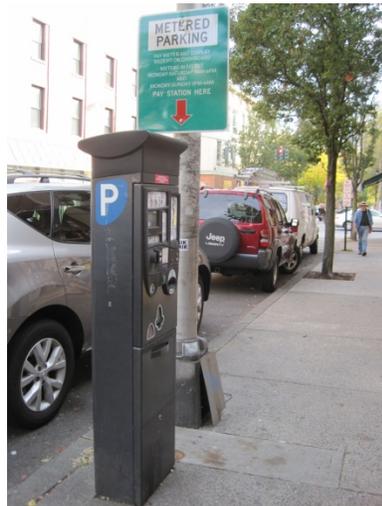
ADA Parking Meter and Signage
Location: Downtown Blocks

Red Parking Meter
Location: Village Hall

Automated Parking Meter and Signage
Location: Downtown Blocks

Parking meters are present throughout the downtown zone. There are three types of parking meters in the project area: blue ADA meters, red Village Hall parking meters, and automated parking meters. The ADA parking meters control one single parking space that is reserved for handicapped drivers. The automated parking meters control multiple parking spaces along the street, and they operate with coins and cards for payment. There are some remnant parking meter posts along the project area on Broadway, which may be hazardous to pedestrians. It may be advisable to saw cut the posts flush with the sidewalk.

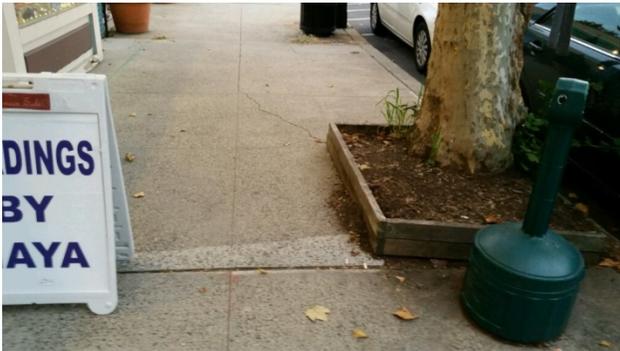
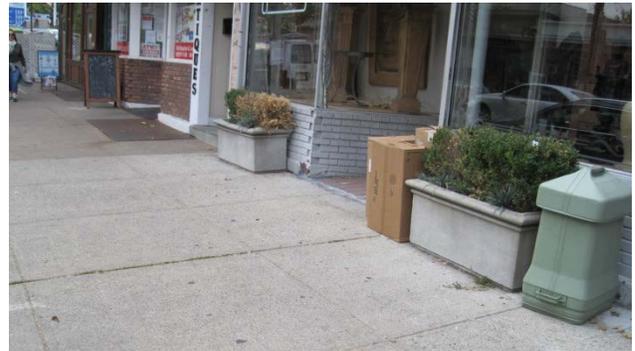
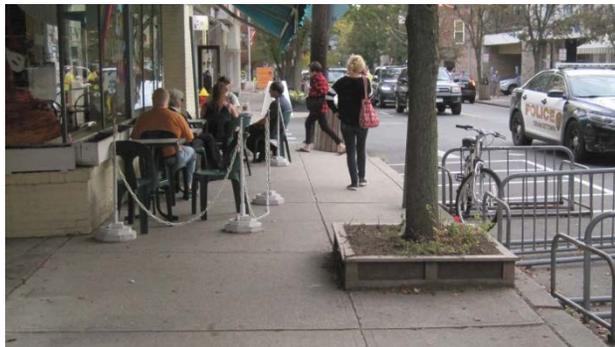
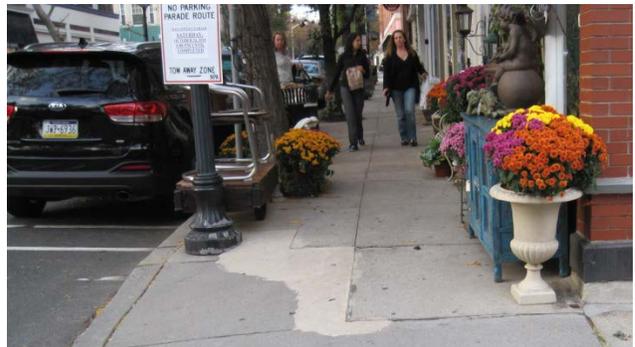
Signage and Ash Tray Stand
Location: Downtown Blocks

Planters and Trash Receptacle
Location: Downtown Blocks

Restaurant Seating
Location: Downtown Blocks

Business Wares for Sale and Planters
Location: Downtown Blocks

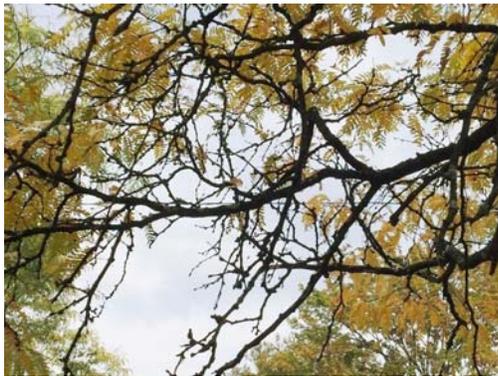
Tree: <i>Gleditsia triacanthos inermis</i> Name: HONEYLOCUST Caliper (DBH): 20	Location: 36 S. Broadway Block No.: Lot No.:	Station Offset:	Tree No. 1
Comments: MINOR DEAD LOWER BRANCHES; INCLUDED BARK; MINOR DAMAGE TO EXPOSED ROOTS IN ROW Condition: 27/32		Date: 9/24/2015 Time: Weather: Sunny Temp: 73 degrees F	
Mitigation Case #:		Cut(-)/Fill(+) (in.):

Minor dead lower branches

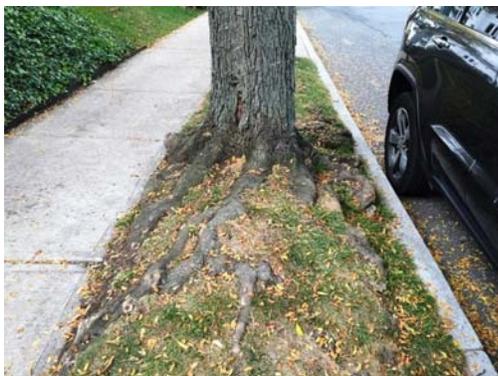
Root collar in grass ROW

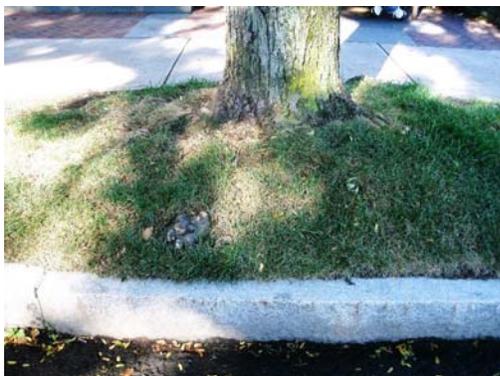
Tree: <i>Gleditsia triacanthos inermis</i> Name: HONEYLOCUST Caliper (DBH): 16	Location: 37 S. Broadway Block No.: Lot No.:	Station Offset:	Tree No. 2
Comments: MINOR DEAD LOWER BRANCHES Condition: 28/32		Date: 9/24/2015 Time: Weather: Sunny Temp: 73 degrees F	
Mitigation Case #:		Cut(-)/Fill(+) (in.):

Root collar in grass ROW

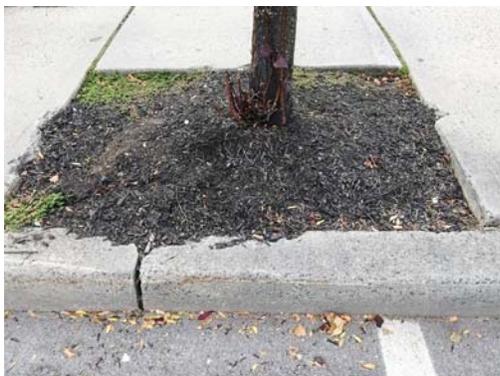
Tree: <i>Prunus cerasifera</i> Name: PLUM, PURPLELEAF Caliper (DBH): 6	Location: 38 S. Broadway Block No.: Lot No.:	Station Offset:	Tree No. 3
Comments: MINOR TRUNK DAMAGE; DEAD SMALLER BRANCHES; POOR FOLIAGE Condition: 25/32		Date: 9/24/2015 Time: Weather: Sunny Temp: 73 degrees F	
Mitigation Case #:		Cut(-)/Fill(+) (in.):

Tree pit

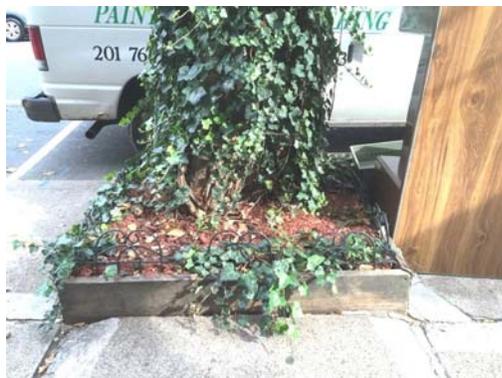
Tree: <i>Platanus x acerifolia</i> Name: LONDON PLANETREE Caliper (DBH): 23	Location: 40 S. Broadway Block No.: Lot No.:	Station Offset:	Tree No. 5
Comments: BURIED ROOT COLLAR IN RAISED PLANTER; MAJOR VINE COVERAGE; CANOPY IN CONFLICT WITH POWER LINES; PARKING METER POST IN TREE PIT Condition: 27/32		Date: 9/24/2015 Time: Weather: Sunny Temp: 73 degrees F	
Mitigation Case #:		Cut(-)/Fill(+) (in.):

Buried root collar in raised planter

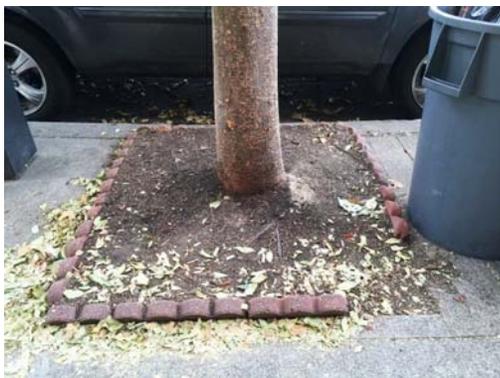
Tree: <i>Zelkova serrata</i> Name: ZELKOVA, JAPANESE Caliper (DBH): 10	Location: 41 S. Broadway Block No.: Lot No.:	Station Offset:	Tree No. 6
Comments: BURIED ROOT COLLAR; INCLUDED BARK; CANOPY IN CONFLICT WITH POWER LINES Condition: 28/32		Date: 9/24/2015 Time: Weather: Sunny Temp: 73 degrees F	
Mitigation Case #:		Cut(-)/Fill(+) (in.):

Tree pit with buried root collar

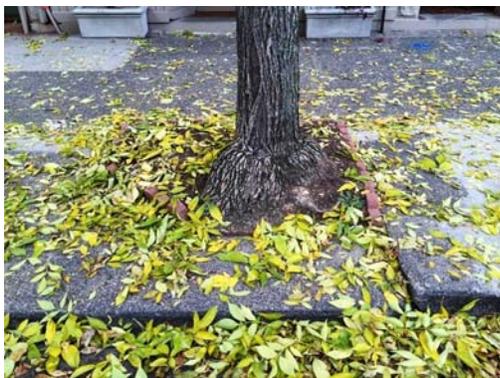
Tree: <i>Fraxinus pennsylvanica</i> Name: ASH, GREEN Caliper (DBH): 11	Location: 42 S. Broadway Block No.: Lot No.:	Station Offset:	Tree No. 7
Comments: LEANING TOWARDS STREET; WATERSPROUTING AT OLD PRUNING CUTS; CANOPY IN CONFLICT WITH STREET LIGHT; UNDERSIZED TREE PIT Condition: 23/32		Date: 9/24/2015 Time: Weather: Sunny Temp: 73 degrees F	
Mitigation Case #:		Cut(-)/Fill(+) (in.):

Swollen root collar in tree pit

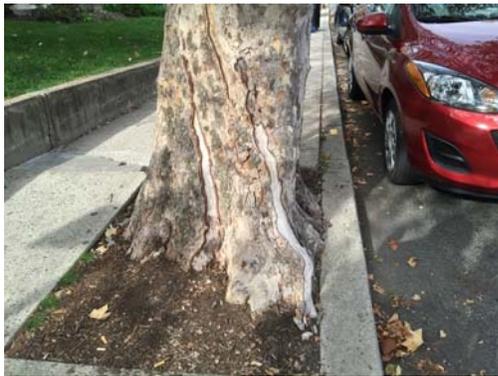
Tree: <i>Platanus x acerifolia</i> Name: LONDON PLANETREE Caliper (DBH): 25	Location: 43 S. Broadway Block No.: Lot No.:	Station Offset:	Tree No. 8
Comments: SIDEWALK HEAVING FROM ROOTS; MINOR DEAD BRANCHES; TRUNK SCARS; UNDERSIZED TREE PIT Condition: 28/32		Date: 9/24/2015 Time: Weather: Sunny Temp: 73 degrees F	
Mitigation Case #:		Cut(-)/Fill(+) (in.):

Trunk scars and heaving sidewalk

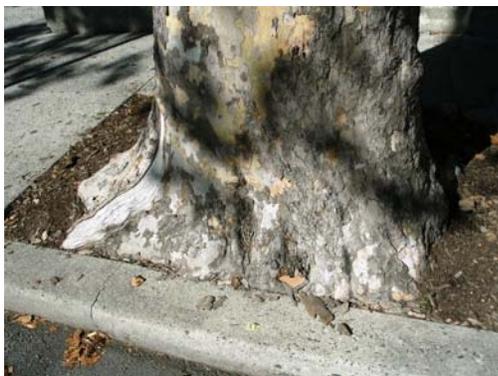
Undersized tree pit

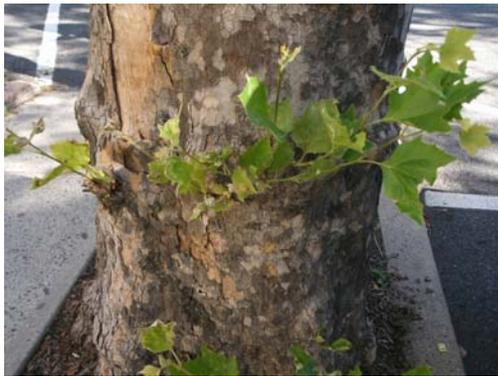
Tree: <i>Platanus x acerifolia</i> Name: LONDON PLANETREE Caliper (DBH): 24	Location: 44 S. Broadway Block No.: Lot No.:	Station Offset:	Tree No. 9
Comments: MINOR SIDEWALK HEAVING, DEAD SMALLER BRANCHES; WATERSPROUTING ON TRUNK; TRUNK SCARS; CANOPY IN CONFLICT WITH POWER POLE Condition: 27/32		Date: 9/24/2015 Time: Weather: Sunny Temp: 73 degrees F	
Mitigation Case #:		Cut(-)/Fill(+) (in.):

Watersprouting on trunk

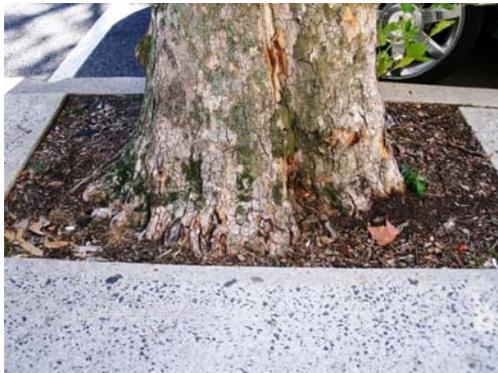
Undersized tree pit

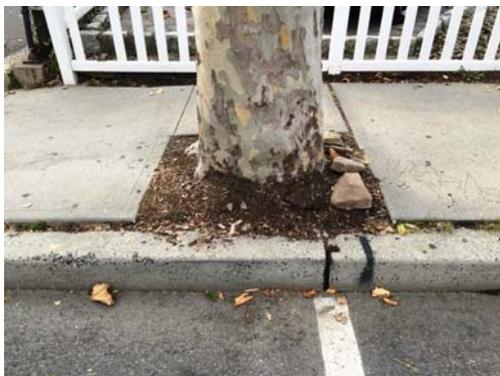
Tree: <i>Platanus x acerifolia</i> Name: LONDON PLANETREE Caliper (DBH): 18	Location: 45 S. Broadway Block No.: Lot No.:	Station Offset:	Tree No. 10
Comments: MAJOR LEADER DEAD AND PARTIALLY BROKEN OFF; MAJOR TRUNK DECAY; MAJOR DEAD BRANCHES Condition: 16/32		Date: 9/24/2015 Time: Weather: Sunny Temp: 73 degrees F	
Mitigation Case #:		Cut(-)/Fill(+) (in.):

Undersized tree pit

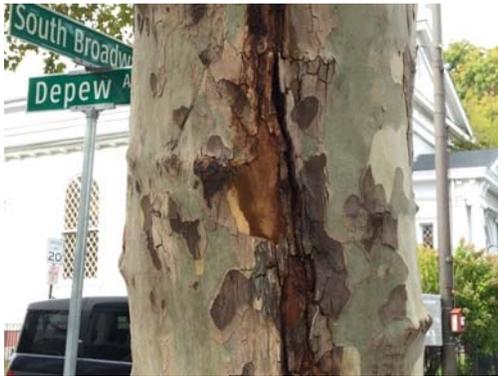
Tree: <i>Platanus x acerifolia</i> Name: LONDON PLANETREE Caliper (DBH): 22	Location: 46 S. Broadway Block No.: Lot No.:	Station Offset:	Tree No. 11
Comments: MAJOR SIDEWALK HEAVING; TRUNK DAMAGE; MAJOR PRUNING DUE TO POWER LINES Condition: 24/32		Date: 9/24/2015 Time: Weather: Sunny Temp: 73 degrees F	
Mitigation Case #:		Cut(-)/Fill(+) (in.):

Trunk damage

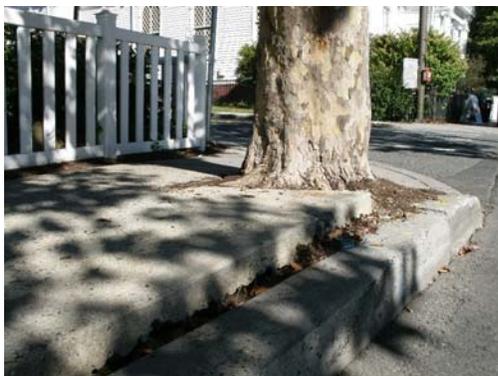
Undersized tree pit

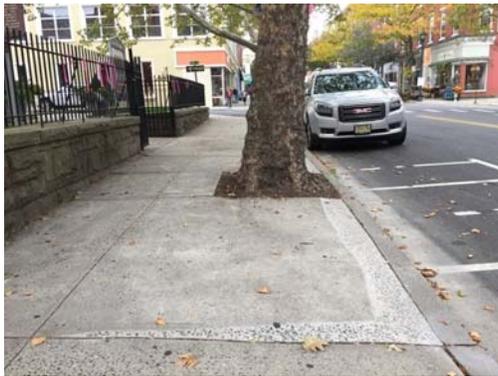
Tree: <i>Platanus x acerifolia</i> Name: LONDON PLANETREE Caliper (DBH): 23	Location: 16 S. Broadway Block No.: Lot No.:	Station Offset:	Tree No. 12
Comments: MINOR SIDEWALK HEAVING Condition: 28/32		Date: 9/24/2015 Time: Weather: Sunny Temp: 73 degrees F	
Mitigation Case #:		Cut(-)/Fill(+) (in.):

Heaving sidewalk

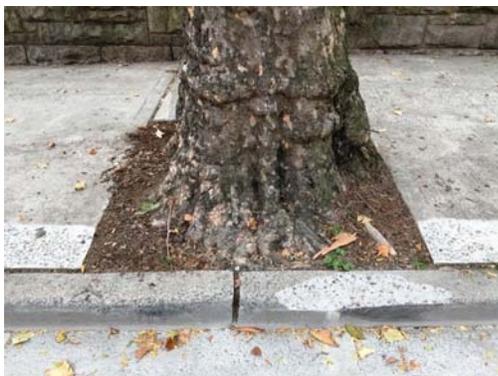
Undersized tree pit

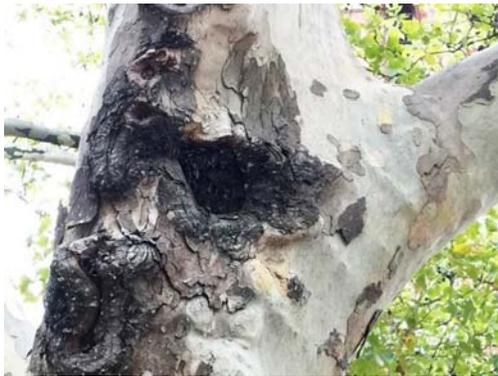
Tree: <i>Platanus x acerifolia</i> Name: LONDON PLANETREE Caliper (DBH): 25	Location: 17 S. Broadway Block No.: Lot No.:	Station Offset:	Tree No. 13
Comments: MAJOR SIDEWALK HEAVING AND CRACKING; TRUNK DAMAGE Condition: 25/32		Date: 9/24/2015 Time: Weather: Sunny Temp: 73 degrees F	
Mitigation Case #:		Cut(-)/Fill(+) (in.):

Trunk damage

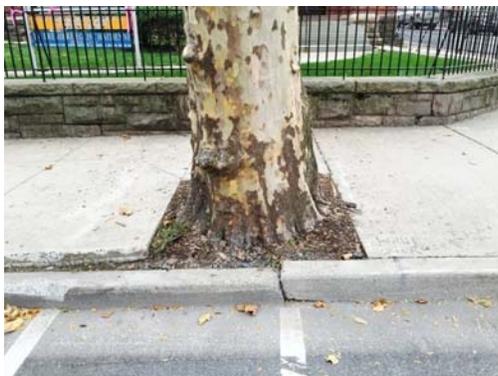
Undersized tree pit

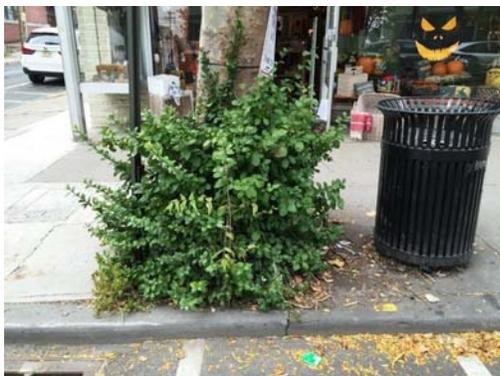
Tree: <i>Platanus x acerifolia</i> Name: LONDON PLANETREE Caliper (DBH): 17	Location: 18 S. Broadway Block No.: Lot No.:	Station Offset:	Tree No. 14
Comments: THIN IRREGULAR SHAPED CROWN; MINOR DEAD BRANCHES; EUONYMOUS AT BASE AND CLIMBING TRUNK Condition: 23/32		Date: 9/24/2015 Time: Weather: Sunny Temp: 73 degrees F	
Mitigation Case #:		Cut(-)/Fill(+) (in.):

Undersized tree pit with planting

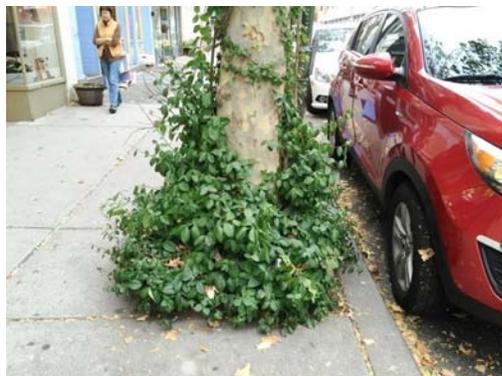
Tree: <i>Platanus x acerifolia</i> Name: LONDON PLANETREE Caliper (DBH): 18	Location: 19 S. Broadway Block No.: Lot No.:	Station Offset:	Tree No. 15
Comments: MAJOR VINE COVERAGE; MINOR DEAD BRANCHES Condition: 27/32		Date: 9/24/2015 Time: Weather: Sunny Temp: 73 degrees F	
Mitigation Case #:		Cut(-)/Fill(+) (in.):

Undersized tree pit with planting

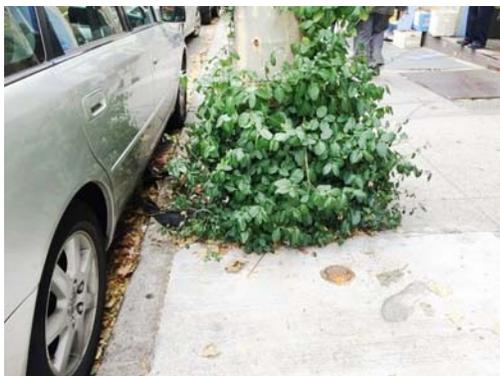
Tree: <i>Platanus x acerifolia</i> Name: LONDON PLANETREE Caliper (DBH): 24	Location: 20 S. Broadway Block No.: Lot No.:	Station Offset:	Tree No. 16
Comments: CROOKED MAIN LEADER; THIN CROWN; MAJOR DEAD BRANCHES; EUONYMOUS AT BASE AND CLIMBING TRUNK Condition: 13/32		Date: 9/24/2015 Time: Weather: Sunny Temp: 73 degrees F	
Mitigation Case #:		Cut(-)/Fill(+) (in.):

Undersized tree pit with planting

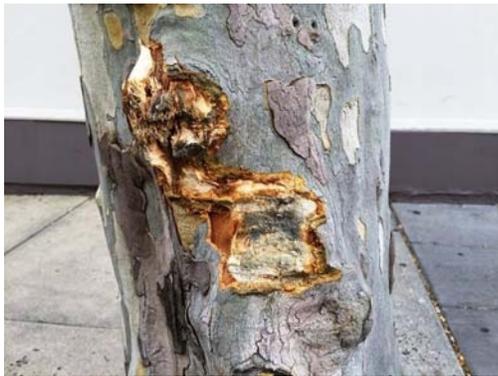
Tree: <i>Platanus x acerifolia</i> Name: LONDON PLANETREE Caliper (DBH): 11	Location: 21 S. Broadway Block No.: Lot No.:	Station Offset:	Tree No. 17
Comments: MAJOR DAMAGE TO TRUNK; THIN CROWN; MINOR DEAD BRANCHES; WATERSPROUTING ON TRUNK Condition: 26/32		Date: 9/24/2015 Time: Weather: Sunny Temp: 73 degrees F	
Mitigation Case #:		Cut(-)/Fill(+) (in.):

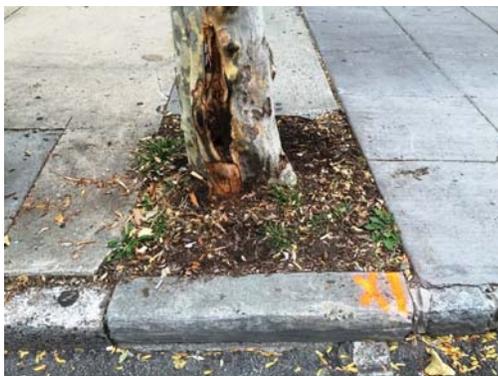
Undersized tree pit

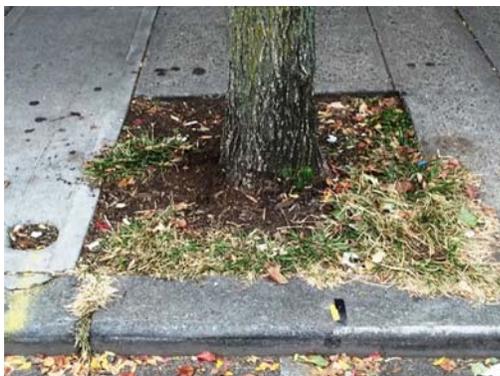
Undersized tree pit

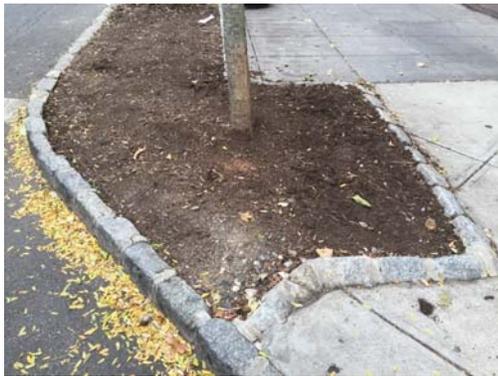
Tree: <i>Fraxinus pennsylvanica</i> Name: ASH, GREEN Caliper (DBH): 4	Location: 23 S. Broadway Block No.: Lot No.:	Station Offset:	Tree No. 19
Comments: BURIED ROOT COLLAR; MINOR DEAD BRANCHES		Date: 9/24/2015	Time:
Condition: 26/32		Weather: Sunny	Temp: 73 degrees F
Mitigation Case #:		Cut(-)/Fill(+) (in.):

Sidewalk bump out

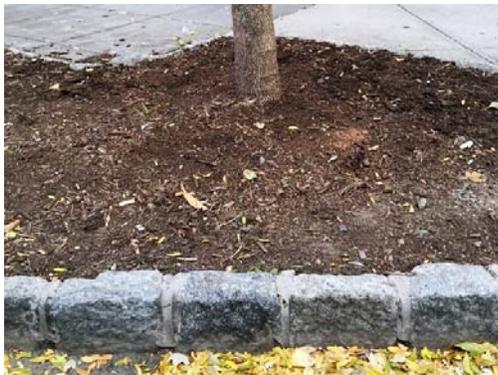
Undersized tree pit

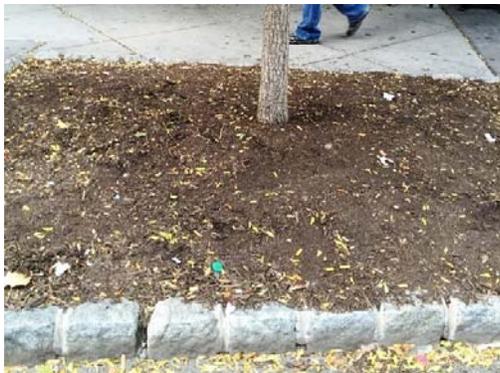
Undersized tree pit

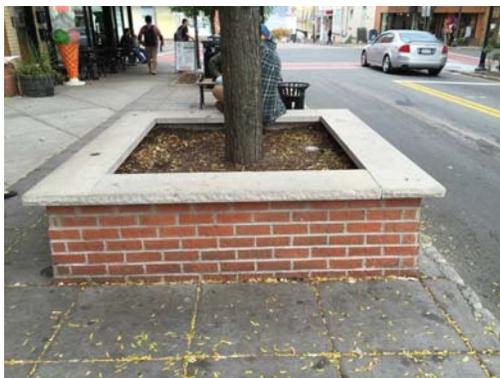
Tree: <i>Gleditsia triacanthos inermis</i> Name: HONEYLOCUST Caliper (DBH): 12	Location: 25 S. Broadway Block No.: Lot No.:	Station Offset:	Tree No. 21
Comments: BURIED ROOT COLLAR IN RAISED PLANTER; MINOR DEAD BRANCHES; INCLUDED BARK Condition: 23/32		Date: 9/24/2015 Time: Weather: Sunny Temp: 73 degrees F	
Mitigation Case #:		Cut(-)/Fill(+) (in.):

Buried root collar in raised planter

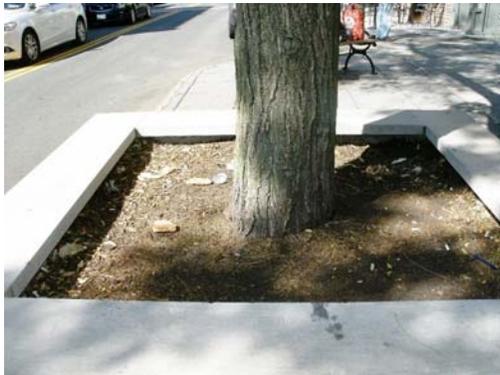
Tree: <i>Styphnolobium japonicum</i> Name: JAPANESE PAGODA TREE Caliper (DBH): 16	Location: 26 S. Broadway Block No.: Lot No.:	Station Offset:	Tree No. 22
Comments: BURIED ROOT COLLAR IN RAISED PLANTER; MAJOR SCAFFOLD DAMAGE; MINOR DEAD BRANCHES; THIN CROWN Condition: 20/32		Date: 9/24/2015 Time: Weather: Sunny Temp: 73 degrees F	
Mitigation Case #:		Cut(-)/Fill(+) (in.):

Buried root collar in raised planter

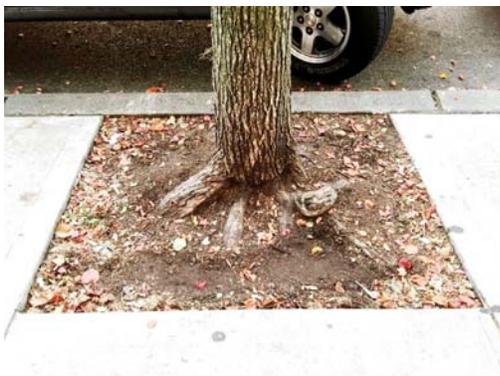
Undersized tree pit

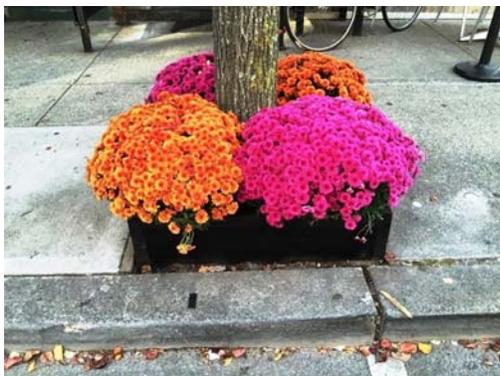
Tree pit with mums in pots

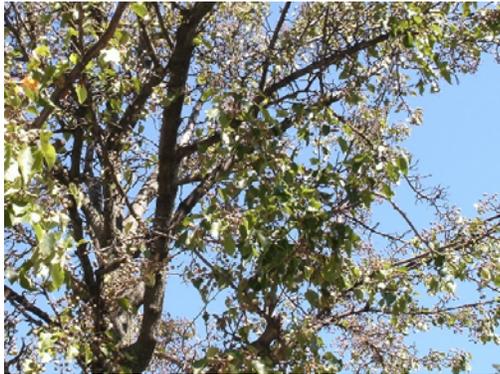
Tree: <i>Pyrus calleryana</i> Name: PEAR, CALLERY Caliper (DBH): 8	Location: 30 S. Broadway Block No.: Lot No.:	Station Offset:	Tree No. 26
Comments: MINOR DEAD BRANCHES; THIN CROWN Condition: 28/32		Date: 9/24/2015 Time: Weather: Sunny Temp: 73 degrees F	
Mitigation Case #:		Cut(-)/Fill(+) (in.):

Minor dead branches

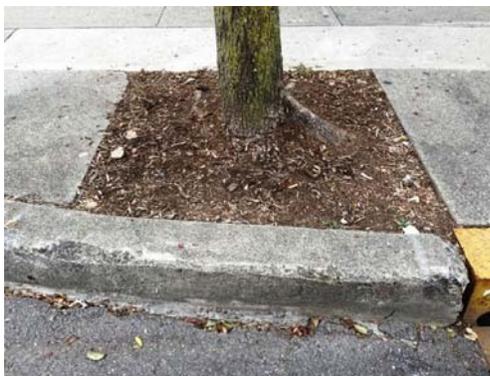
Undersized tree pit

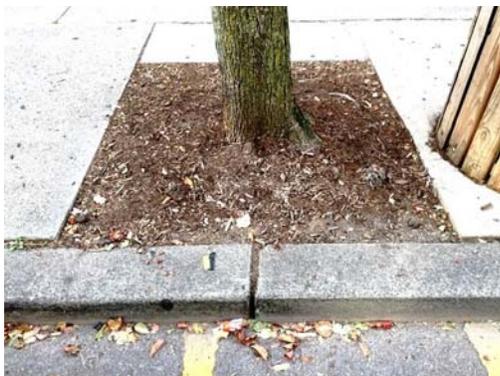
Undersized tree pit

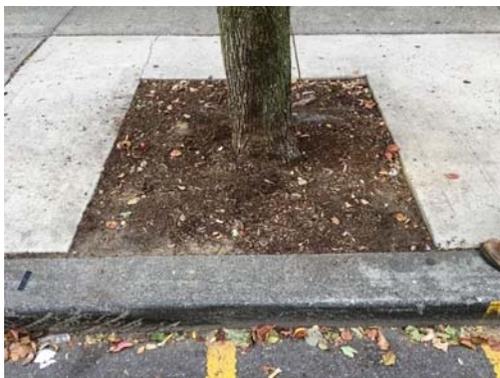
Undersized tree pit

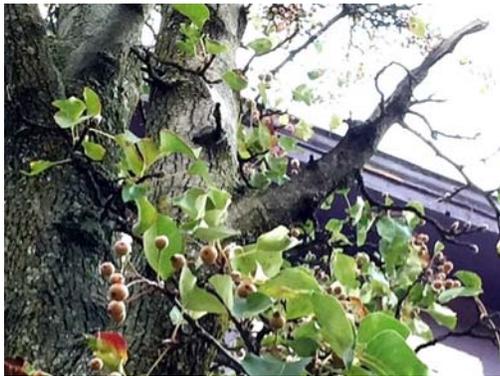
Tree: <i>Pyrus calleryana</i> Name: PEAR, CALLERY Caliper (DBH): 8	Location: 33 S. Broadway Block No.: Lot No.:	Station Offset:	Tree No. 29
Comments: BROKEN MINOR BRANCH; THIN CROWN; ; EXPOSED ROOTS WITH MINOR DAMAGE Condition: 24/32		Date: 9/24/2015 Time: Weather: Sunny Temp: 73 degrees F	
Mitigation Case #:		Cut(-)/Fill(+) (in.):

Broken minor branch

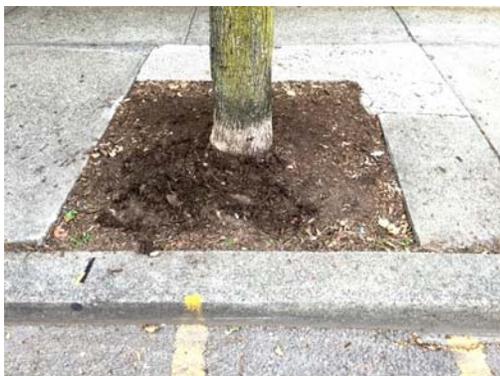
Undersized tree pit

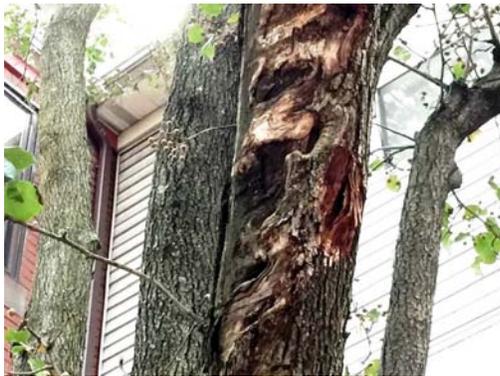
Tree: <i>Pyrus calleryana</i> Name: PEAR, CALLERY Caliper (DBH): 17	Location: 34 S. Broadway Block No.: Lot No.:	Station Offset:	Tree No. 30
Comments: VEHICLE DAMAGE TO SCAFFOLD BRANCHES; DEAD LOWER BRANCHES; MINOR TRUNK SCAR Condition: 26/32		Date: 9/24/2015 Time: Weather: Sunny Temp: 73 degrees F	
Mitigation Case #:		Cut(-)/Fill(+) (in.):

Damage to scaffold branches

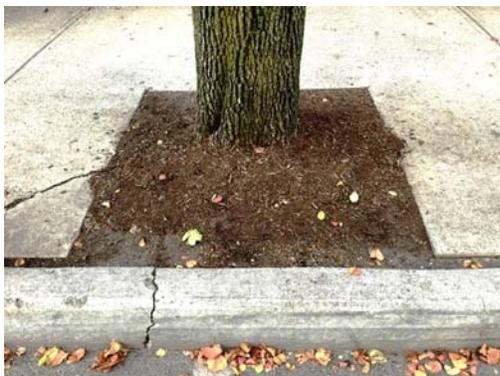
Undersized tree pit

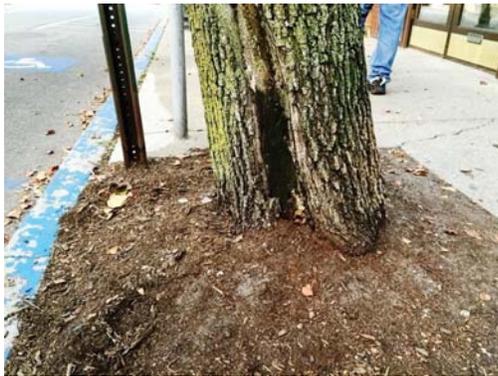
Tree: <i>Pyrus calleryana</i> Name: PEAR, CALLERY Caliper (DBH): 16	Location: 35 S. Broadway Block No.: Lot No.:	Station Offset:	Tree No. 31
Comments: MAJOR TRUNK DAMAGE; DEAD BRANCHES; SIGN POST IN TREE PIT Condition: 24/32		Date: 9/24/2015 Time: Weather: Sunny Temp: 73 degrees F	
Mitigation Case #:		Cut(-)/Fill(+) (in.):

Major trunk damage

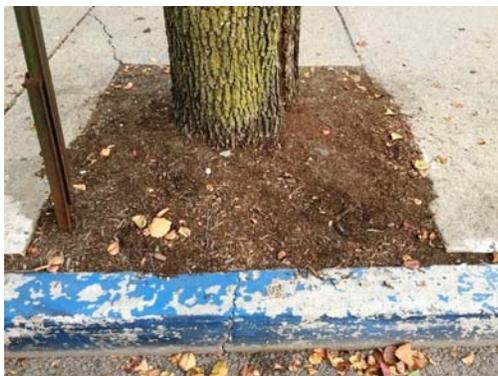
Undersized tree pit with sign post

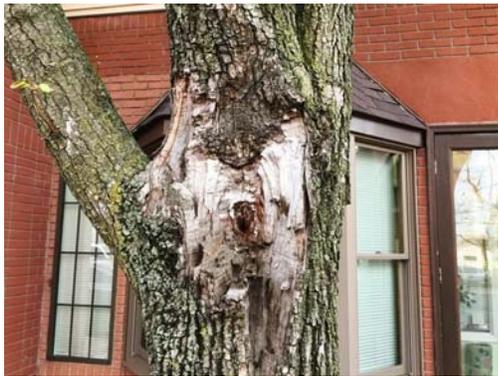
Tree: <i>Pyrus calleryana</i> Name: PEAR, CALLERY Caliper (DBH): 14	Location: 36 S. Broadway Block No.: Lot No.:	Station Offset:	Tree No. 32
Comments: MAJOR TRUNK DAMAGE; VEHICLE DAMAGE TO SCAFFOLD BRANCHES; POOR CANOPY STRUCTURE Condition: 16/32		Date: 9/24/2015 Time: Weather: Sunny Temp: 73 degrees F	
Mitigation Case #:		Cut(-)/Fill(+) (in.):

Major trunk damage

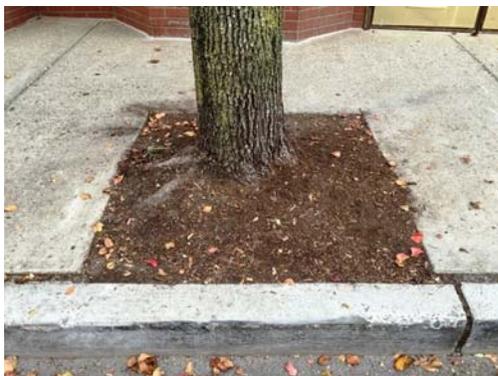
Undersized tree pit

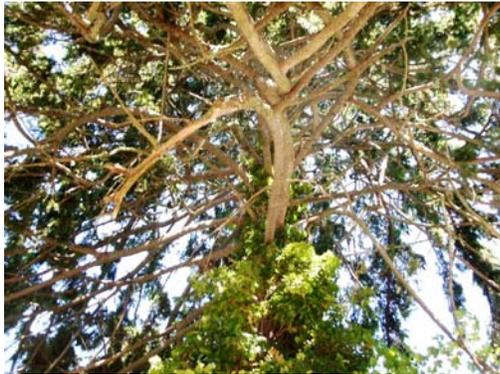
Tree: <i>Picea abies</i> Name: SPRUCE, NORWAY Caliper (DBH): 31	Location: 37 S. Broadway Block No.: Lot No.:	Station Offset:	Tree No. 33
Comments: PRIVATE PROPERTY; IVY GROWING UP TRUNK; DEAD BRANCHES Condition: 25/32		Date: 9/24/2015 Time: Weather: Sunny Temp: 73 degrees F	
Mitigation Case #:		Cut(-)/Fill(+) (in.):

Dead branches

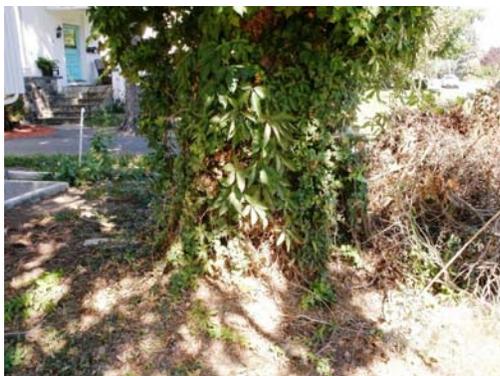
Root collar in lawn

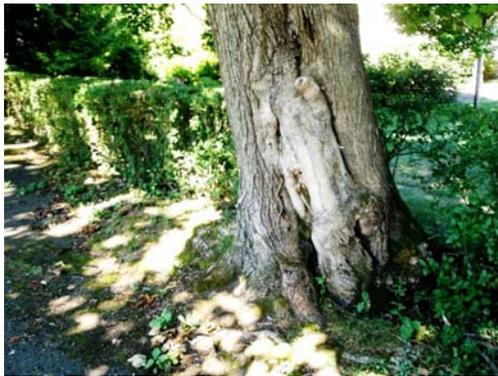
Tree: <i>Acer platanoides</i> Name: MAPLE, NORWAY Caliper (DBH): 30	Location: 38 S. Broadway Block No.: Lot No.:	Station Offset:	Tree No. 34
Comments: PRIVATE PROPERTY; MINOR TRUNK DAMAGE Condition: 28/32		Date: 9/24/2015 Time: Weather: Sunny Temp: 73 degrees F	
Mitigation Case #:		Cut(-)/Fill(+) (in.):

Minor trunk wound

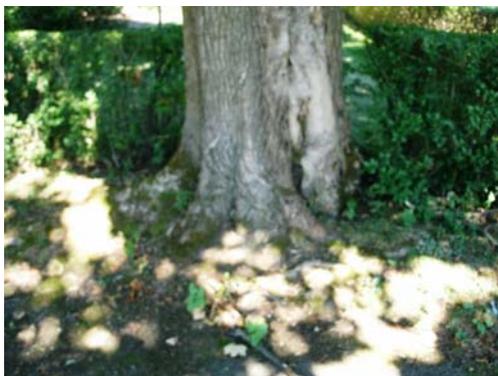
Root collar in lawn

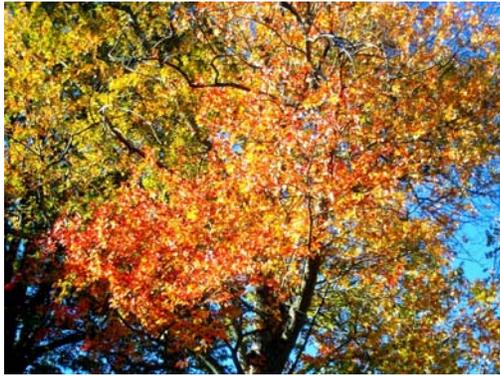
Tree: <i>Acer rubrum</i> Name: MAPLE, RED Caliper (DBH): 22	Location: 42 S. Broadway Block No.: Lot No.:	Station Offset:	Tree No. 38
Comments: PRIVATE PROPERTY; MINOR DEAD BRANCHES Condition: 27/32		Date: 9/24/2015 Time: Weather: Sunny Temp: 73 degrees F	
Mitigation Case #:		Cut(-)/Fill(+) (in.):

Minor dead branches

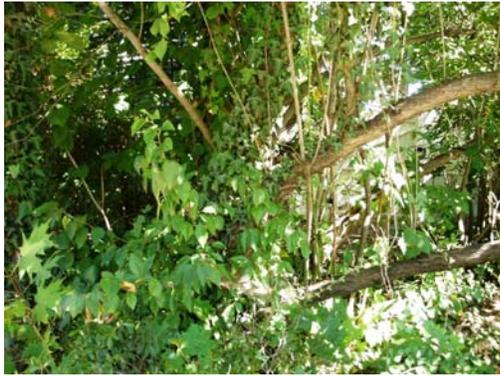
Tree: <i>Syringa reticulata</i> Name: LILAC, JAPANESE TREE Caliper (DBH): 4,3,3	Location: 52 S. Broadway Block No.: Lot No.:	Station Offset:	Tree No. 48
Comments: PRIVATE PROPERTY; IVY GROWING UP TRUNK Condition: 27/32		Date: 9/24/2015 Time: Weather: Sunny Temp: 73 degrees F	
Mitigation Case #:		Cut(-)/Fill(+) (in.):

Ivy growing up trunk

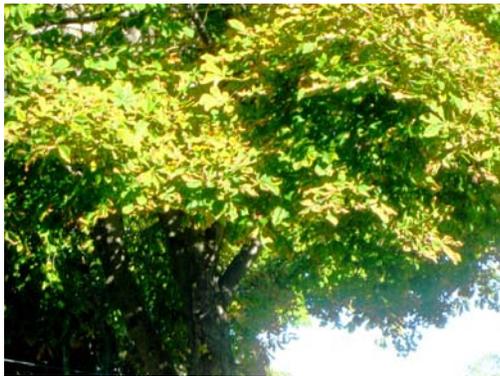
Tree: <i>Aesculus hippocastanum</i> Name: HORSECHESTNUT Caliper (DBH): 20	Location: 53 S. Broadway Block No.: Lot No.:	Station Offset:	Tree No. 49
Comments: LEAF SCORCH; HEAVILY PRUNED Condition: 26/32		Date: 9/24/2015 Time: Weather: Sunny Temp: 73 degrees F	
Mitigation Case #:		Cut(-)/Fill(+) (in.):

Leaf scorch

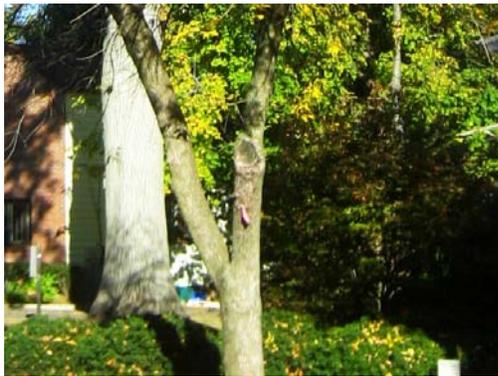
Tree: <i>Fraxinus pennsylvanica</i> Name: ASH, GREEN Caliper (DBH): 15	Location: 56 S. Broadway Block No.: Lot No.:	Station Offset:	Tree No. 52
Comments: CODOMINANT LEADERS; CANOPY PRUNED DUE TO POWER LINES; MINOR DEAD BRANCHES Condition: 24/32		Date: 9/24/2015 Time: Weather: Sunny Temp: 73 degrees F	
Mitigation Case #:		Cut(-)/Fill(+) (in.):

Codominant leaders

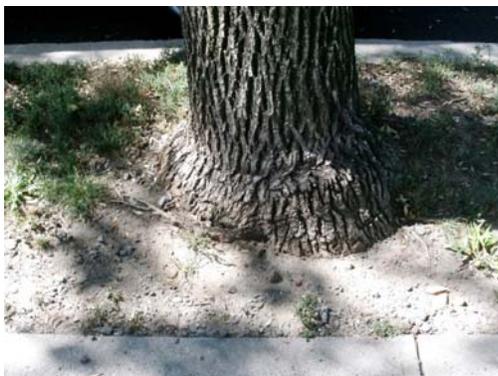
Swollen root collar in grass ROW

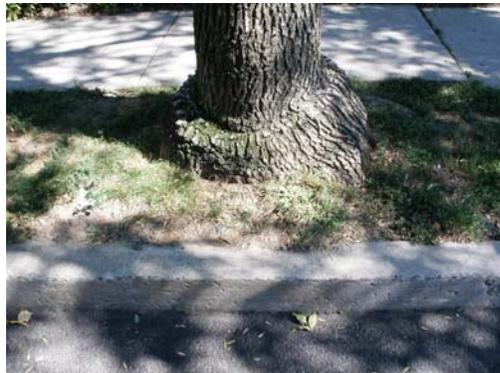
Tree: <i>Fraxinus pennsylvanica</i> Name: ASH, GREEN Caliper (DBH): 16	Location: 57 S. Broadway Block No.: Lot No.:	Station Offset:	Tree No. 53
Comments: SCAFFOLD BRANCHES PRUNED DUE TO POWER LINES Condition: 21/32		Date: 9/24/2015 Time: Weather: Sunny Temp: 73 degrees F	
Mitigation Case #:		Cut(-)/Fill(+) (in.):

Swollen root collar in grass ROW

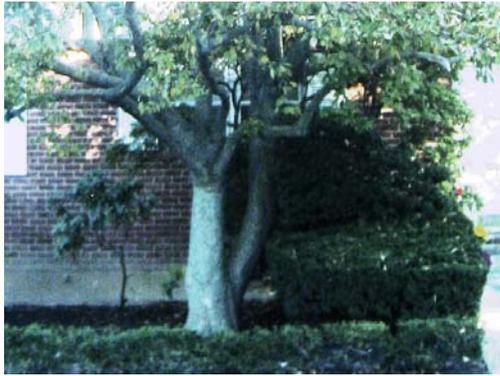
Tree: <i>Magnolia x soulangiana</i> Name: MAGNOLIA, OTHER Caliper (DBH): 12,13	Location: 65 S. Broadway Block No.: Lot No.:	Station Offset:	Tree No. 61
Comments: PRIVATE PROPERTY; CODOMINANT TRUNK Condition: 30/32		Date: 9/24/2015 Time: Weather: Sunny Temp: 73 degrees F	
Mitigation Case #:		Cut(-)/Fill(+) (in.):

Codominant trunk

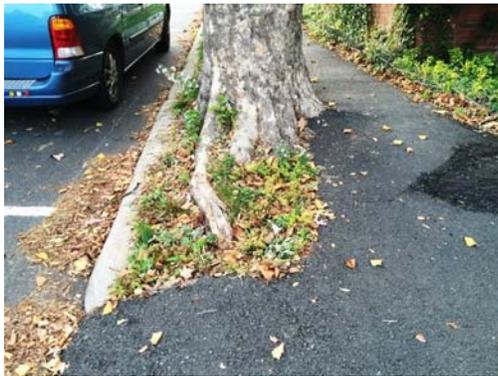
Tree: <i>Platanus x acerifolia</i> Name: LONDON PLANETREE Caliper (DBH): 29	Location: 66 S. Broadway Block No.: Lot No.:	Station Offset:	Tree No. 62
Comments: ROOTS HEAVING ASPHALT PAVING; MINOR DAMAGE TO EXPOSED ROOTS Condition: 26/32		Date: 9/24/2015 Time: Weather: Sunny Temp: 73 degrees F	
Mitigation Case #:		Cut(-)/Fill(+) (in.):

Roots heaving asphalt paving

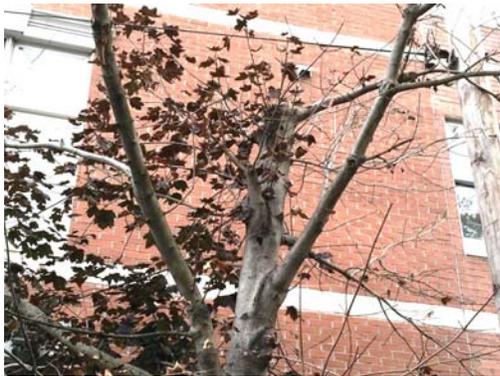
Tree: <i>Acer platanoides</i> 'Crimson King' Name: MAPLE, NORWAY -CR KNG Caliper (DBH): 11	Location: 67 S. Broadway Block No.: Lot No.:	Station Offset:	Tree No. 63
Comments: MAJOR DECLINE; TREE DYING; TOPPED LEADER Condition: 15/32		Date: 9/24/2015 Time: Weather: Sunny Temp: 73 degrees F	
Mitigation Case #:		Cut(-)/Fill(+) (in.):

Topped leader

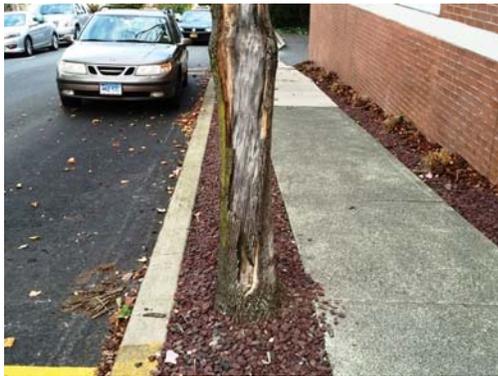
Tree: <i>Acer platanoides</i> 'Crimson King' Name: MAPLE, NORWAY -CR KNG Caliper (DBH): 10	Location: 68 S. Broadway Block No.: Lot No.:	Station Offset:	Tree No. 64
Comments: PARTIALLY DEAD; MAJOR TRUNK DECAY Condition: 10/32		Date: 9/24/2015 Time: Weather: Sunny Temp: 73 degrees F	
Mitigation Case #:		Cut(-)/Fill(+) (in.):

Major trunk decay

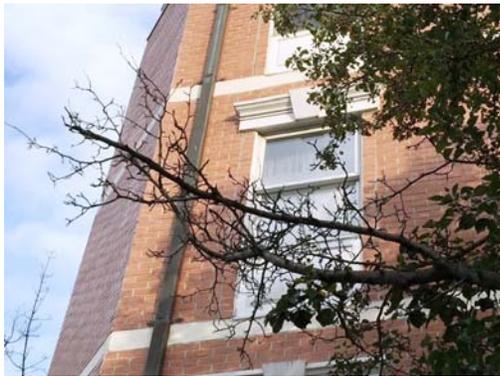
Tree: <i>Pyrus calleryana</i> Name: PEAR, CALLERY Caliper (DBH): 9	Location: 69 S. Broadway Block No.: Lot No.:	Station Offset:	Tree No. 65
Comments: DEAD SCAFFOLD BRANCHES; MINOR DEAD BRANCHES; INCLUDED BARK; CODOMINANT LEADERS; CANOPY IN CONFLICT WITH POWER LINES Condition: 24/32		Date: 9/24/2015 Time: Weather: Sunny Temp: 73 degrees F	
Mitigation Case #:		Cut(-)/Fill(+) (in.):

Dead scaffold branches

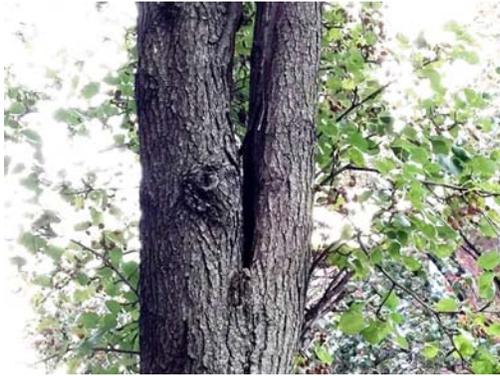
Tree: <i>Pyrus calleryana</i> Name: PEAR, CALLERY Caliper (DBH): 10	Location: 70 S. Broadway Block No.: Lot No.:	Station Offset:	Tree No. 66
Comments: BURIED ROOT COLLAR IN RAISED PLANTER; CODOMINANT LEADERS; INCLUDED BARK; CANOPY IN CONFLICT WITH POWER LINES Condition: 25/32		Date: 9/24/2015 Time: Weather: Sunny Temp: 73 degrees F	
Mitigation Case #:		Cut(-)/Fill(+) (in.):

Codominant leaders

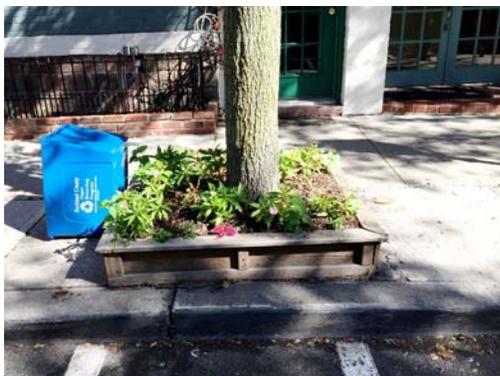
Buried root collar in raised planter
