**Village of Nyack TAP
New Connectivities for Nyack
Village of Nyack, NY**

**Site Reconnaissance
Report**

**McLaren Project No. 150119.00
October 30, 2015**

Prepared by:
**McLaren Engineering Group
100 Snake Hill Road
West Nyack, NY 10994
(845) 353-6400**

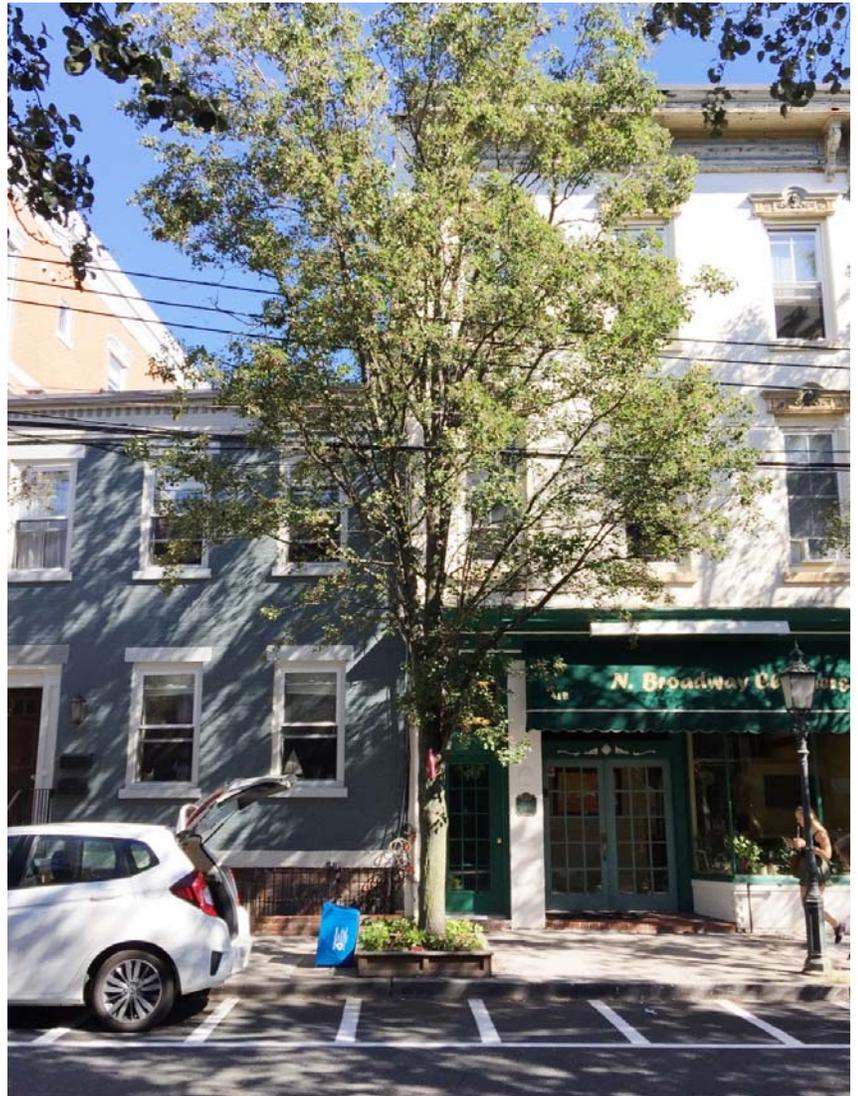
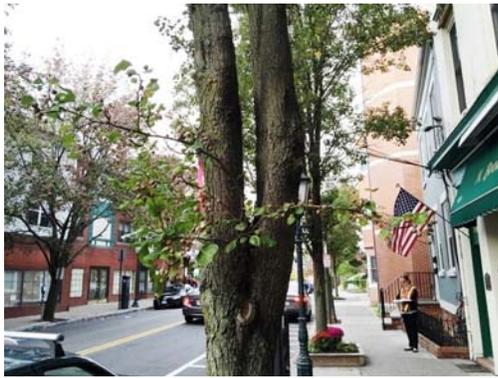
Tree: <i>Pyrus calleryana</i>	Location: 71 S. Broadway	Station Offset:	Tree No.
Name: PEAR, CALLERY	Block No.:		67
Caliper (DBH): 9	Lot No.:		
Comments: BURIED ROOT COLLAR IN RAISED PLANTER; CODOMINANT LEADERS; INCLUDED BARK; CANOPY IN CONFLICT WITH POWER LINES		Date: 9/24/2015	
Condition: 28/32		Time:	
Mitigation Case #:		Weather: Sunny	
		Temp: 73 degrees F	
		Cut(-)/Fill(+) (in.):

Codominant leaders

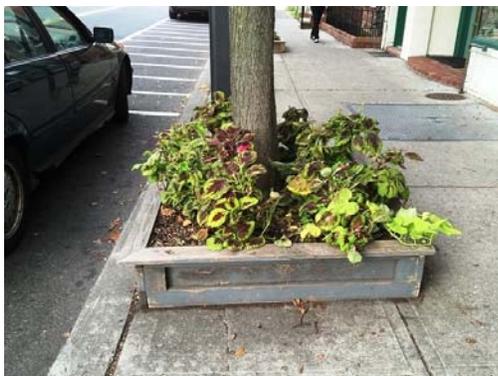
Buried root collar in raised planter

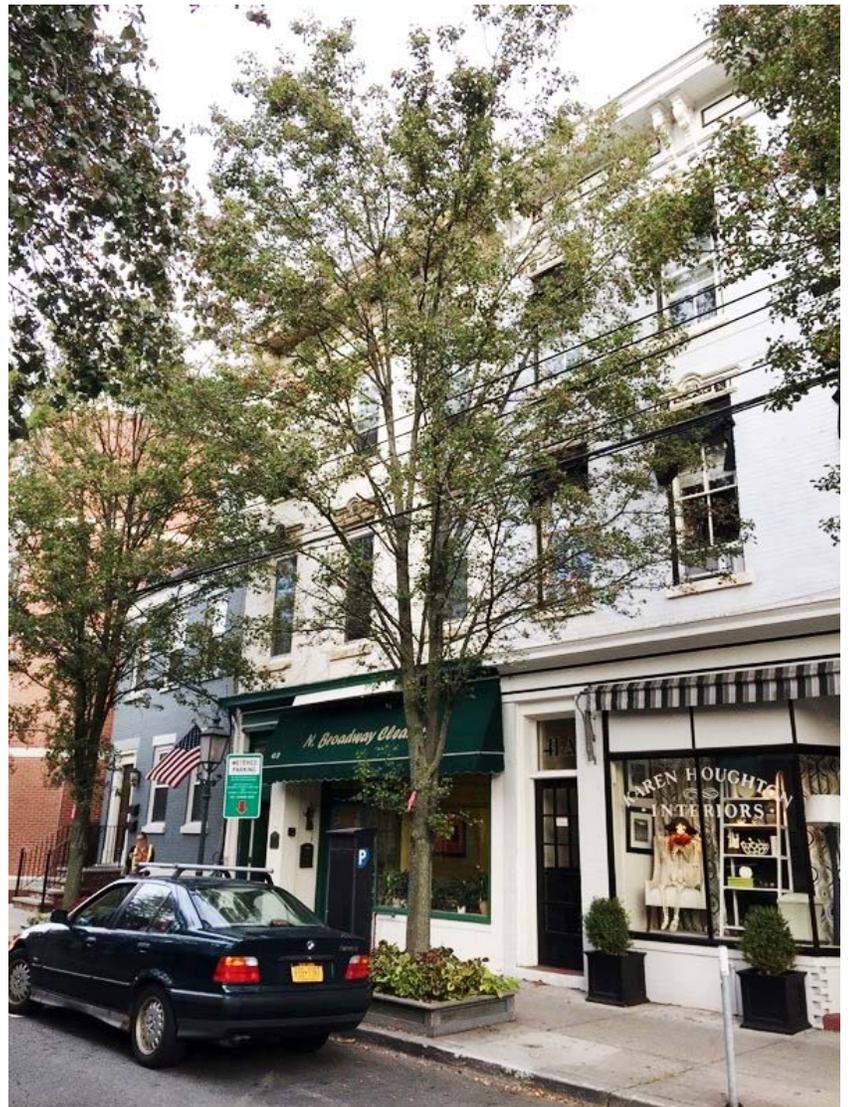
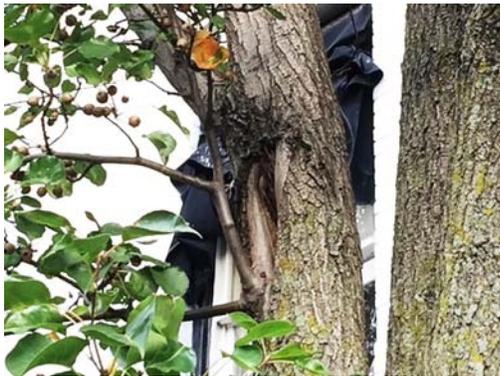
Tree: <i>Pyrus calleryana</i> Name: PEAR, CALLERY Caliper (DBH): 11	Location: 72 S. Broadway Block No.: Lot No.:	Station Offset:	Tree No. 68
Comments: BURIED ROOT COLLAR IN RAISED PLANTER; MINOR SCAFFOLD DAMAGE; CODOMINANT LEADERS; INCLUDED BARK Condition: 27/32		Date: 9/24/2015 Time: Weather: Sunny Temp: 73 degrees F	
Mitigation Case #:		Cut(-)/Fill(+) (in.):

Minor scaffold damage

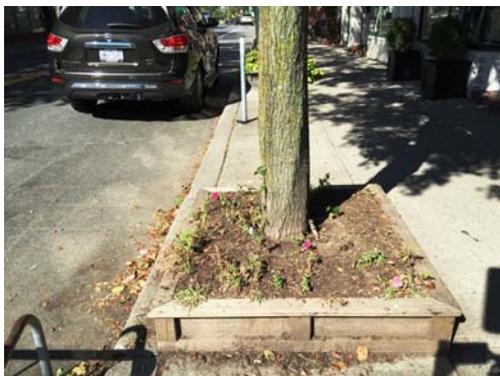
Buried root collar in raised planter

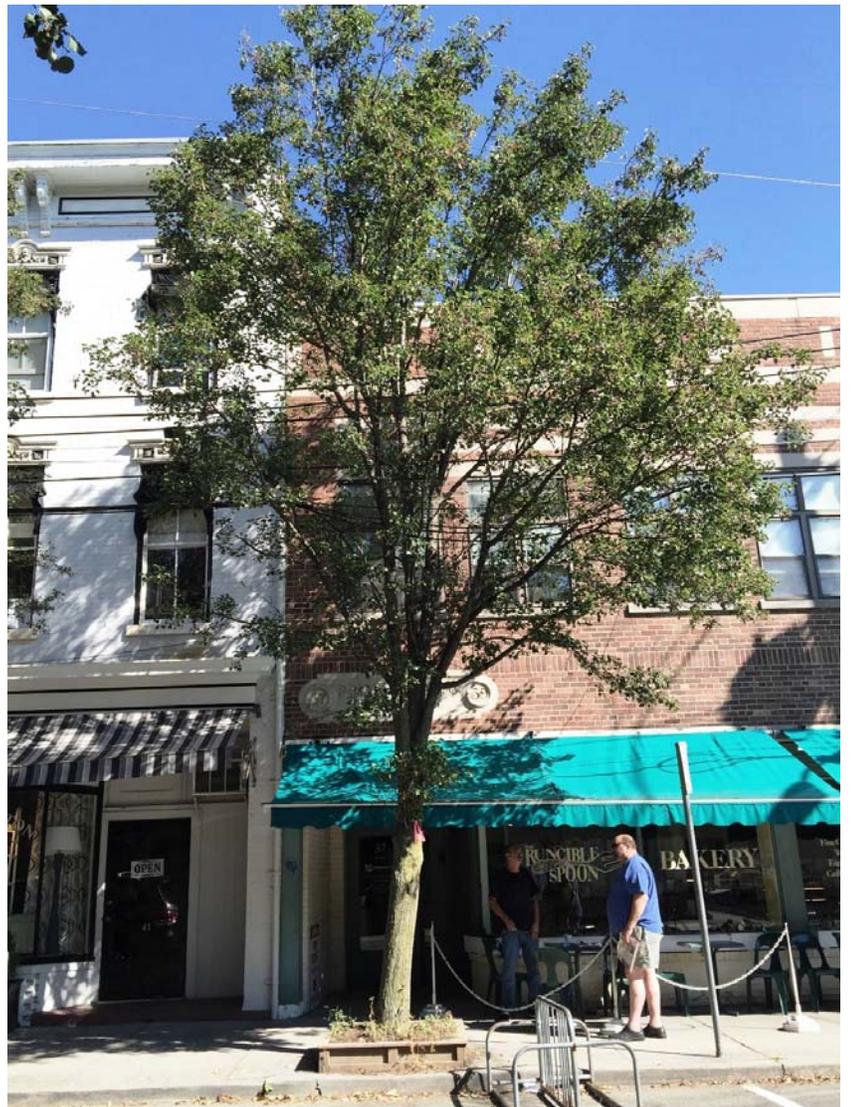
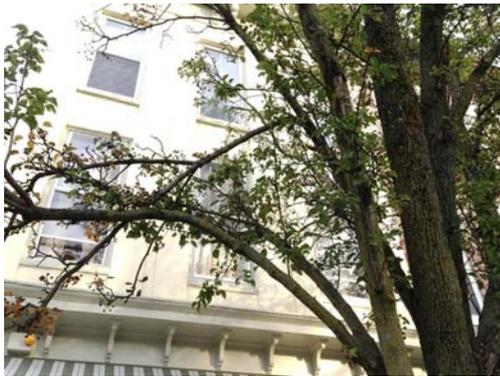
Tree: <i>Pyrus calleryana</i> Name: PEAR, CALLERY Caliper (DBH): 10	Location: 73 S. Broadway Block No.: Lot No.:	Station Offset:	Tree No. 69
Comments: BURIED ROOT COLLAR IN RAISED PLANTER; MINOR DEAD BRANCHES; CODOMINANT LEADERS; INCLUDED BARK Condition: 27/32		Date: 9/24/2015 Time: Weather: Sunny Temp: 73 degrees F	
Mitigation Case #:		Cut(-)/Fill(+) (in.):

Minor dead branches

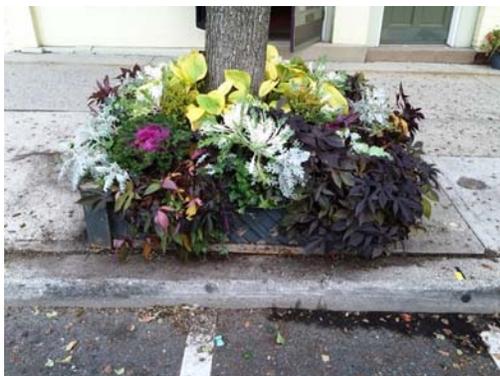
Buried root collar in raised planter

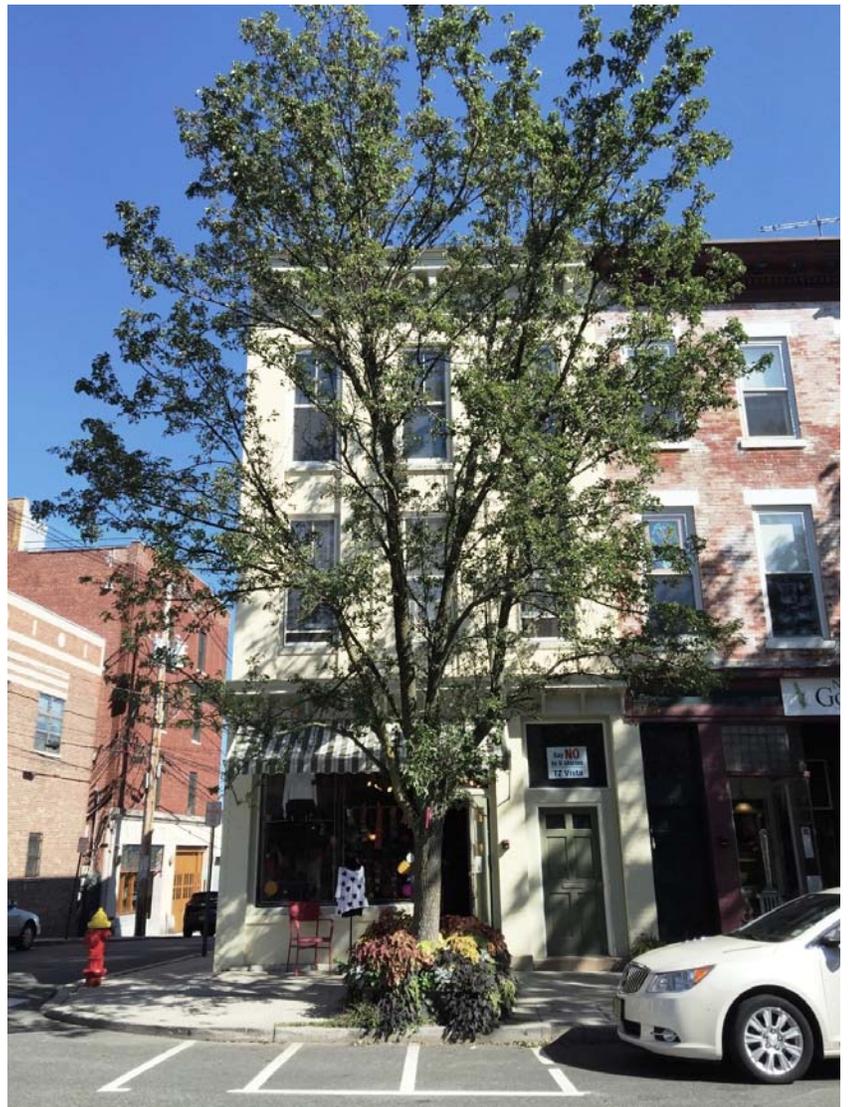
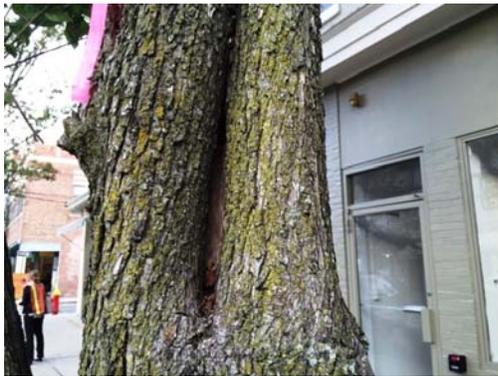
Tree: <i>Pyrus calleryana</i> Name: PEAR, CALLERY Caliper (DBH): 15	Location: 74 S. Broadway Block No.: Lot No.:	Station Offset:	Tree No. 70
Comments: BURIED ROOT COLLAR IN RAISED PLANTER; CODOMINANT LEADERS; INCLUDED BARK; MINOR TRUNK SCAR Condition: 26/32		Date: 9/24/2015 Time: Weather: Sunny Temp: 73 degrees F	
Mitigation Case #:		Cut(-)/Fill(+) (in.):

Minor trunk scar

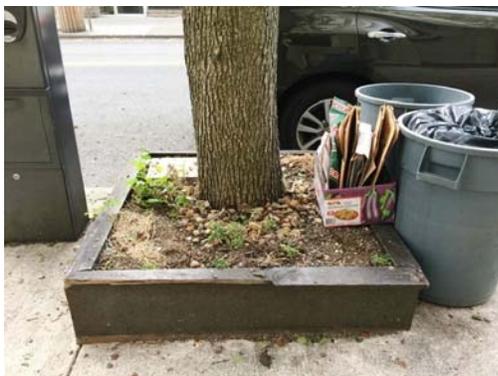
Buried root collar in raised planter

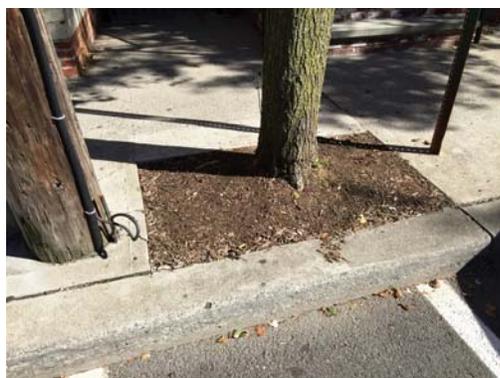
Undersized tree pit

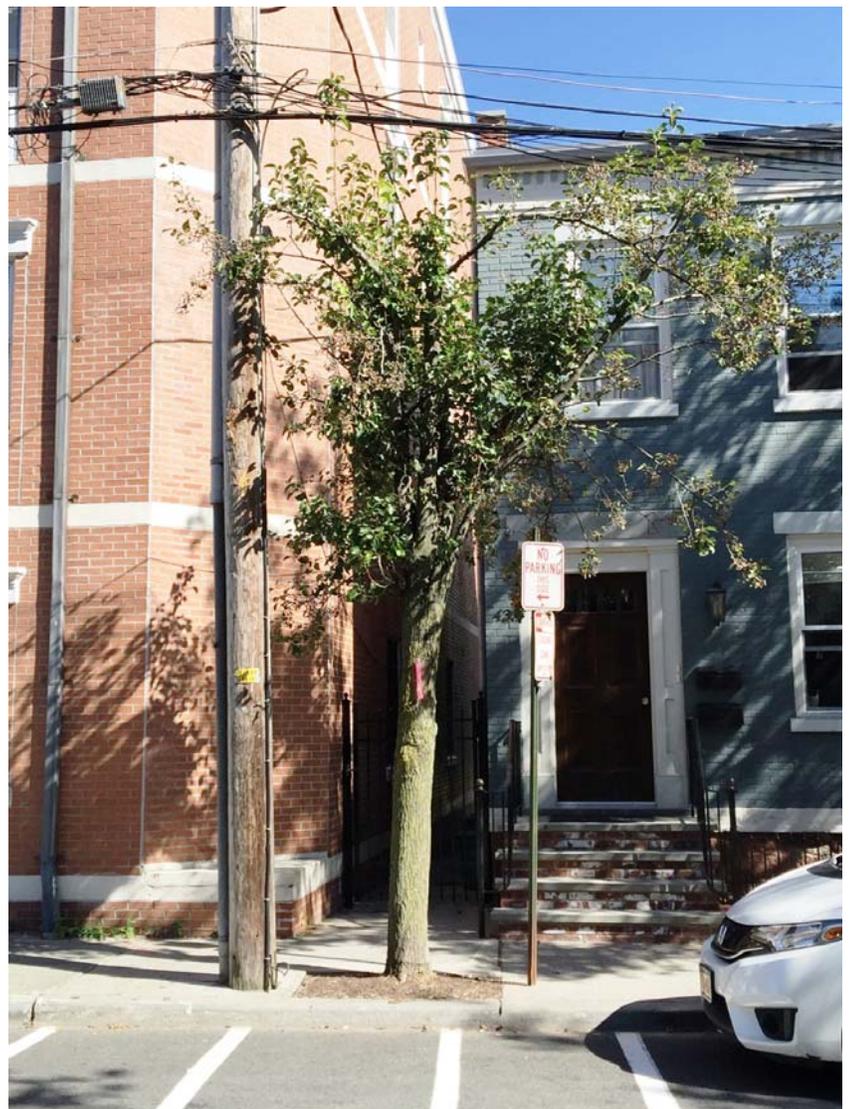
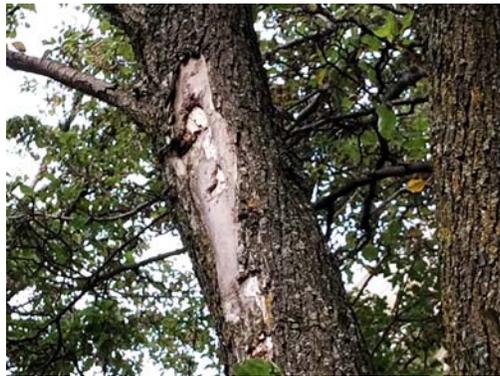
Tree: <i>Pyrus calleryana</i> Name: PEAR, CALLERY Caliper (DBH): 10	Location: 76 S. Broadway Block No.: Lot No.:	Station Offset:	Tree No. 72
Comments: VEHICULAR DAMAGE TO SCAFFOLD BRANCHES Condition: 29/32		Date: 9/24/2015 Time: Weather: Sunny Temp: 73 degrees F	
Mitigation Case #:		Cut(-)/Fill(+) (in.):

Damage to scaffold branches

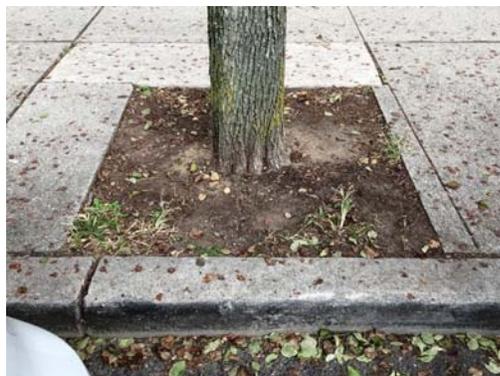
Undersized tree pit

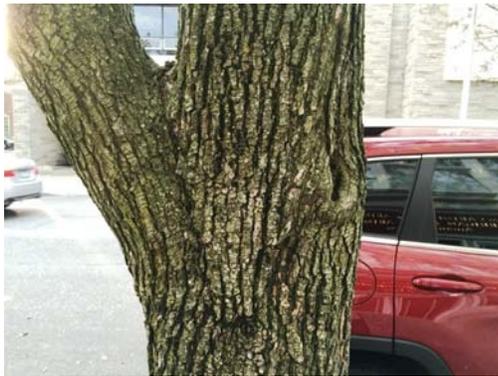
Tree: <i>Pyrus calleryana</i> Name: PEAR, CALLERY Caliper (DBH): 11	Location: 77 S. Broadway Block No.: Lot No.:	Station Offset:	Tree No. 73
Comments: MINOR ROOT FLARE DAMAGE; CODOMINANT LEADERS; INCLUDED BARK Condition: 29/32		Date: 9/24/2015 Time: Weather: Sunny Temp: 73 degrees F	
Mitigation Case #:		Cut(-)/Fill(+) (in.):

Included bark

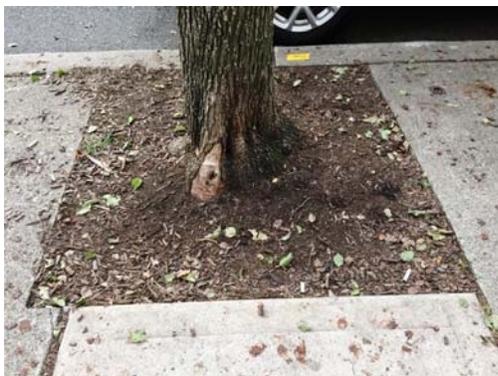
Undersized tree pit

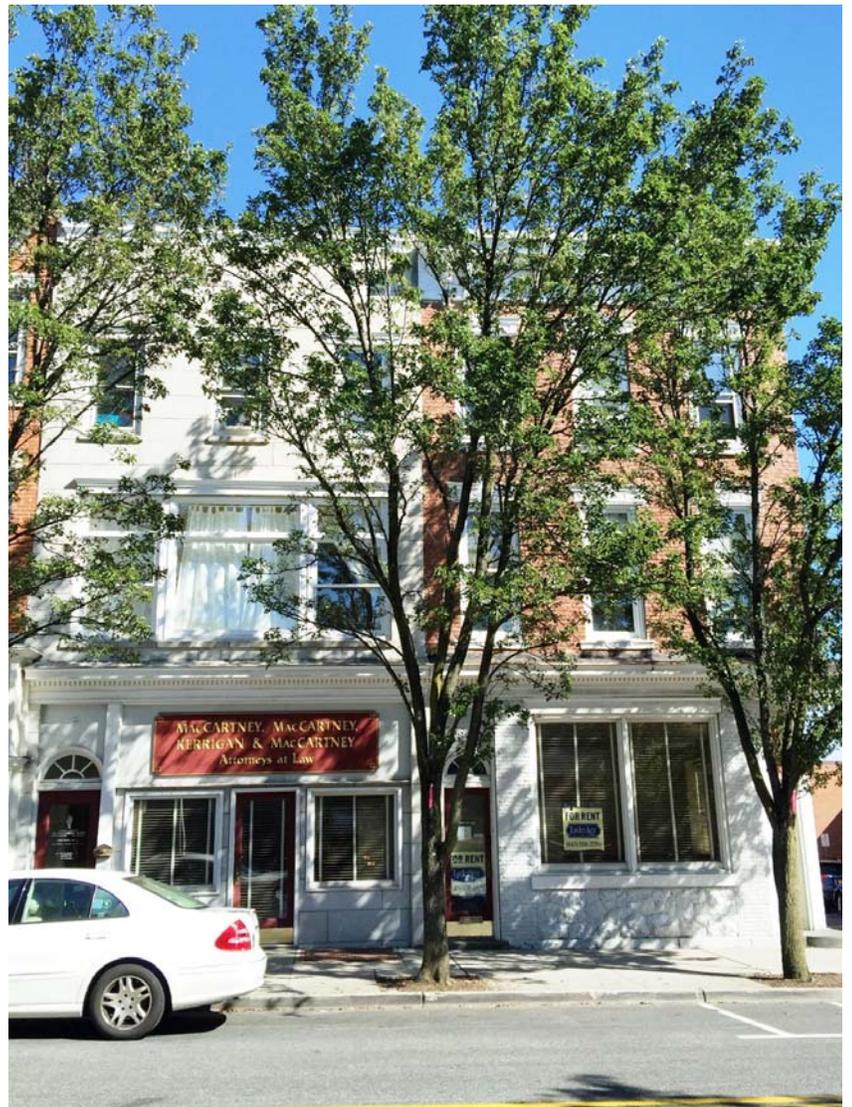
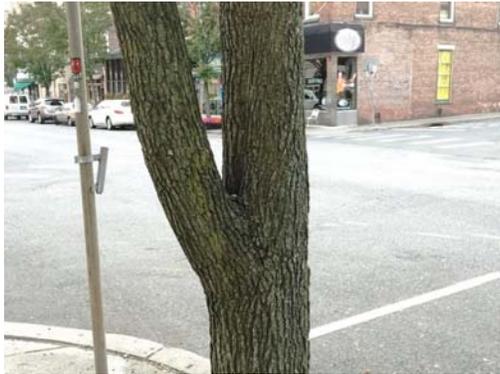
Tree: <i>Pyrus calleryana</i> Name: PEAR, CALLERY Caliper (DBH): 11	Location: 78 S. Broadway Block No.: Lot No.:	Station Offset:	Tree No. 74
Comments: CODOMINANT LEADERS; INCLUDED BARK Condition: 26/32		Date: 9/24/2015 Time: Weather: Sunny Temp: 73 degrees F	
Mitigation Case #:		Cut(-)/Fill(+) (in.):

Included bark

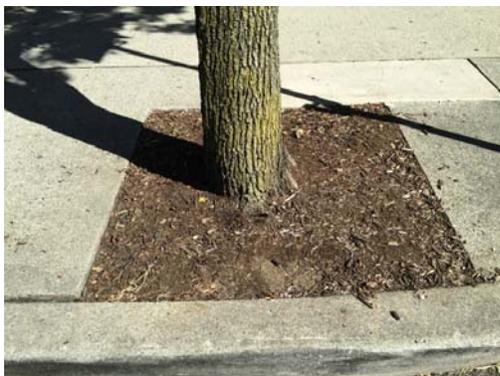
Undersized tree pit

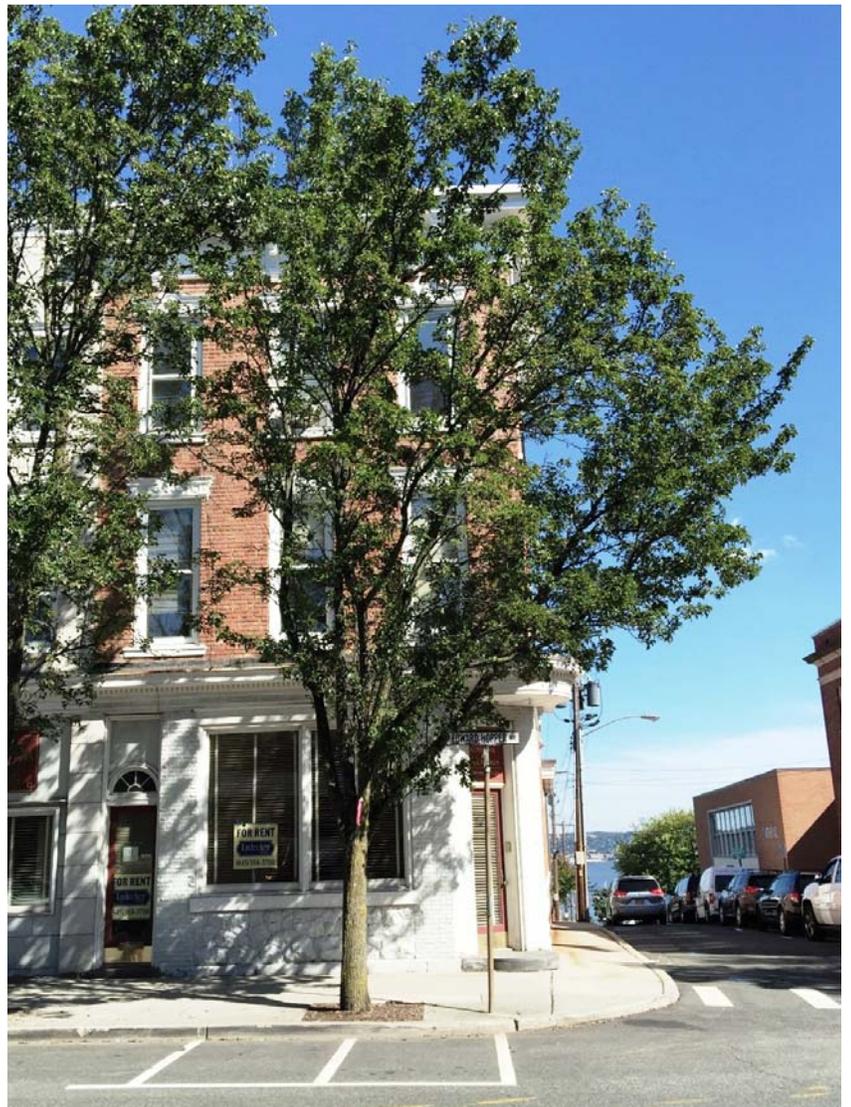
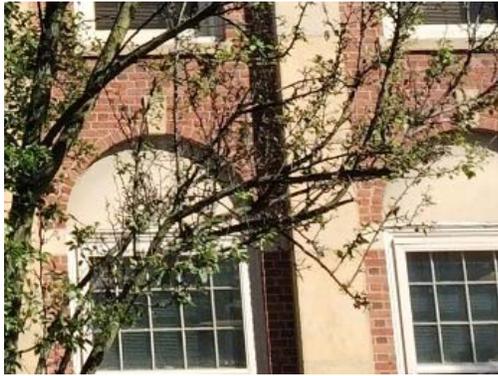
Tree: <i>Pyrus calleryana</i> Name: PEAR, CALLERY Caliper (DBH): 13	Location: 79 S. Broadway Block No.: Lot No.:	Station Offset:	Tree No. 75
Comments: MINOR DEAD BRANCHES; CANOPY GROWING INTO LIGHT POLE; CODOMINANT LEADERS; INCLUDED BARK Condition: 26/32		Date: 9/24/2015 Time: Weather: Sunny Temp: 73 degrees F	
Mitigation Case #:		Cut(-)/Fill(+) (in.):

Minor dead branches

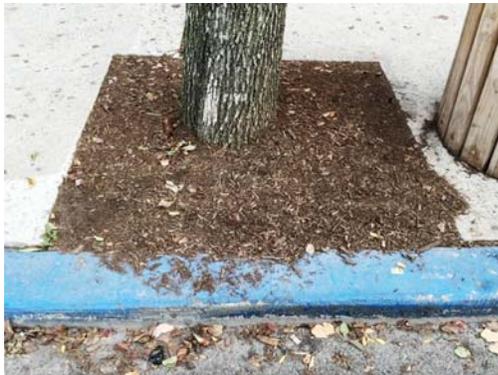
Undersized tree pit

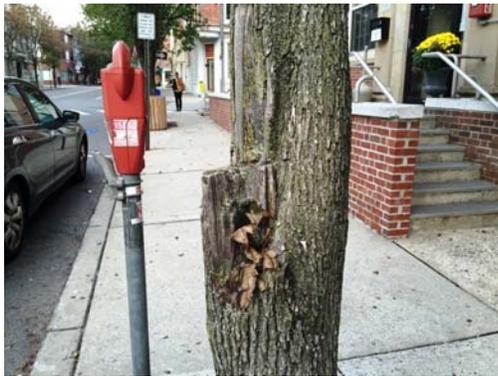
Tree: <i>Pyrus calleryana</i> Name: PEAR, CALLERY Caliper (DBH): 10	Location: 80 S. Broadway Block No.: Lot No.:	Station Offset:	Tree No. 76
Comments: DEAD BRANCHES; DECLINING CANOPY FOLIAGE; TRUNK SCAR Condition: 16/32		Date: 9/24/2015 Time: Weather: Sunny Temp: 73 degrees F	
Mitigation Case #:		Cut(-)/Fill(+) (in.):

Trunk scar

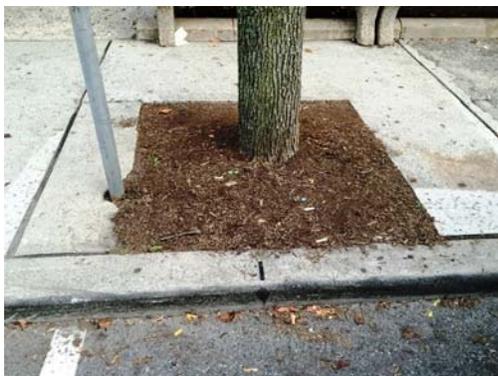
Undersized tree pit

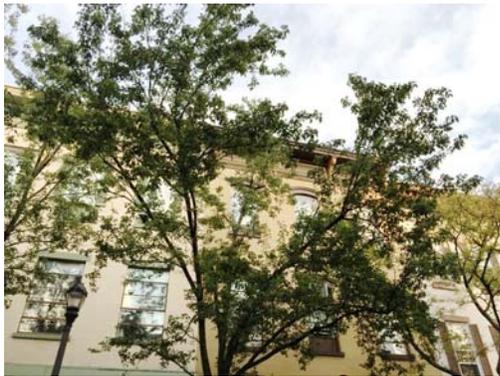
Tree: <i>Pyrus calleryana</i> Name: PEAR, CALLERY Caliper (DBH): 10	Location: 82 S. Broadway Block No.: Lot No.:	Station Offset:	Tree No. 78
Comments: THIN CROWN DENSITY; EUONYMOUS GROWING IN TREE PIT WITH PLASTIC EDGING Condition: 27/32		Date: 9/24/2015 Time: Weather: Sunny Temp: 73 degrees F	
Mitigation Case #:		Cut(-)/Fill(+) (in.):

Thin crown density

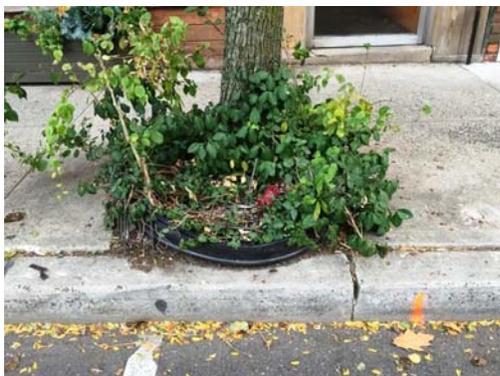
Root collar in planting bed

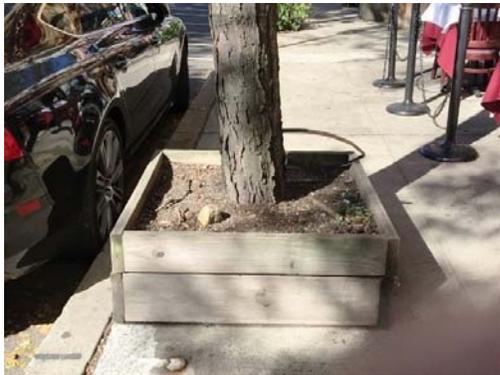
Buried root collar in raised planter

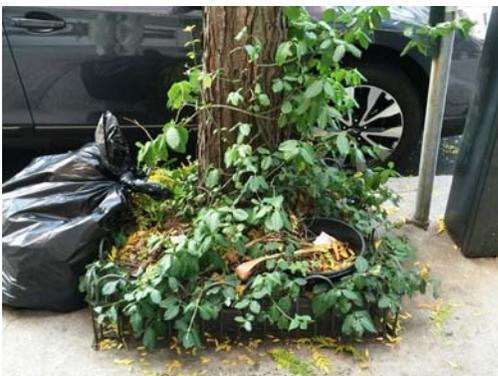
Buried root collar in raised planter

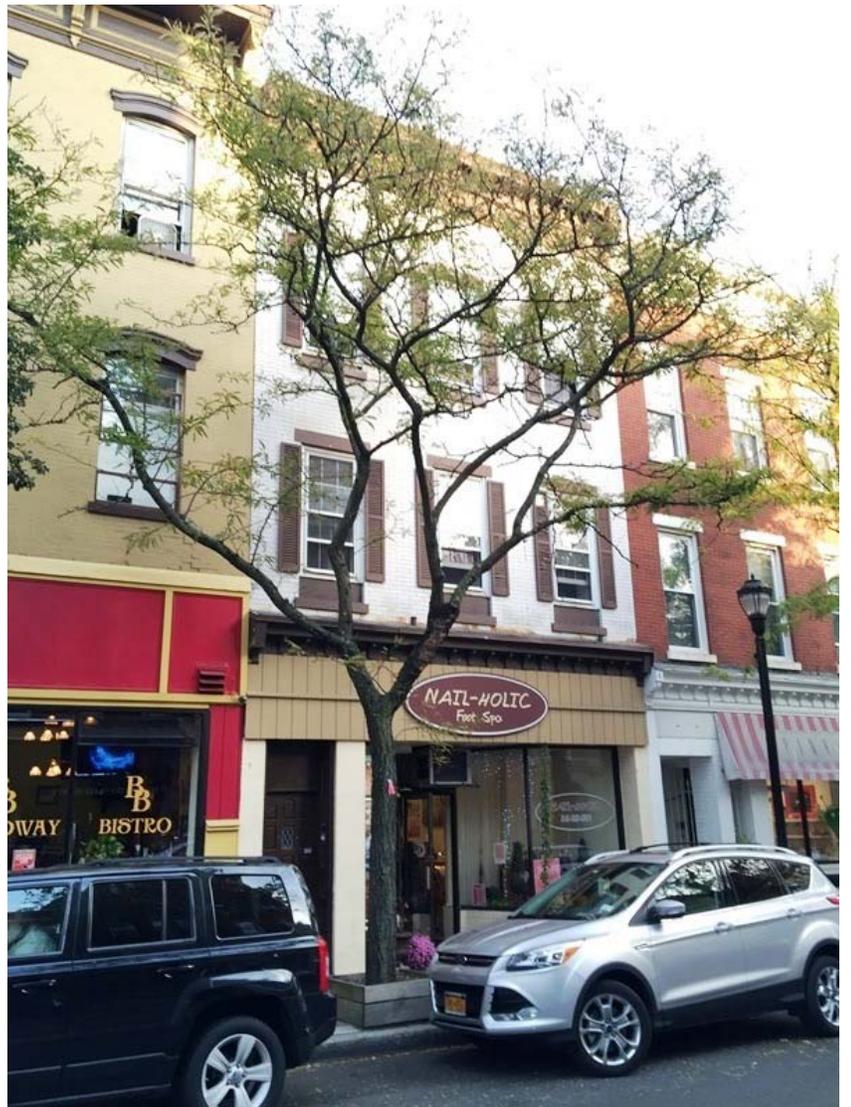
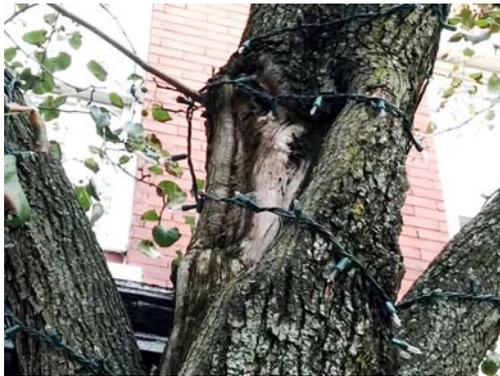
Tree: <i>Pyrus calleryana</i> Name: PEAR, CALLERY Caliper (DBH): 11	Location: 85 S. Broadway Block No.: Lot No.:	Station Offset:	Tree No. 81
Comments: DAMAGE AND TRUNK DECAY; BROKEN SCAFFOLD BRANCHES; BURIED ROOT COLLAR; ENGLISH IVY GROWING AT BASE Condition: 21/32		Date: 9/24/2015 Time: Weather: Sunny Temp: 73 degrees F	
Mitigation Case #:		Cut(-)/Fill(+) (in.):

Major damage and trunk decay

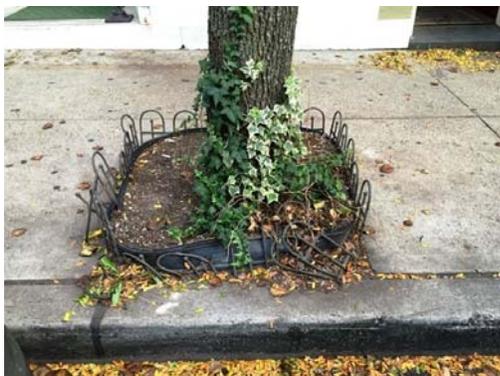
Buried root collar in raised planter

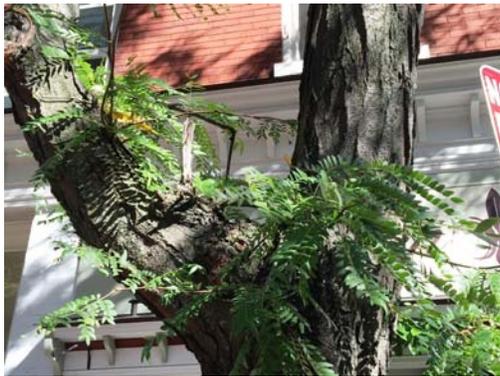
Tree: <i>Gleditsia triacanthos inermis</i> Name: HONEYLOCUST Caliper (DBH): 13	Location: 86 S. Broadway Block No.: Lot No.:	Station Offset:	Tree No. 82
Comments: CODOMINANT LEADERS WITH WATERSPROUTING; INCLUDED BARK; BROKEN SCAFFOLD BRANCHES; EUONYMOUS GROWING IN TREE PIT Condition: 27/32		Date: 9/24/2015 Time: Weather: Sunny Temp: 73 degrees F	
Mitigation Case #:		Cut(-)/Fill(+) (in.):

Codominant leaders with watersprouting

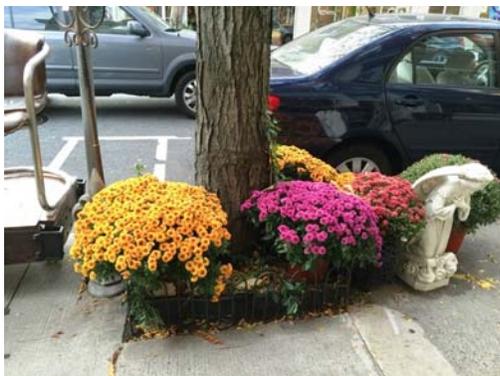
Buried root collar in raised planter

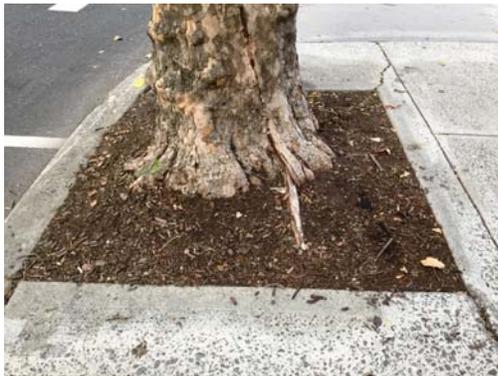
Tree: <i>Platanus x acerifolia</i> Name: LONDON PLANETREE Caliper (DBH): 20	Location: 87 S. Broadway Block No.: Lot No.:	Station Offset:	Tree No. 83
Comments: MINOR ROOT DAMAGE Condition: 28/32		Date: 9/24/2015 Time: Weather: Sunny Temp: 73 degrees F	
Mitigation Case #:		Cut(-)/Fill(+) (in.):

Minor root damage

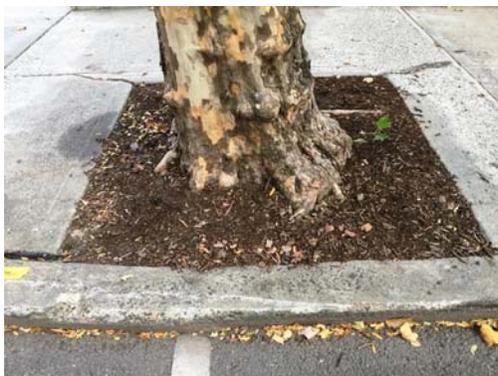
Undersized tree pit

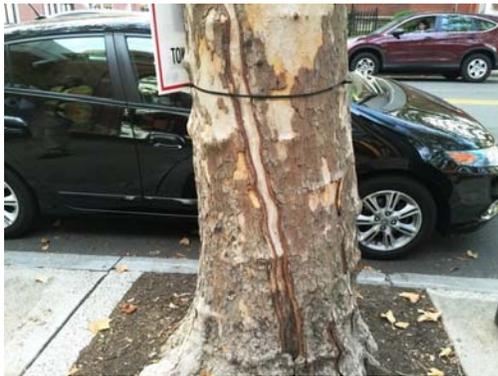
Tree: <i>Platanus x acerifolia</i> Name: LONDON PLANETREE Caliper (DBH): 20	Location: 88 S. Broadway Block No.: Lot No.:	Station Offset:	Tree No. 84
Comments: MINOR TRUNK DAMAGE; DEAD SCAFFOLD BRANCHES; POOR FOLIAGE CONDITION Condition: 23/32		Date: 9/24/2015 Time: Weather: Sunny Temp: 73 degrees F	
Mitigation Case #:		Cut(-)/Fill(+) (in.):

Minor trunk damage

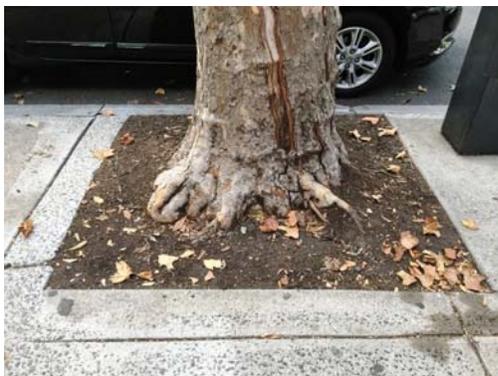
Undersized tree pit

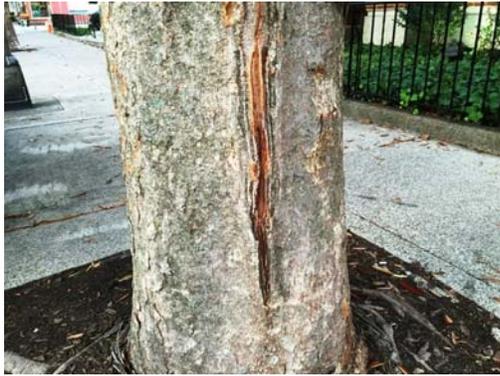
Tree: <i>Zelkova serrata</i> Name: ZELKOVA, JAPANESE Caliper (DBH): 20	Location: 89 S. Broadway Block No.: Lot No.:	Station Offset:	Tree No. 85
Comments: GIRDLING ROOTS; MINOR HEAVING SIDEWALK; MINOR TRUNK DAMAGE Condition: 26/32		Date: 9/24/2015 Time: Weather: Sunny Temp: 73 degrees F	
Mitigation Case #:		Cut(-)/Fill(+) (in.):

Minor trunk damage

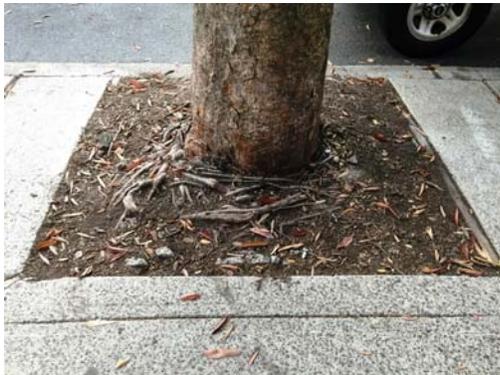
Undersized tree pit with girdling roots

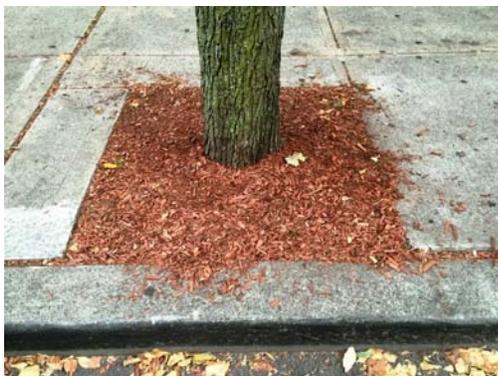
Undersized tree pit

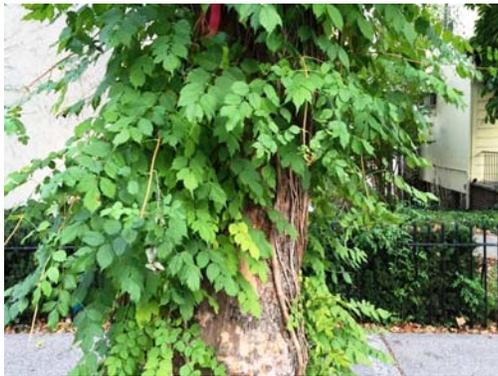
Tree: <i>Platanus x acerifolia</i> Name: LONDON PLANETREE Caliper (DBH): 23	Location: 92 S. Broadway Block No.: Lot No.:	Station Offset:	Tree No. 88
Comments: SIDEWALK HEAVING FROM ROOTS; OVERGROWN VINES CLIMBING UP TRUNK; MINOR DEAD BRANCHES Condition: 26/32		Date: 9/24/2015 Time: Weather: Sunny Temp: 73 degrees F	
Mitigation Case #:		Cut(-)/Fill(+) (in.):

Overgrown vines on trunk

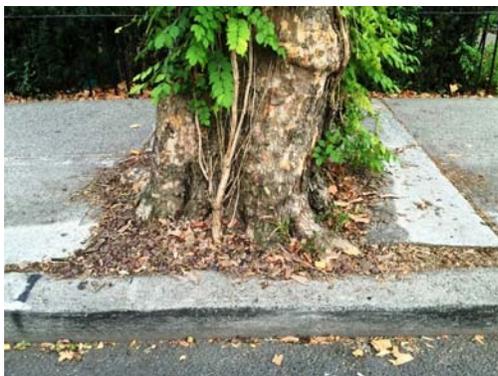
Undersized tree pit

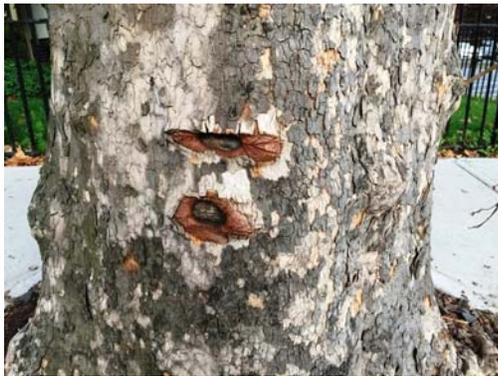
Tree: <i>Platanus x acerifolia</i> Name: LONDON PLANETREE Caliper (DBH): 24	Location: 93 S. Broadway Block No.: Lot No.:	Station Offset:	Tree No. 89
Comments: NEW SIDEWALK INSTALLED CUT-OUT AROUND TRUNK; MINOR VEHICLE TRUNK DAMAGE Condition: 27/32		Date: 9/24/2015 Time: Weather: Sunny Temp: 73 degrees F	
Mitigation Case #:		Cut(-)/Fill(+) (in.):

Minor trunk damage

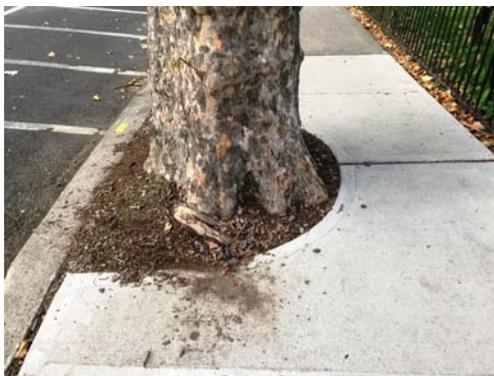
Undersized tree pit cut-out sidewalk

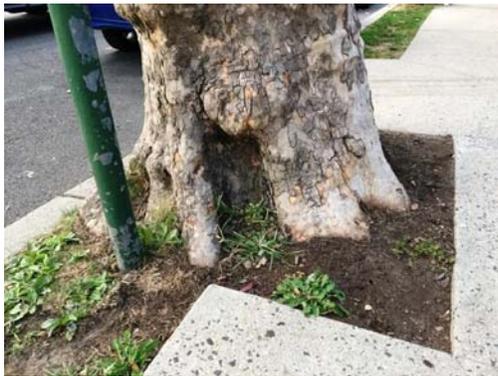
Tree: <i>Platanus x acerifolia</i> Name: LONDON PLANETREE Caliper (DBH): 24	Location: 94 S. Broadway Block No.: Lot No.:	Station Offset:	Tree No. 90
Comments: SIDEWALK HEAVING FROM ROOTS; PARKING METER POST IN UNDERSIZED TREE PIT Condition: 26/32		Date: 9/24/2015 Time: Weather: Sunny Temp: 73 degrees F	
Mitigation Case #:		Cut(-)/Fill(+) (in.):

Parking meter post in tree pit

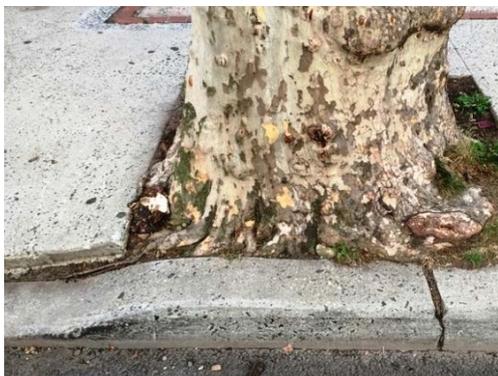
Undersized tree pit

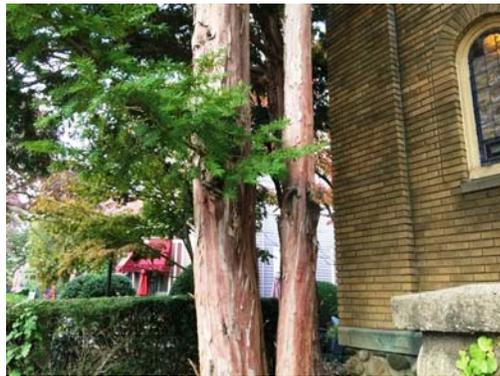
Tree: <i>Taxus spp.</i> Name: YEW Caliper (DBH): 9,4	Location: 95 S. Broadway Block No.: Lot No.:	Station Offset:	Tree No. 91
Comments: PRIVATE PROPERTY; CODOMINANT LEADERS Condition: 28/32		Date: 9/24/2015 Time: Weather: Sunny Temp: 73 degrees F	
Mitigation Case #:		Cut(-)/Fill(+) (in.):

Codominant leaders

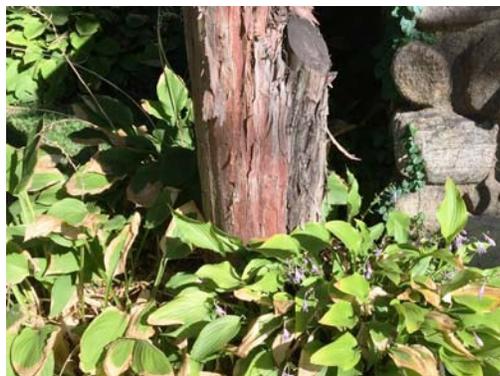
Root collar in planting bed

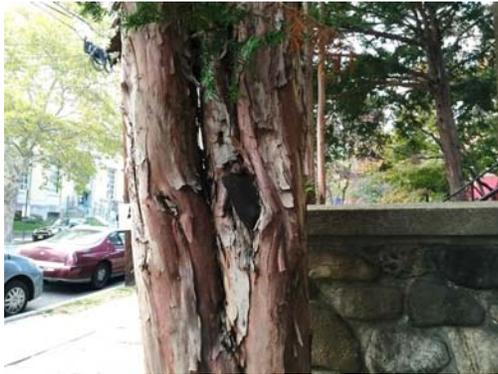
Tree: <i>Taxus spp.</i> Name: YEW Caliper (DBH): 15	Location: 96 S. Broadway Block No.: Lot No.:	Station Offset:	Tree No. 92
Comments: PRIVATE PROPERTY; CODOMINANT LEADERS Condition: 28/32		Date: 9/24/2015 Time: Weather: Sunny Temp: 73 degrees F	
Mitigation Case #:		Cut(-)/Fill(+) (in.):

Codominant leaders

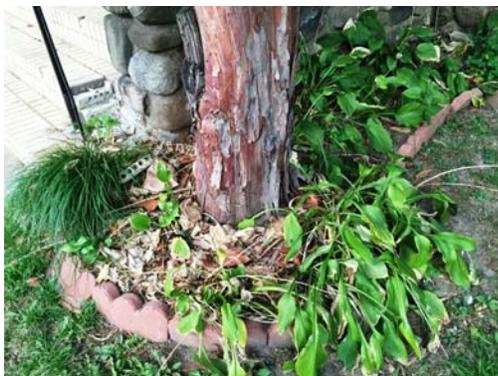
Root collar in planting bed

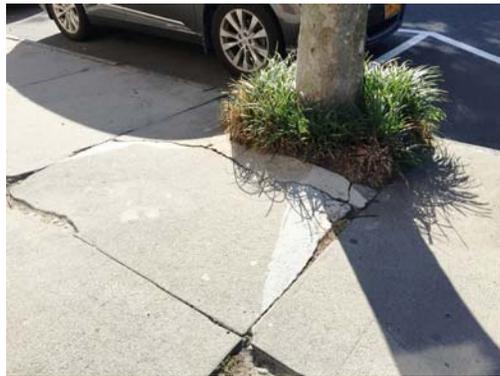
Tree: <i>Zelkova serrata</i>	Location: 97 S. Broadway	Station Offset:	Tree No.
Name: ZELKOVA, JAPANESE	Block No.:		93
Caliper (DBH): 13	Lot No.:		
Comments: HEAVING SIDEWALK; LEAVES ARE BROWNING; CANOPY IN CONFLICT WITH LAMP POST; LIRIOPE GROWING IN UNDERSIZED TREE PIT		Date: 9/24/2015	
Condition: 28/32		Time:	
Mitigation Case #:		Weather: Sunny	
		Temp: 73 degrees F	
		Cut(-)/Fill(+) (in.):

Roots heaving sidewalk

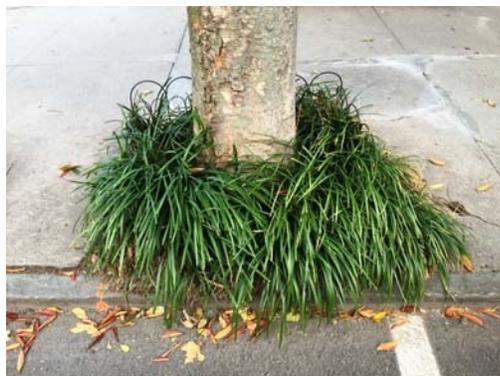
Undersized tree pit with Liriope

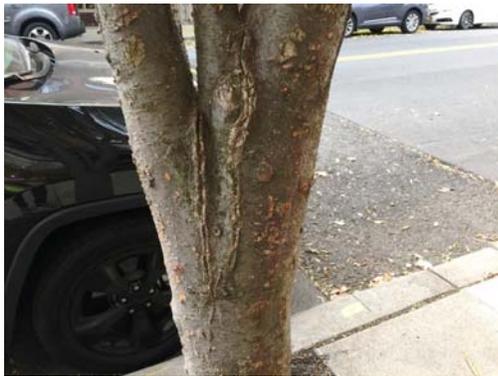
Tree: <i>Zelkova serrata</i>	Location: 98 S. Broadway	Station Offset:	Tree No.
Name: ZELKOVA, JAPANESE	Block No.:		94
Caliper (DBH): 7	Lot No.:		
Comments: INCLUDED BARK; CANOPY IN CONFLICT WITH POWER LINES		Date: 9/24/2015	
Condition: 29/32		Time:	
Mitigation Case #:		Weather: Sunny	
		Temp: 73 degrees F	
		Cut(-)/Fill(+) (in.):

Included bark

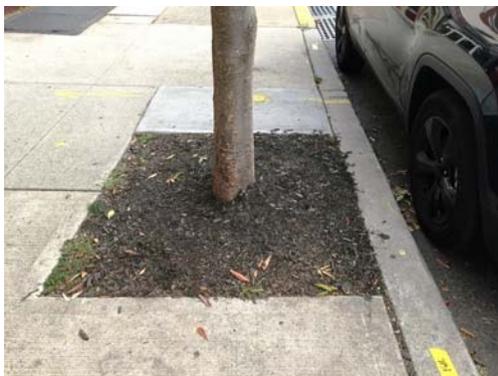
Undersized tree pit

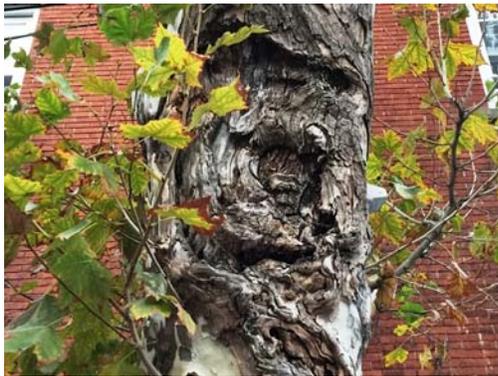
Tree: <i>Platanus x acerifolia</i> Name: LONDON PLANETREE Caliper (DBH): 16	Location: 99 S. Broadway Block No.: Lot No.:	Station Offset:	Tree No. 95
Comments: HEAVING SIDEWALK; MAJOR TRUNK DECAY; MAJOR DEAD SCAFFOLD BRANCHES; MAJOR LEADER DECLINING; CANOPY IN CONFLICT WITH POWER LINES Condition: 16/32		Date: 9/24/2015 Time: Weather: Sunny Temp: 73 degrees F	
Mitigation Case #:		Cut(-)/Fill(+) (in.):

Major trunk damage and decay

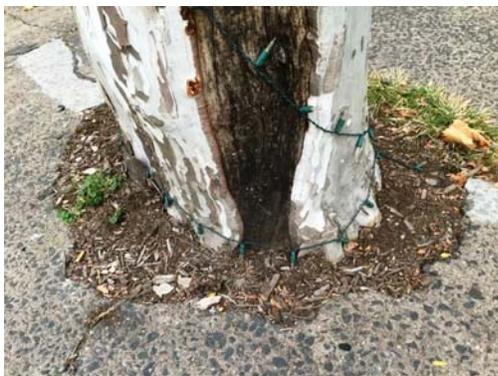
Undersized tree pit

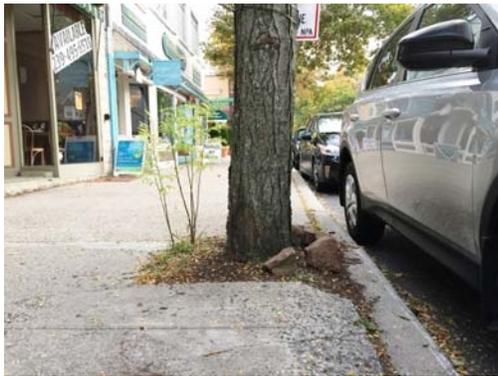
Tree: <i>Gleditsia triacanthos inermis</i>	Location: 100 S. Broadway	Station Offset:	Tree No.
Name: HONEYLOCUST	Block No.:		96
Caliper (DBH): 13	Lot No.:		
Comments: MINOR HEAVING SIDEWALK; BASAL SPROUTS; BRANCH DIE-BACK; CANOPY IN CONFLICT WITH POWER LINES Condition: 27/32		Date: 9/24/2015	
Mitigation Case #:		Time:	
		Weather: Sunny	
		Temp: 73 degrees F	
		Cut(-)/Fill(+) (in.):

Basal sprouts

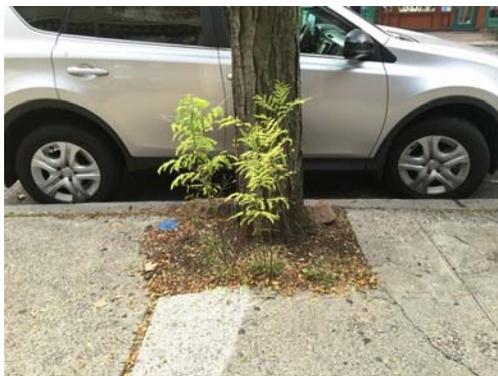
Undersized tree pit

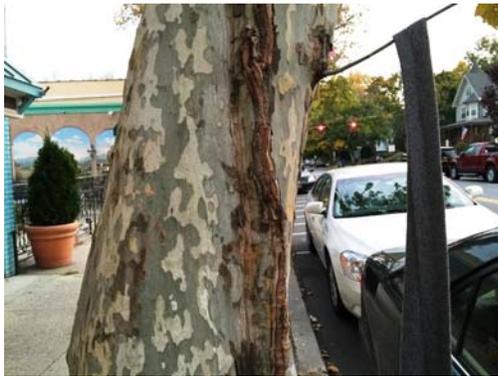
Tree: <i>Platanus x acerifolia</i>	Location: 101 S. Broadway	Station Offset:	Tree No.
Name: LONDON PLANETREE	Block No.:		97
Caliper (DBH): 20	Lot No.:		
Comments: MINOR HEAVING SIDEWALK; MAJOR TRUNK DECAY; CANOPY IN CONFLICT WITH POWER LINES; WOOD TREE PIT BOX IN DISREPAIR		Date: 9/24/2015	
Condition: 17/32		Time:	
Mitigation Case #:		Weather: Sunny	
		Temp: 73 degrees F	
		Cut(-)/Fill(+) (in.):

Major trunk decay

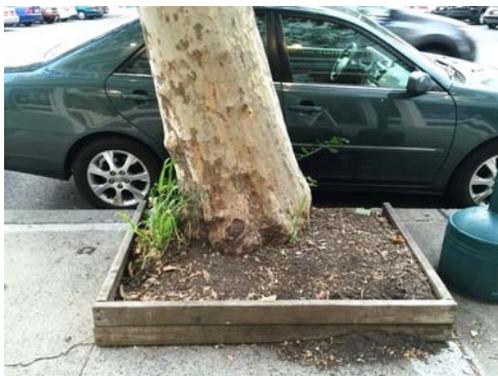
Buried root collar in raised planter

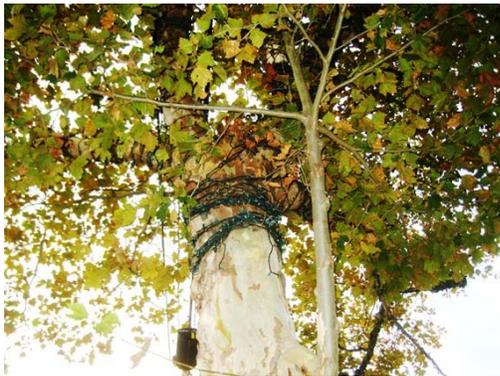
Tree: <i>Platanus x acerifolia</i>	Location: 102 S. Broadway	Station Offset:	Tree No.
Name: LONDON PLANETREE	Block No.:		98
Caliper (DBH): 21	Lot No.:		
Comments: MINOR HEAVING SIDEWALK; IMPROPERLY PRUNED; STRING LIGHTS GIRDLING TRUNK; CANOPY IN CONFLICT WITH POWER LINES		Date: 9/24/2015	
Condition: 27/32		Time:	
Mitigation Case #:		Weather: Sunny	
		Temp: 73 degrees F	
		Cut(-)/Fill(+) (in.):

Lighting girdling trunk

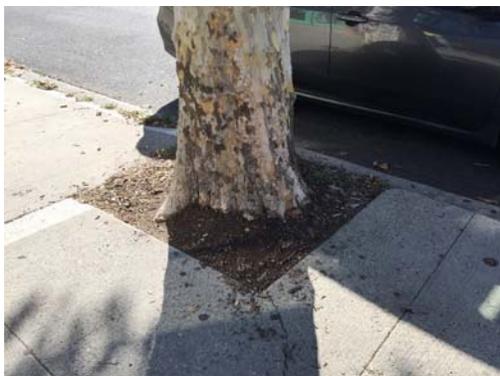
Undersized tree pit

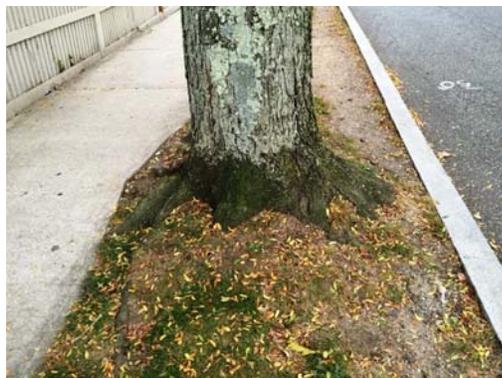
Root collar in grass ROW

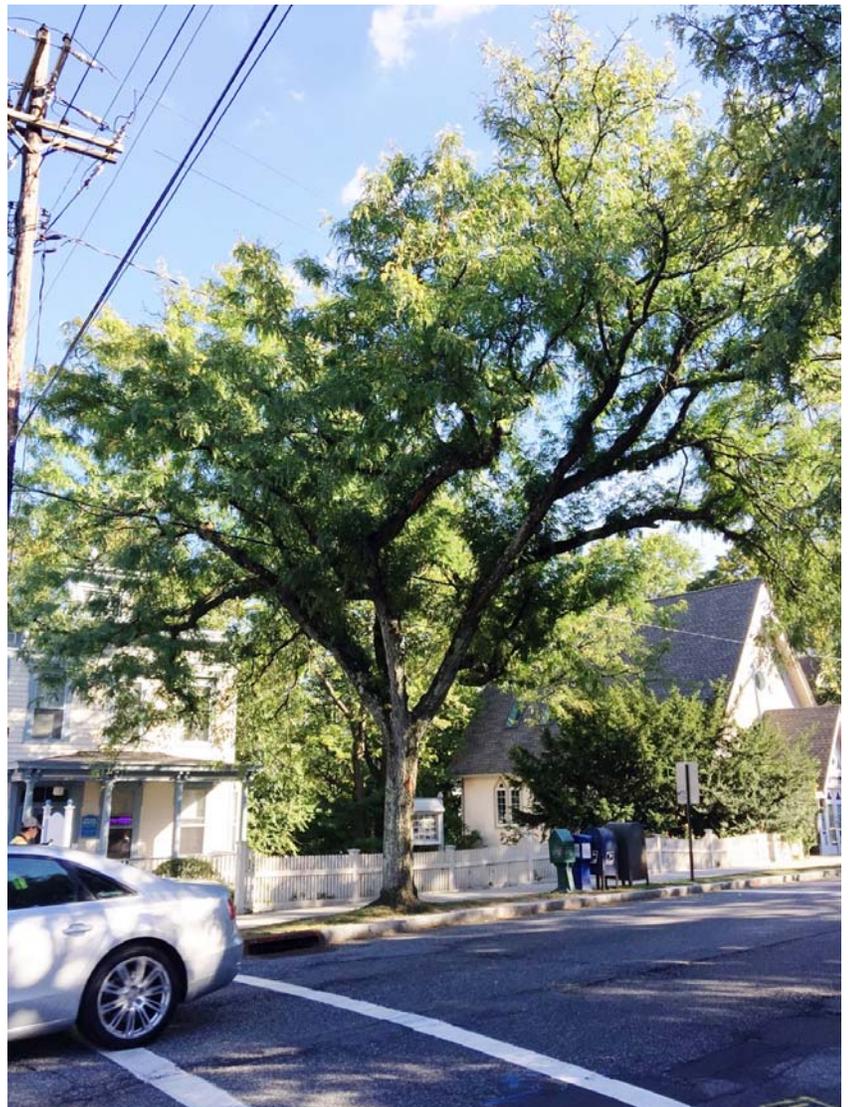
Tree: <i>Gleditsia triacanthos inermis</i> Name: HONEYLOCUST Caliper (DBH): 22	Location: 97 S. Broadway Block No.: Lot No.:	Station Offset:	Tree No. 99
Comments: CODOMINANT LEADER; INCLUDED BARK Condition: 27/32		Date: 9/24/2015 Time: Weather: Sunny Temp: 73 degrees F	
Mitigation Case #:		Cut(-)/Fill(+) (in.):
